Monthly Full Color Journal Landslides: Journal of International Consortium on Landslides

Rain-induced Landslides and Debris Flows on Madeira Island, Portugal

A Large Rock Fall along a Coastal Highway, in Japan

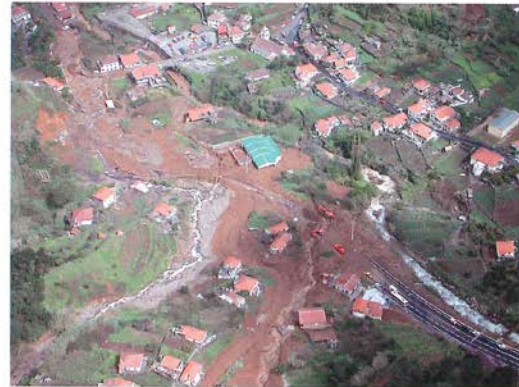
Fig. 2 Oblique airphoto of the debris flow in Rosário area.

In the Sao Vicente valley, rainfall-triggered debris flows and earth flows were widespread. In the Rosario, area two debris flows (Figs. 2 and 3) converged on a road damaging several houses and sweeping away a car containing four tourists, who subsequently died. Several significant earth flows in soils (Figs. 4 and 5) occurred: roads were cut off and a secondary school on a slope nearby was damaged (Fig. 7). The earth flow in the Sao Vicente area affected mostly agricultural fields, many of which were already abandoned due to the poorly maintained irrigation system and the conditions favoring the occurrence of landslides due to water and debris accumulation. The debris flows occurred mainly in streams, initially caused by soil slides, which were transformed into debris slides with the accumulation of vegetation, gravel, and boulders.

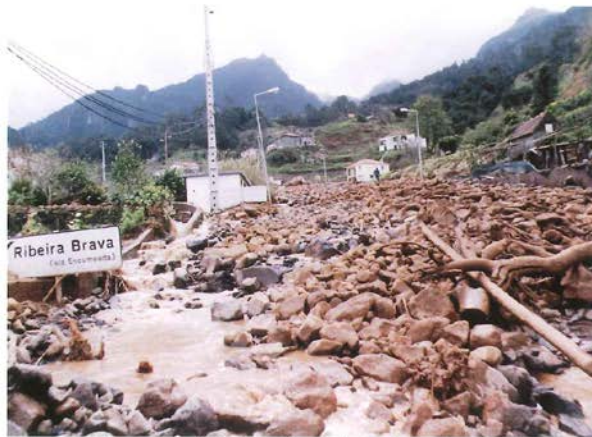
Fig. 3 Debris flow deposits in Rosário area.

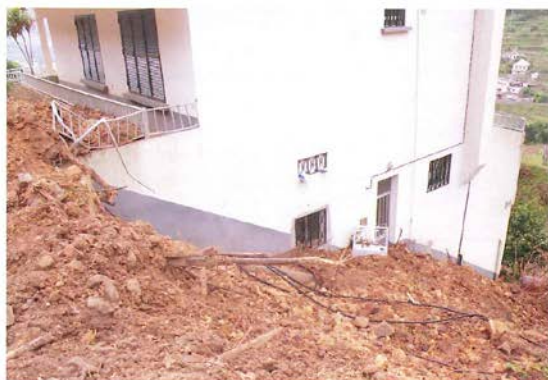
Fig. 5 A house destroyed by the earthflow.

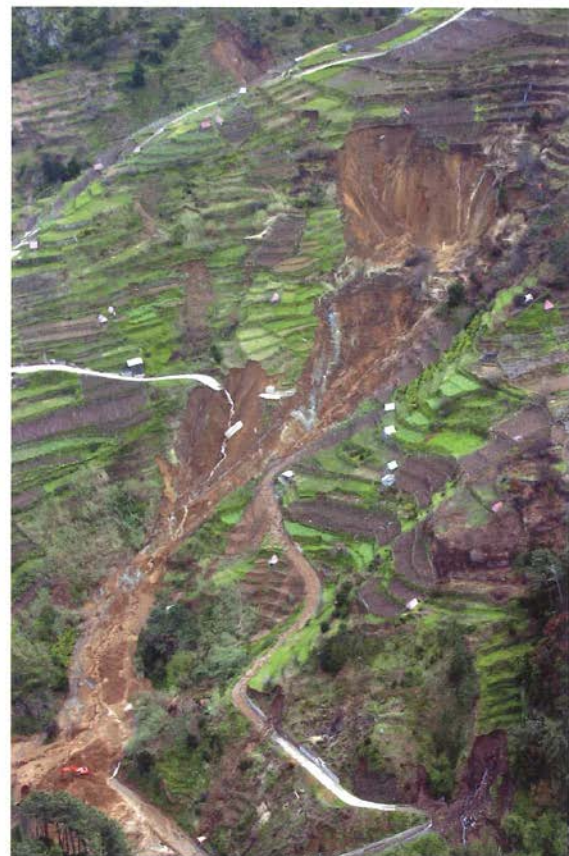
Fig. 4 An earthflow in Sao Vicente valley.

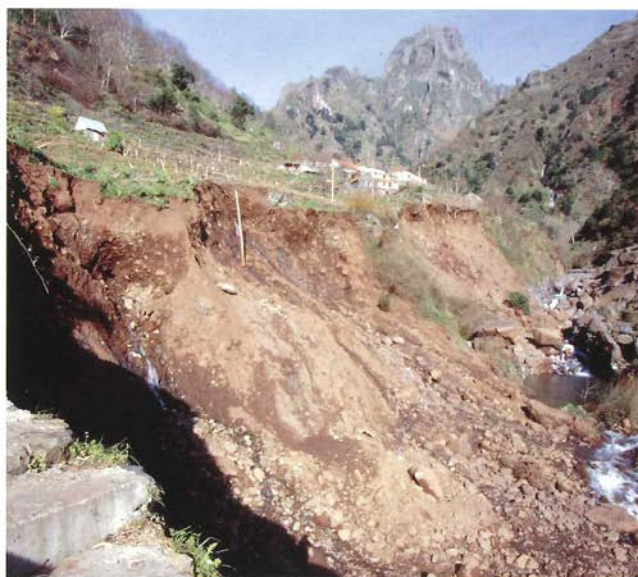
In the city of Curral, one significant slide (Fig 6) and a debris flow (Fig. 7) occurred. The slide took place in consolidated talus deposits at the right hand river-bank; it was caused by river erosion of the channel margin and by water pore pressures. Several houses were evacuated and the immediate area is now considered too hazardous for resettlement. The debris flow occurred in a stream, resulting in deposits of gravel and boulders that buried several houses (Fig. 8).

Fig. 6 Slide in the city of Curral.

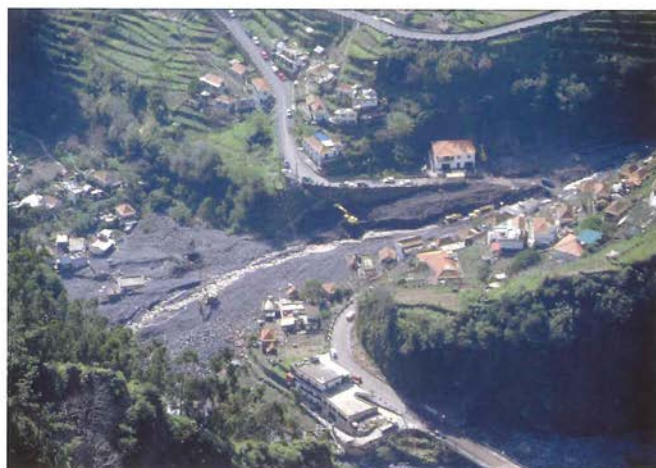
Fig. 7 A debris flow in the city of Curral.

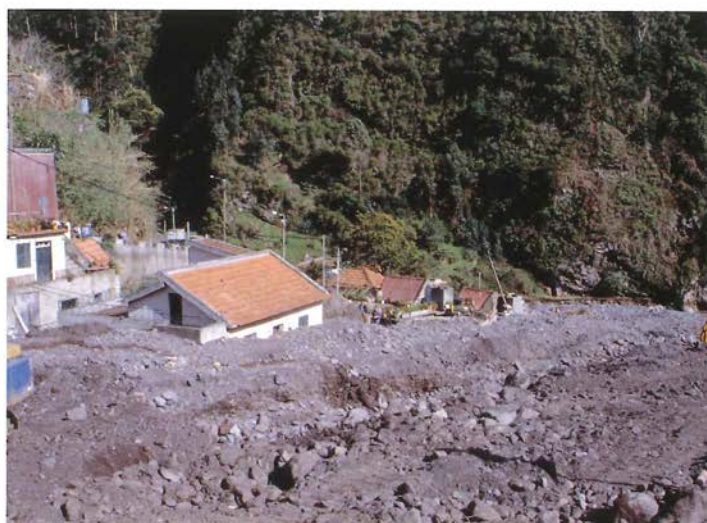
Fig. 8 Houses buried by the debris.

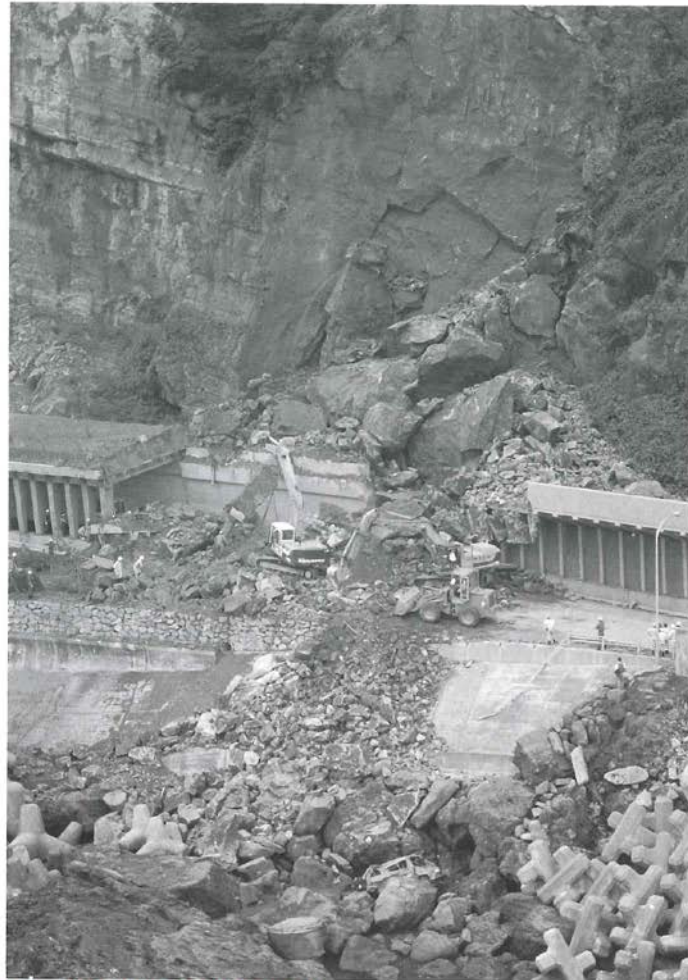
A coastal rock cliff suddenly collapsed onto a rock shed protecting traffic of National Highway Route 305 in Echizen-cho, Fukui Prefecture, Japan, at about 15.20 hrs on 10 July 1989. The collapsed mass was about 30 m high, 30 m wide, and 1,400 m³ in volume; its weight was much greater than the bearing capacity of the rock shed. The rock shed was destroyed for a length of approximately 15 m. Although the retaining wall facing the cliff at the rock shed remained, its crest was displaced approximately 50 cm toward the shore of the Sea of Japan. Unfortunately a micro-bus that happened to be passing this point was crushed, and all 15 passengers were killed (Fig. 1).

The cliff where the rockfall occurred is composed of Miocene volcanic rocks, rising 100 m above the shore of the Sea of Japan. The inclination of the cliff is about 70–80°. The structure of these rock layers is diverse, and the strata are discontinuous. From the form of the rockfall, as rocks which dropped from higher points were dispersed close to the seaside, the rockfall is assumed to be a rock topple.

Fig. 2 The rockfall in Echizen-cho (by courtesy of the Yomiuri Shinbun).

Because, disasters of this sort are significant problems in our country, detailed studies have been continued to clarify the cause of the present rockslide. Also, national checks of road slopes that are in danger from landsliding are being considered so as to avoid a recurrence of similar rockfalls, and rock slides and the resultant disasters.
