2017 IPL SYMPOSIUM ON LANDSLIDES

29 November 2017
UNESCO Headquarters in Paris, France

Organized by
International Consortium on Landslides (ICL)

Kyoji Sassa • Khang Dang *Editors*

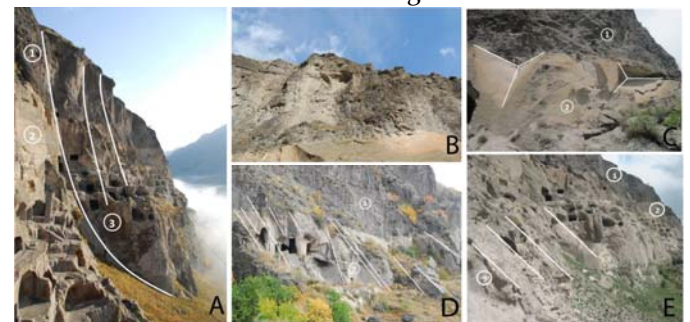
Fig. 3 Slope failure type and processes affecting the rocky cliff of Vardzia. (A) Large roto-translational rock slide involving both layers 1, 2 and 3. (B) Rock fall scarp in the upper part of layer 1. (C) Wedge failure at the contact between layer 1 (on top) and layer 2. (D) High and low angle potential planar rock slide. (E) High and low angle potential planar rock slide.

just above the main Church, to support the rock cliff potential instability, till the very recent rock slide of spring 2011. Following the general scheme of the cross section defined in Fig. 2 and with the aim to provide a preliminary assessment according to slope failure type and processes affecting the entire rocky cliff (from the top to bottom), most failures can be classified into various categories (Cruden 1991; Cruden and Varnes 1996), depending on the combination of the main joint sets and the geo-mechanical and geo-structural conditions of the different layers. Only exception is the large roto-translational rock slide, potentially affecting both layers 1, 2 and 3. With reference to the different levels of Fig. 4, the main rock slope failures can be classified as follow and displayed in Fig. 3.

- a) Large roto-translational rock slide affecting layers 1, 2 and 3 (Fig. 6A);
- b) Rock fall, topple or wedge failure often due to the lack of support of the underlying layer frequently affected by planar sliding (Fig. 6B);
- c) Rock fall of clasts, detached from the matrix of volcanoclastic breccia.

- d) wedge failure and rock falling (Fig. 6C);
- e) high and low angle planar rock sliding along the main discontinuities (Fig. 6D).

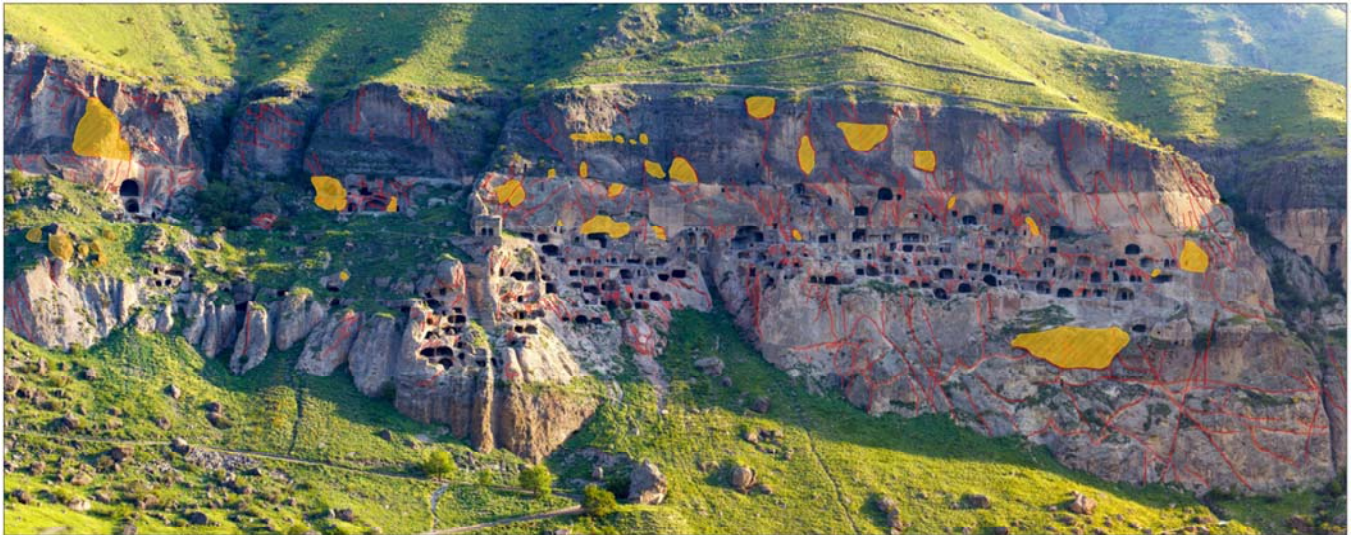
Figure 4. Unstable blocks and joints and open cracks in the Vardzia cliff

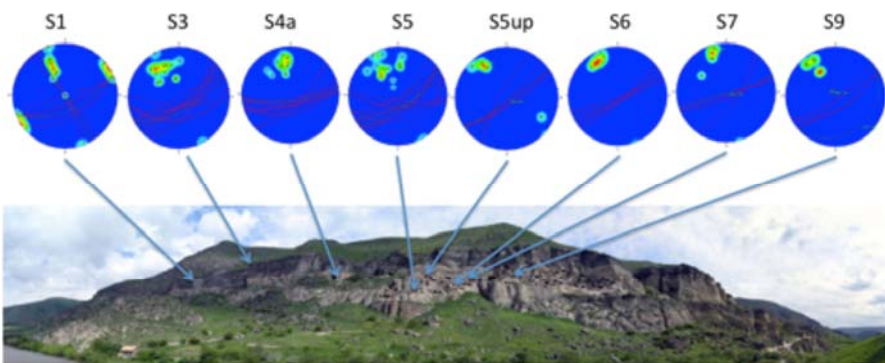
Figure 5. Stereoplots of joint dip measurements from the Vardzia monastery area and kinematic feasibility analyses: a) direct toppling (0,42% of total planes); b) flexural toppling (no critical planes) ; c) planar sliding (32,88% of total planes); d) wedge failure (44,59% of total planes).

the entire study area in order to describe the structural setting of the area and recognize eventual master joints. Rock weathering, slope degradation and instability in the area are the result of different structural combinations of the main joint sets (Spizzichino et al., 2009). Our analyses, although only a preliminary and not exhaustive discontinuity survey was performed over the whole area, allowed to characterize some relevant slope sector in terms of discontinuity orientation. All collected data have been analysed (DIPS® Rocscience software). The rock mass strength has been observed to depend on the density, nature and extent of fracture and rock strength (i.e. lower within the black volcanic breccia, higher within whitish tuff and lapilli tuff). The stereoplots in figure 5 show that the major joint systems are steeply dipping (70°) towards SE (dip direction 140° -165°) and the main results of kinematic feasibility tests are reported in figure 5.

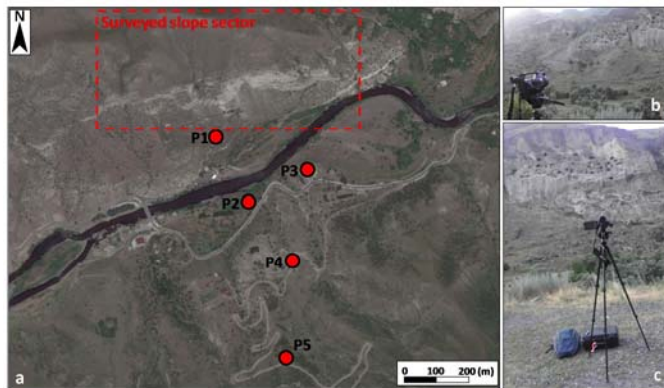
Fig. 8 Vardzia IRT surveys acquisition points (P1=monastery road; P2=GB-InSAR position; P3=river bank; P4=mountain road 1; P5= mountain road 2) (picture from Frodella 2016 field survey).

Field inspections were also carried out during the monitoring campaign in order to validate the outcomes of the remotely sensed data. Various acquiring positions were tested during different times of the day in order to survey the slope scenario daily illumination conditions (Fig. 8).

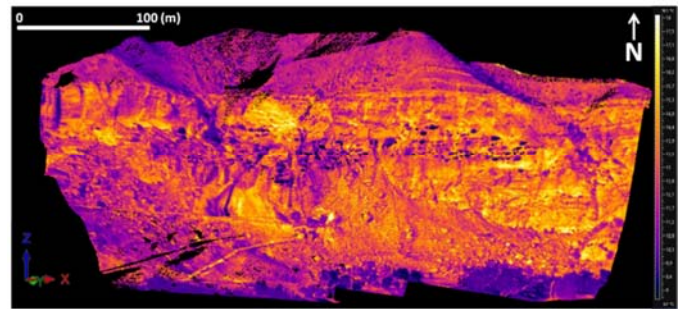
Fig. 9 Mosaicked 3D surface temperature maps of the vardzia monastery, obtained by merging the single thermograms (acquired from P4 position on October 20th 2016 at 15:30 a.m.) with TLS point cloud (picture from Frodella 2016 field survey).

the available terrestrial laser scanning (TLS) 3D model, a refinement of the slope drainage pattern and a 3D mosaicked surface temperature maps of the Vardzia slope was obtained (Fig.9).

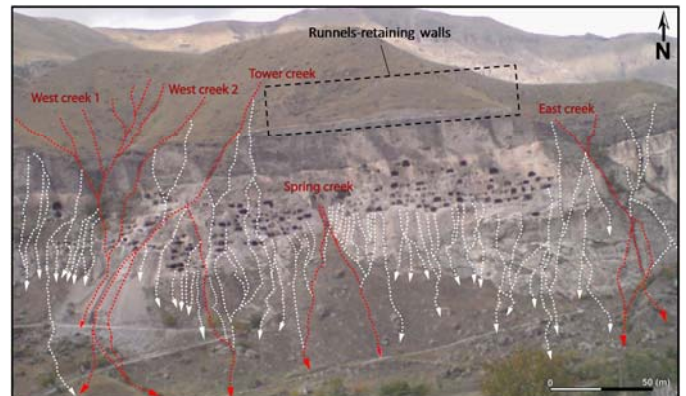
Fig. 10 Inferred pattern of the vardzia slope ephemeral drainage network, including the main detected ephemeral creeks (picture from Frodella 2016 field survey).

This allowed to map the moisture drainage pattern of the overall analysed slope area, for a better understanding of rain infiltration and runoff in correspondence of the slope more critical sectors, as well as the detection of the overall drainage network and the main ephemeral creeks. The monastery slope eastern sector is less affected by the presence of ephemeral creeks, due to the slope conformation and the presence of a runnels-retaining wall system (Fig. 10).

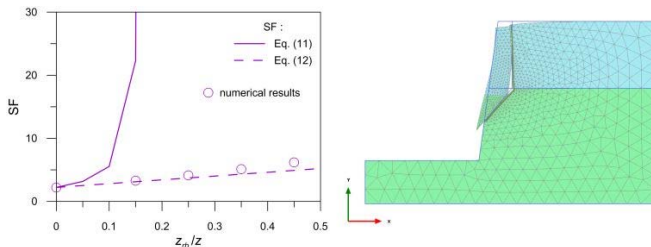
Figure 11. Variation of the safety factor against sliding considering different percentages of rock bridges along the breccia joint for the simplified model with two discontinuities: comparison between limit equilibrium and numerical results ($Lrb/L = 0.45$) (on the left) and deformed mesh at failure ($zrb/z = 0.15$) (on the right) (Boldini et al., 2017).

The stability analysis on some potential unstable blocks was carried out (both numerical and analytical methods), using the limit equilibrium method. For each individual block detected in the period 2013-2017 a detail local stability analysis was performed (Fig. 11).

All the simulation shows that only the presence of rock bridges along the base and the sub-vertical joints has guaranteed the current stable conditions. In conclusion, stability analysis in Vardzia site and related design of mitigation measurements, cannot disregard a proper investigation and estimation of rock bridges contribution.

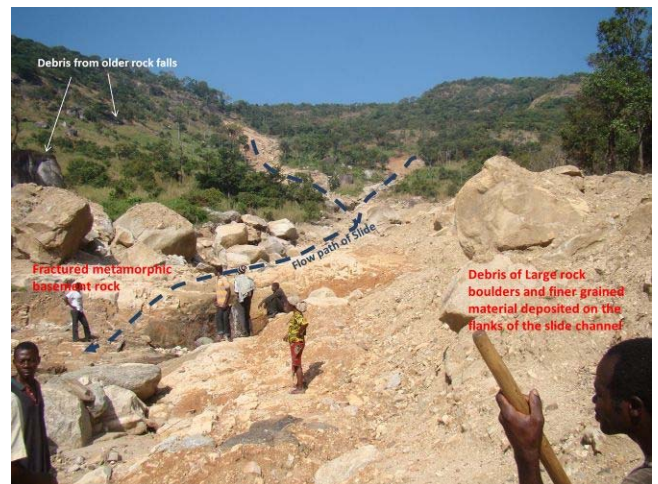
Fig. 6 The 2010 complex avalanche at the Nigeria-Cameroon border

lithology, structural discontinuities, and erosion. It is noted that wide human interference in different areas for mining, road constructions, change in land use, buildings, bush burning, deforestation and global warming have contributed to slope instability and subsequent landslides in Africa. The rise in the number of long travel landslides in Africa is mainly due to this factors. Avalanche was not know in nigeria, and was rarely known in Africa until the 2010 debris-rock complex avalanche at the mountain range bounding Nigeria and Cameroon (Fig. 6).

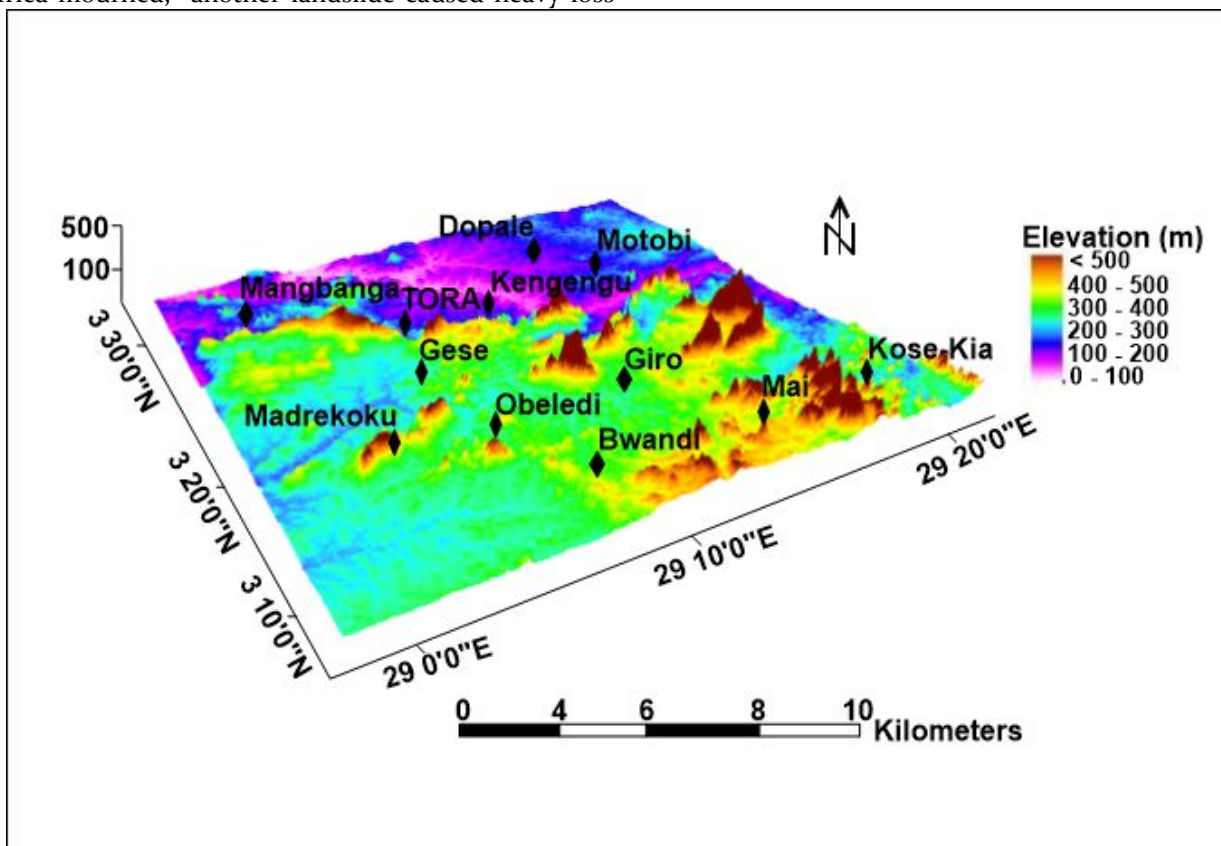
Figure 11 3D ASTER DEM of the Tora landslide DR Congo revealing the geomorphology of the area

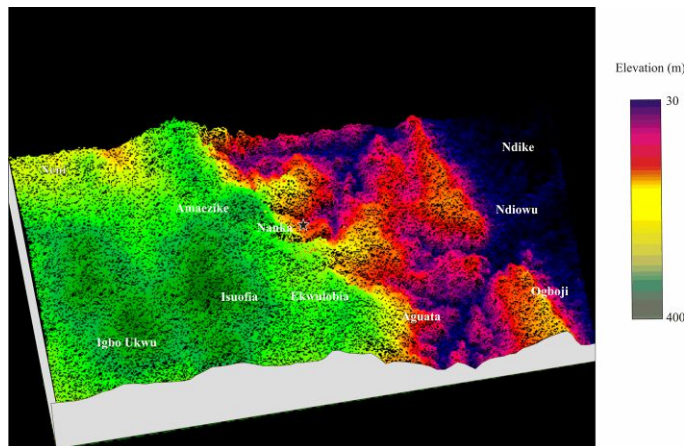
Figure 14 3D DEM of Nanka landslide

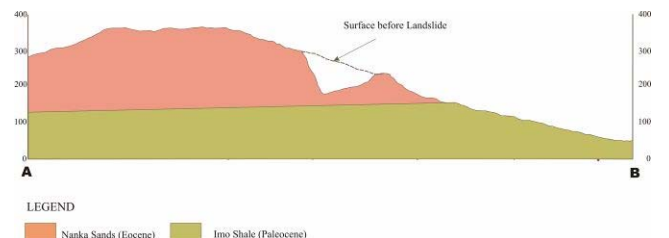
Figure 16 Cross-section of the Nanka landslide

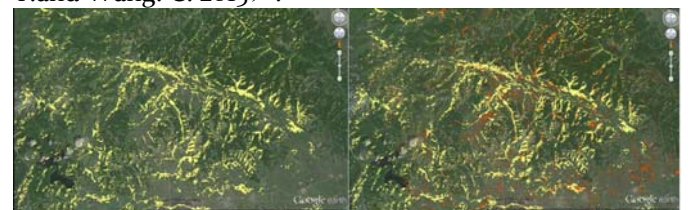
Figure3 A: PF distribution using Landsat 7 ETM+ Imagine data,2012; B: PF distribution and the surface deformation

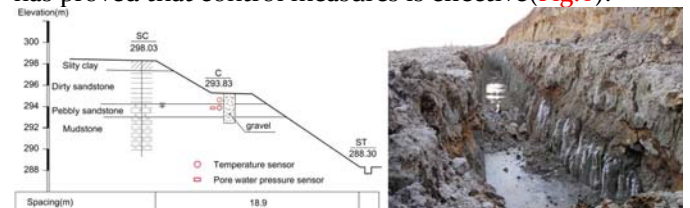
Figure 6: Gravel blind ditch along the cutting slope

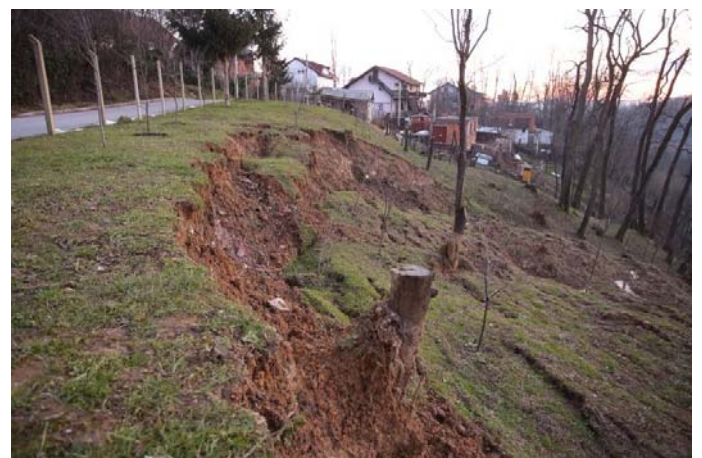
Figure 2 Typical soil slide developed in Plio-Quaternary soils in the City of Zagreb. The cause was concentrated flow of superficial water from road which activated sliding during heavy precipitation in 2013 (Bernat Gazibara et al. 2017b)

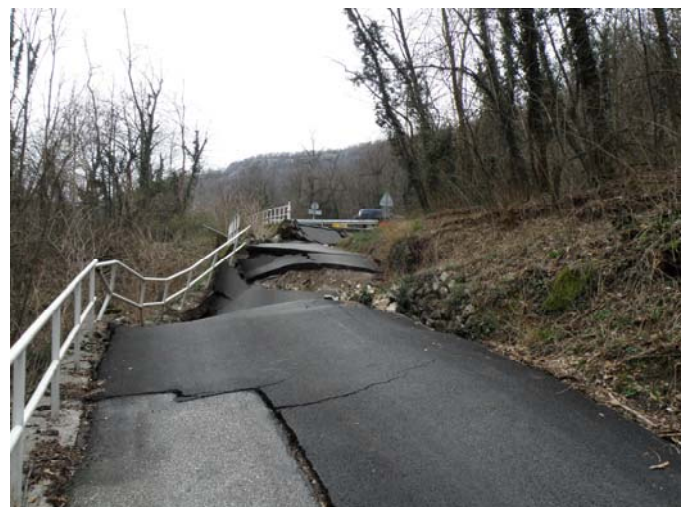
Figure 4 Valići Landslide developed in flysch-like rock in the Rječina River Valley. The cause was heavy precipitation in February 2014 (Mihalić Arbanas et al. 2017)

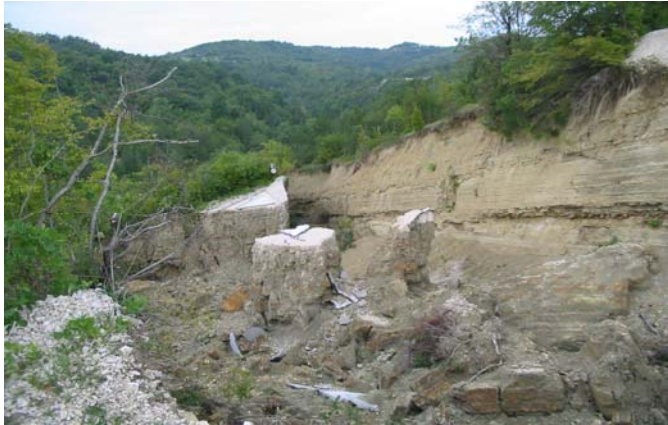
Figure 5 Atypical block slide developed in flysch-like rocks in Istria which belongs to “Gray Istria”. The trigger was heavy rainfall in 2004 (Arbanas et al. 2010)

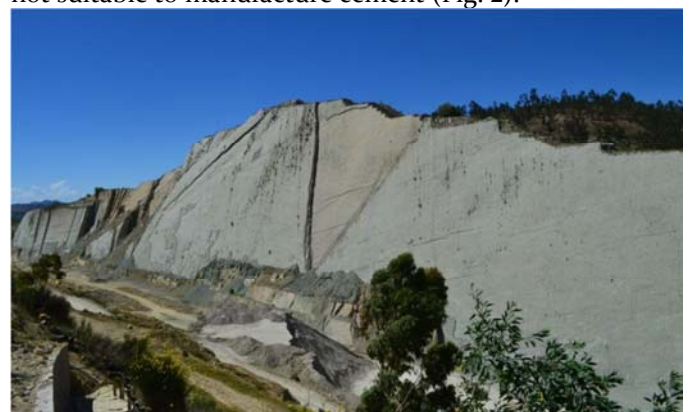
Figure 2 A partial view of Calorcko paleoichnic cliff. In the middle, the so called "advanced deterioration triangle" collapsed in February 2010.

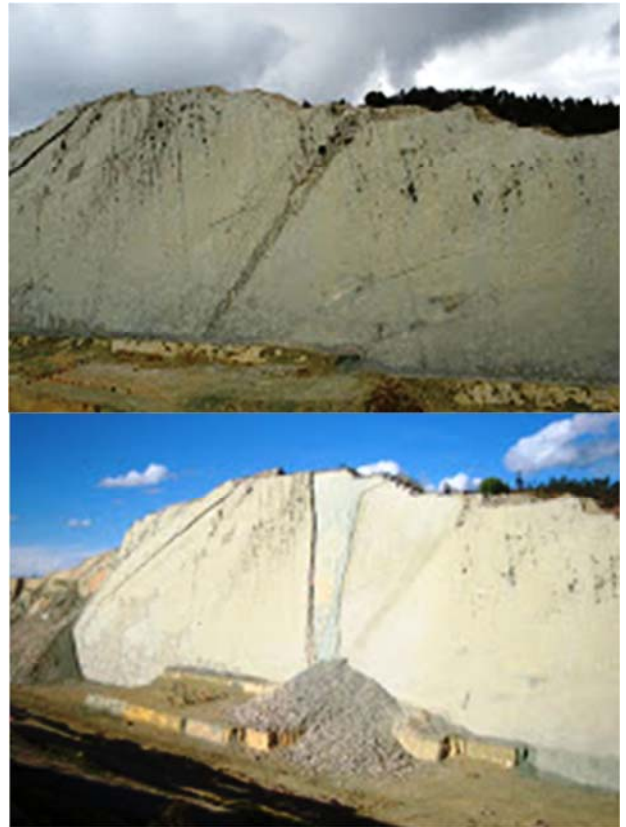
Figure 4 The paleoichnic cliff before and immediately after the February 2010 dip slope failure (Pictures: Willy Jordán)

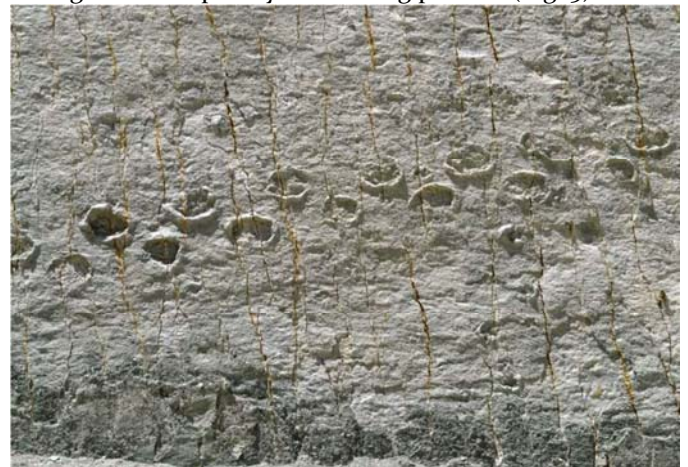
Figure 5 Synsedimentary cracks worsened by the elastic rebound

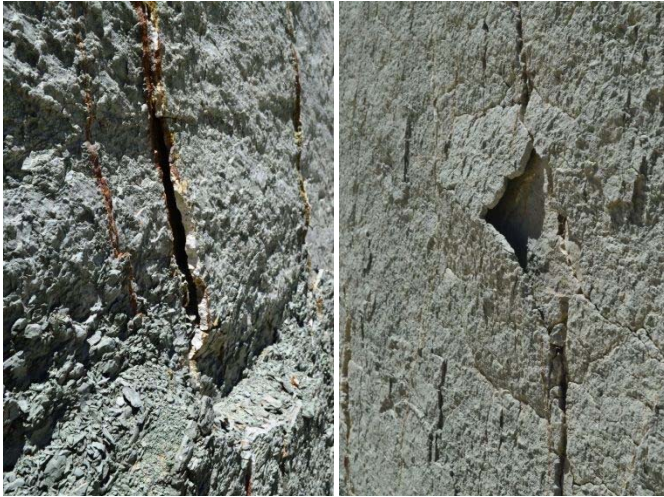
Figure 6 Elastic rebound effect on the paleoichnic crust.

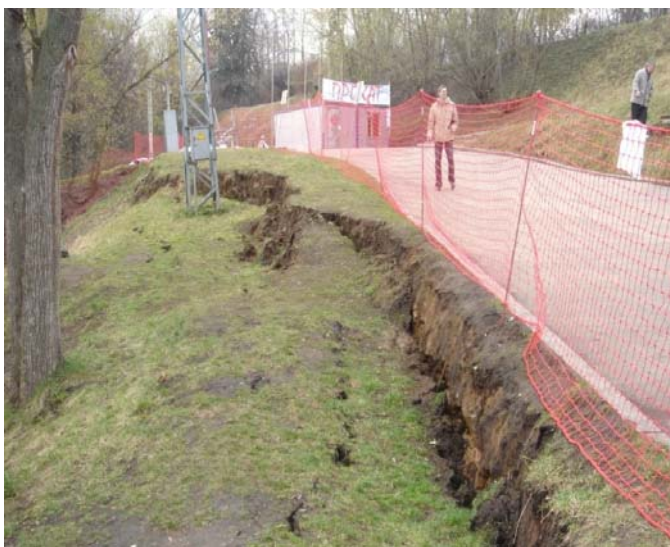
Figure 2. Landslide formed in Quaternary deposits in 2006.

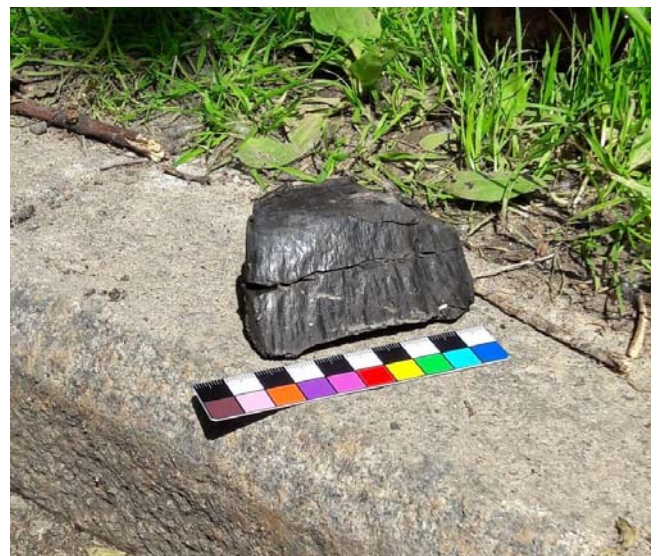
Figure 3. Slickenside in Oxfordian clay (borehole 7-K)

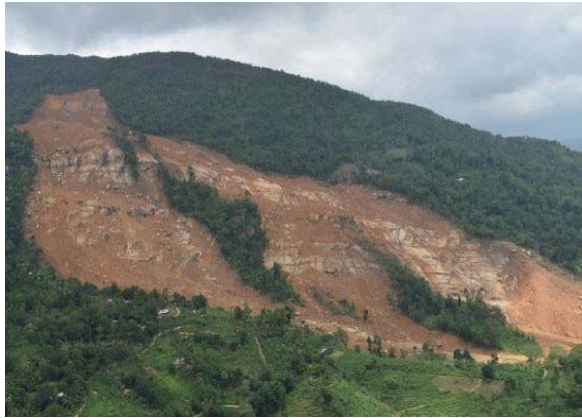
Fig 1: May 2016 Aranayake landslide in Kegalle District, Sri Lanka, which killed 127 people. The image indicates landslide failure initiated in residual soil and boundary intact with weathered rock face.

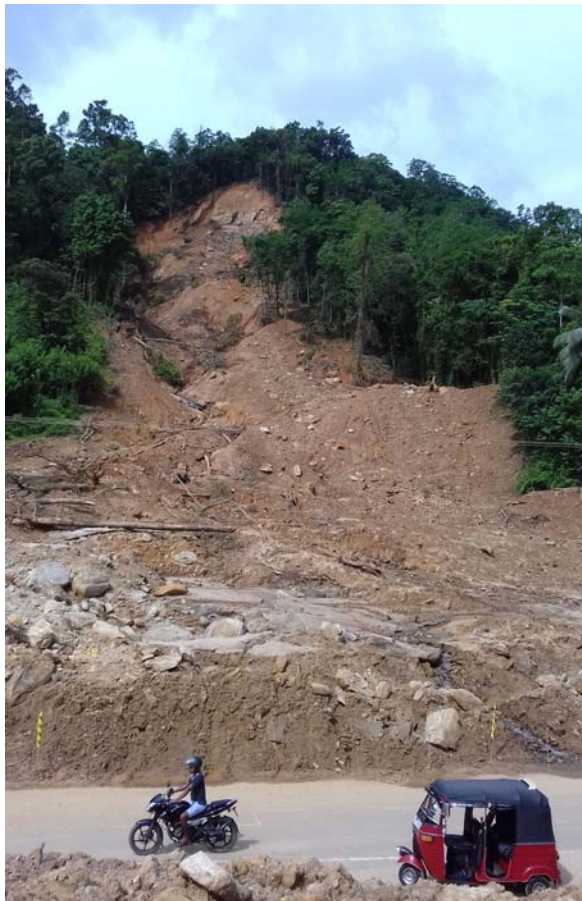
Fig 2: May 2017 Athwelthota landslide in Kalutara District Sri Lanka, which killed 09 people. Landslide was initiated from residual soil origin.

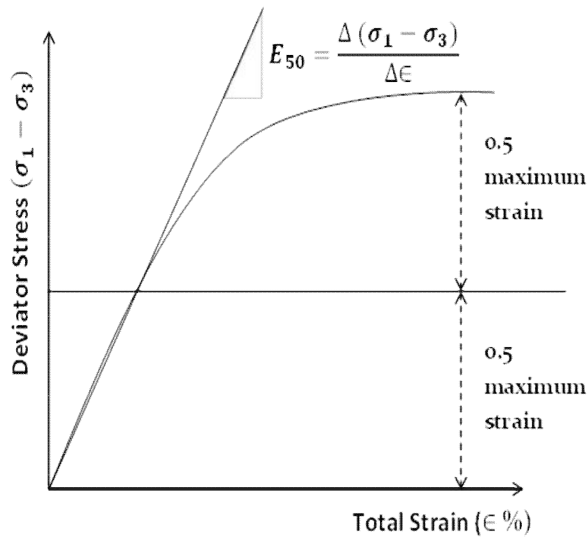
Fig. 3: Determination of E_{50} in a standard stress - strain plot of Consolidated Undrained Triaxial Test

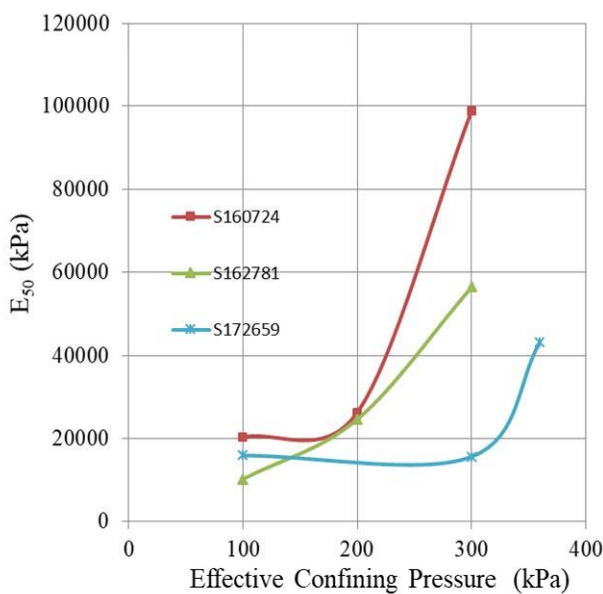
Fig 13: Effective confining pressure Vs E_{50} for samples of S160724, S162781 and S172659

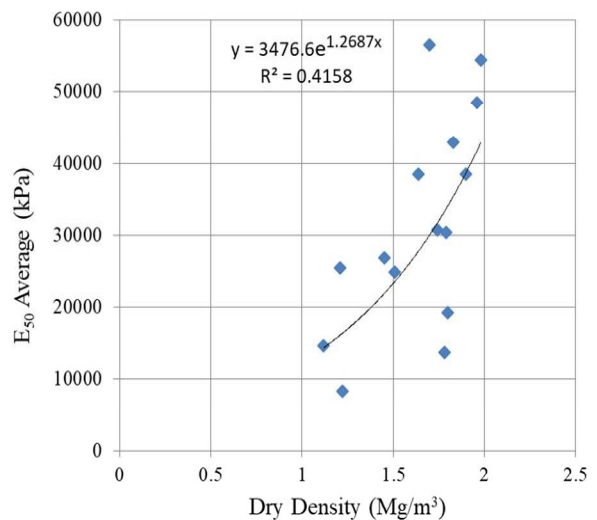
Fig 15: Interpretation of Dry density Vs Average E_{50}

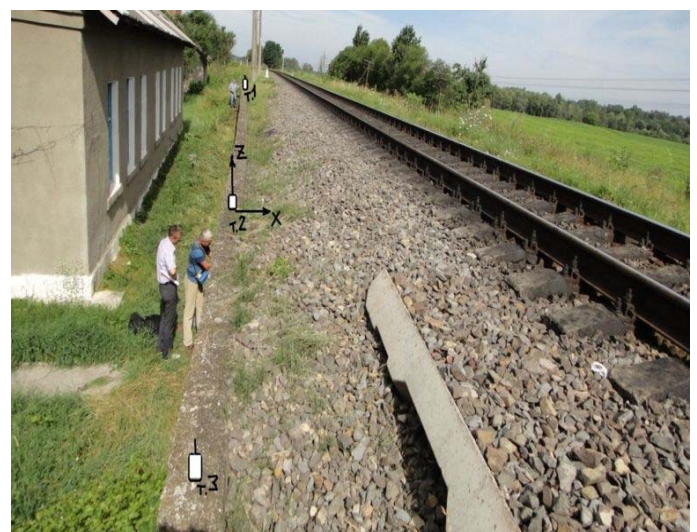
Figure 1 Location of vibration pickups during the inspection of the retaining wall.

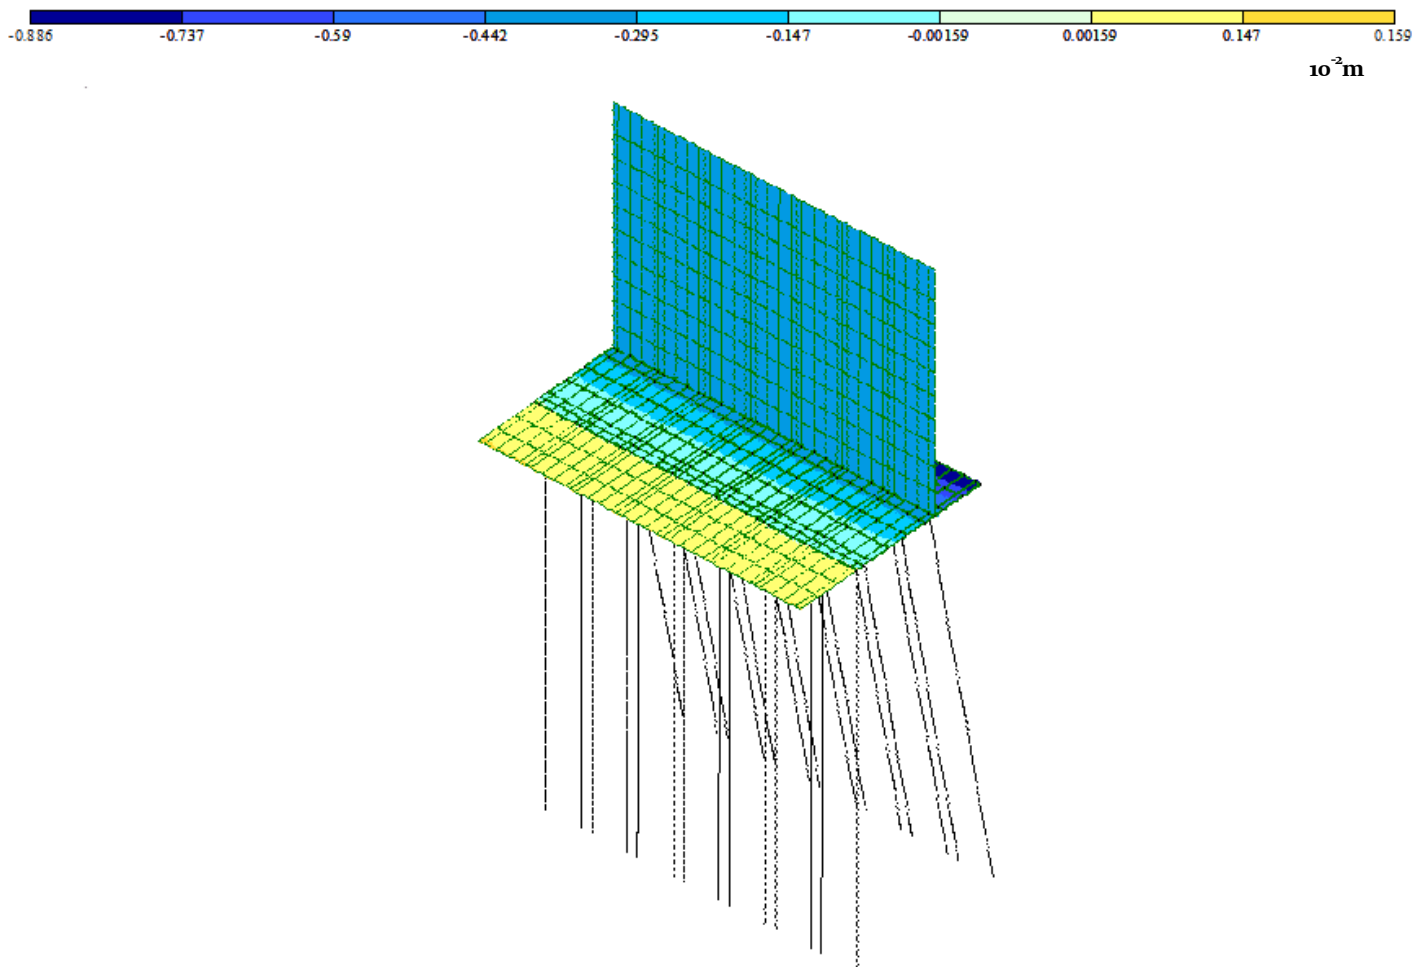
Figure 3 Izofields of vertical movements of the retaining wall along the Z axis at seismic loads acting at a right angle to the railroad bed.

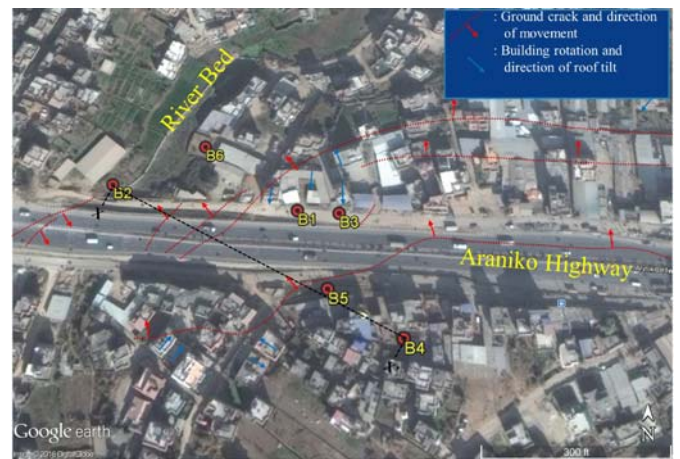
Figure 5 Location of sub-soil exploration points and landslide cross section used in the numerical analysis.

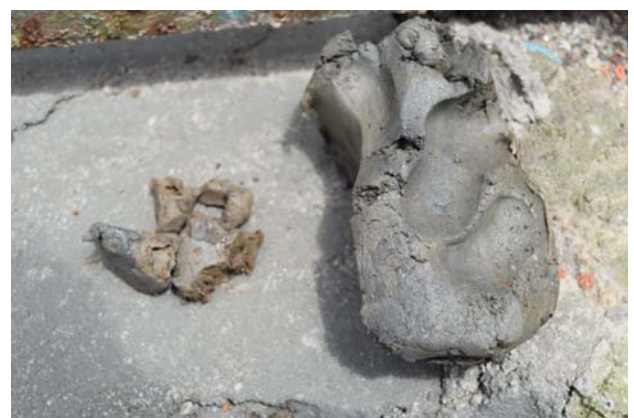
Figure 6 Soft clay observed at the site.

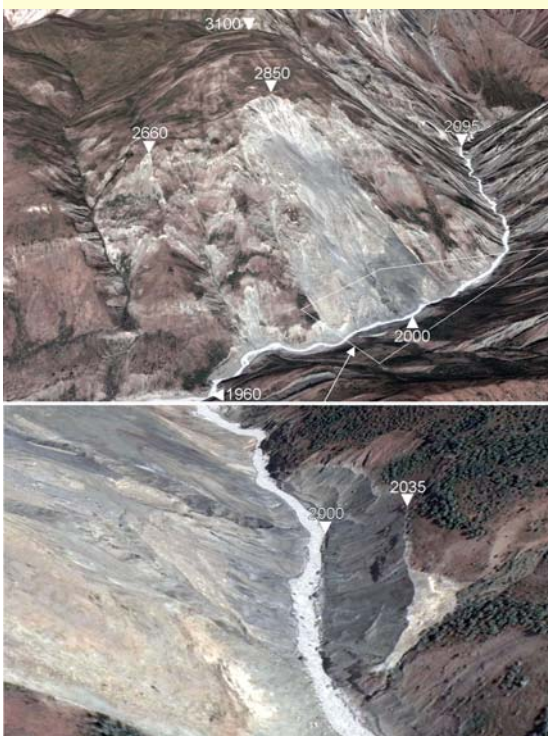
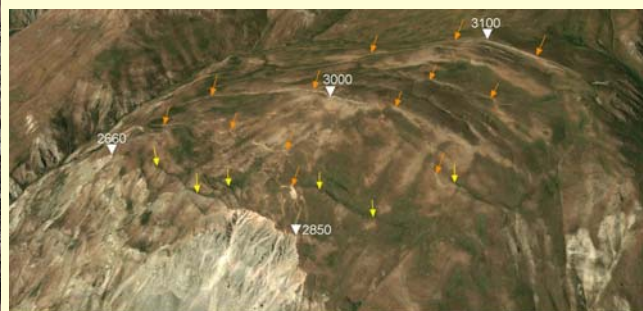
System of fractures on top of the ca. 1 km high slope and schematic profile of the Ragnow River valley
