**COMPENDIUM  
2nd Central American and Caribbean  
Landslide Congress**

**July 18th- 20th, 2016 / 8:00 AM - 4:00 PM  
Tegucigalpa, Honduras.**

**Special Issue:**  
**Second Central American and  
Caribbean Landslide Congress**  
**18-20 July 2016**  
**Tegucigalpa, Honduras**

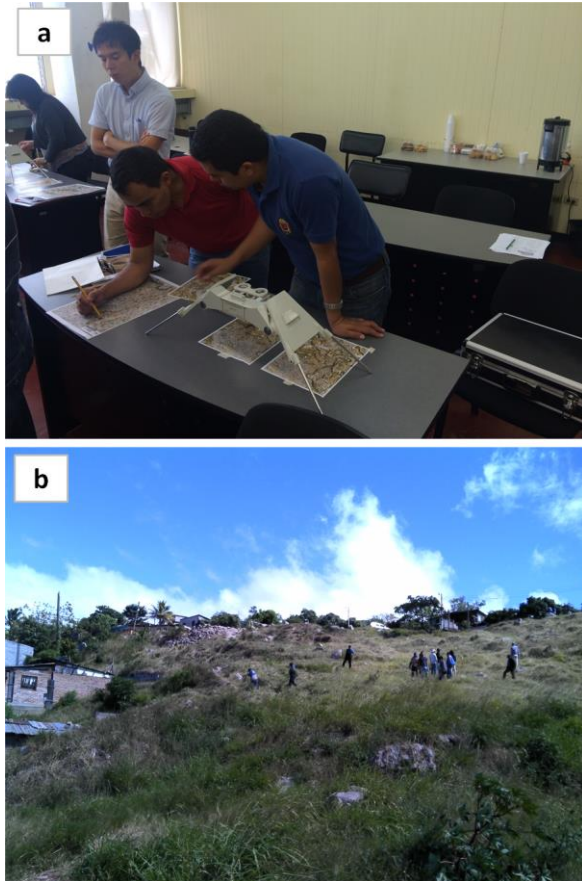
Fig. 1 a. Training session in stereoscopy for the landslide inventory mapping of two neighborhoods recently affected by landslides in Tegucigalpa, Honduras. b. Fieldwork inspection in one of the landslide sites of the Nueva Santa Rosa neighborhood, which experienced a major activation in 2012. The reconnaissance was done in April, 2016

The latest research initiative proposed by JICA is the implementation of pilot projects in two neighborhoods in Tegucigalpa recently affected by landslides (Kuwano et al., 2016). Fig. 1 shows photographs of the training and fieldwork sessions in the Nueva Santa Rosa and El Eden neighborhoods. For both neighborhoods, L. Torres et al. (2016) stress the importance of developing landslide inventories for future studies. Hirota (2016) has investigated how the relationship between geology and landform brings about landslide occurrence in these two neighborhoods. Sato et al. (2016) has proposed the use of high-resolution topographical data to complement the

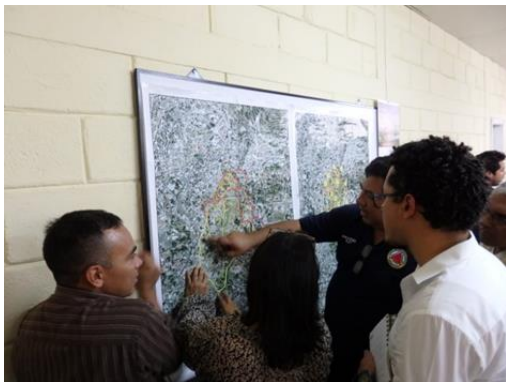
Fig. 1 Example photo of making a landslide distribution map.

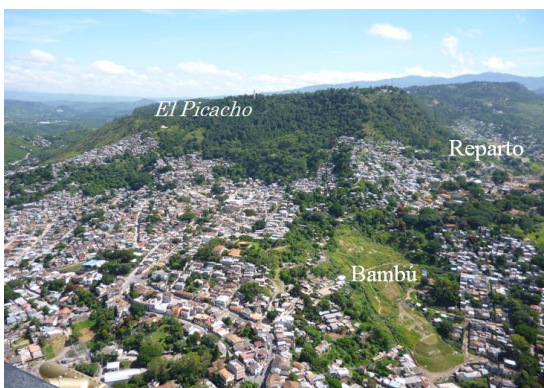
Fig. 4 South side slope of *El Picacho* with landslides *Bambú* and *Reparto*.

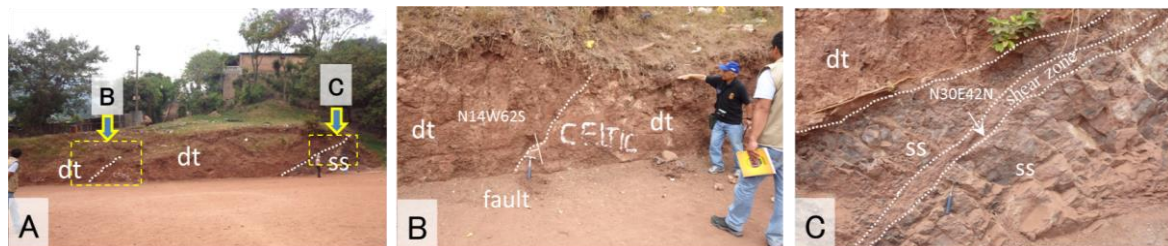
Fig. 8 Site-1 as listed on Figure 7: outcrop with faults at Nueva Santa Rosa. A: Outcrop, B: fault with strike/dip of  $N14^{\circ}W62^{\circ}S$  in detritus (dt), C: fault with strike/dip of  $N30^{\circ}E42^{\circ}N$  in sandstone (ss).

Site-1 has two faults (Fig. 8). The first fault strikes at  $N14^{\circ}W$  and dips  $62^{\circ}S$  in detritus (Fig. 8B). The second fault strikes at  $N30^{\circ}E$  and dips  $42^{\circ}N$  in sandstone (Fig. 8C). Site-2 is composed crushed pumice tuff due to the fault's movement (Fig. 9A). Site-3 is composed of pumice tuff (Fig. 9B, 9B'). Site-4 is composed of sandstone and pumice tuff, in which two of the faces are in contact with fault (Fig. 9C). The fault strikes at  $N32^{\circ}E$  and dips  $57^{\circ}S$ . The pumice tuff is crushed into fine particles and composed of massive broken tuff blocks.

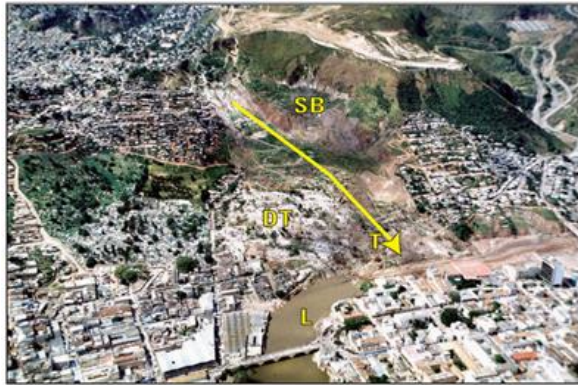
Fig. 1 Aerial view of the land called the Berrinche, followed by subsidence / rotational flow. The arrow indicates the direction of displacement of the whole landslide body. "T" denotes the sliding to the river; the "L" indicates the lake dammed by landslide. (Harp et al., 2002)

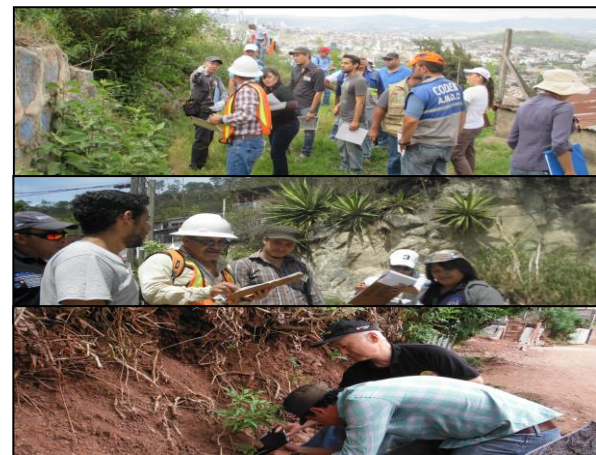
Fig. 3 Photographic overview of the different field activities done for obtaining susceptibility maps

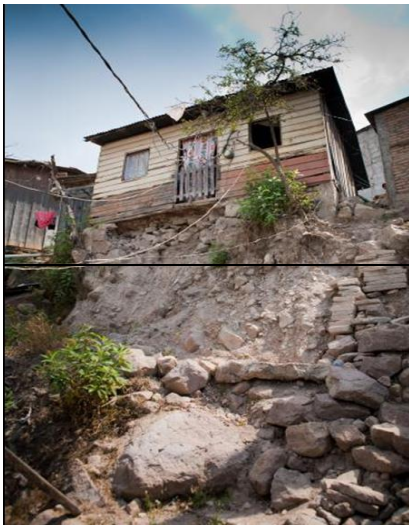
Fig. 3 Neighborhood exposed to landslides in Tegucigalpa

- unplanned urbanization and housing development (see Fig. 3)
- increased erosion due to removed vegetative layer and other excavations to the natural terrain
- increased impermeable surface and inadequate surface water management
- construction of major highways crossing landslide zones without assessment of the effects of the vibrations from heavy traffic volumes on landslide hazard.

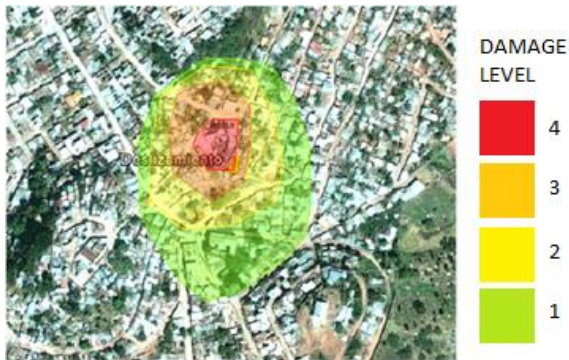
Fig.2 Illustration of the impact of a previous landslide that occurred in the area. The higher the number of damage level according to the legend, the higher the severity of the impact in a specific zone

The suffered damage in this zone is presented with different characteristics (e.g. mass movement, soil instability, loss of structural support) and these lead to the land to be loose and fail (see Fig. 2 and 3) another damage suffered is in the structures of the water service and waste water systems, where the mass movement had taken the pipes to fracture and this limits the services and the fluids can contaminate the area.

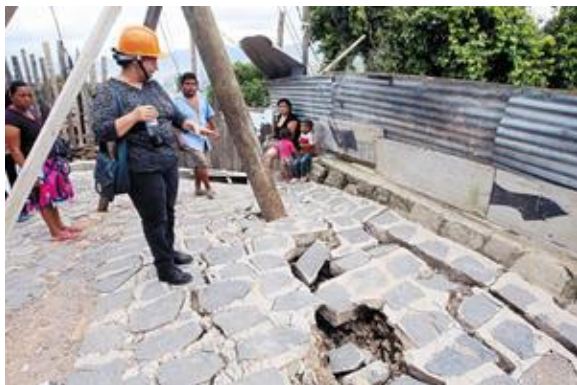
Fig.3 Location of a damage level 4 (see Fig. 2), presenting the structural damage of the road (Photography by Xiomara Robleda, 2013).

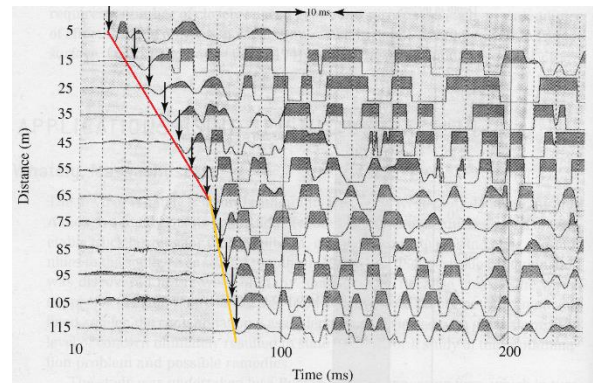
Fig.5 Illustration of the recorded signals from the geophones arraign and variation that appears on the record from the phenomena of the Head wave. (Rodriguez 2013)

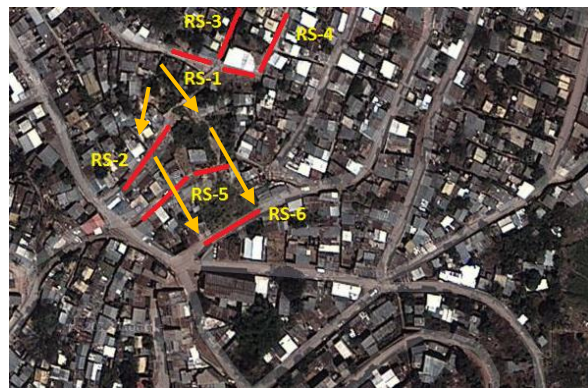
Fig.6 Illustration of the seismic refraction profiles that were made to study the layering of the zone (Source for basemap: www.google.com/maps)

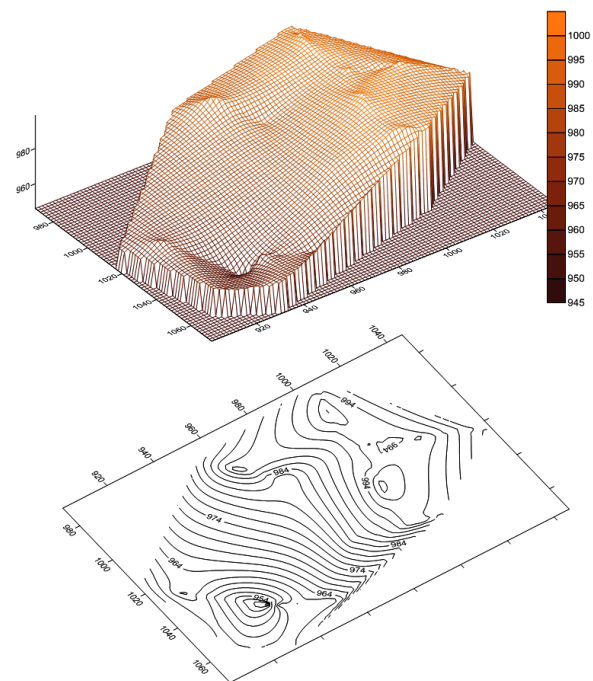
Fig. 8 3D model made from the seismic refraction profiles considering only the information for the lower layer of the model and the continuity of the medium, the model show the form of the lower layer respective to its elevation as shown the values in the colour bar legend

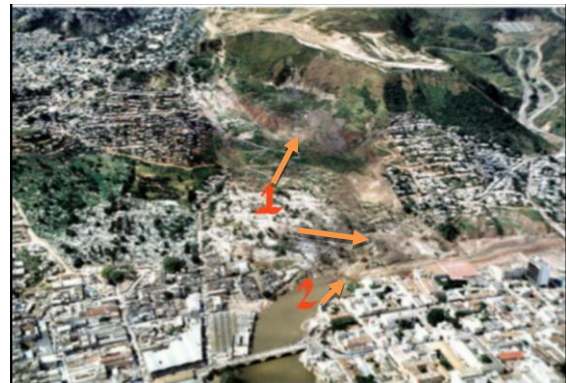
Fig. 1 Frontal view of the landslide in Berrinche (1). Landslide from the top and toe portion of the mountain (2). The dam formed in the Choluteca River due to the soil deposited from the landslide. (Harp et al, 2002).

Aside from the destruction of these houses, the soil from the landslide was deposited at the bottom of the mountain where the Choluteca River crosses. This material blocked the water from following its natural course, causing a dam to form and consequently flooding the city as can be seen in Fig.1.

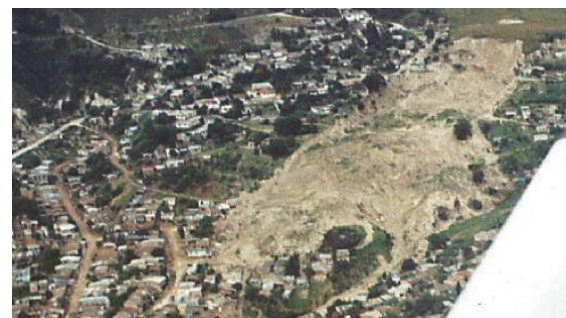
Fig. 2 Frontal view in Reparto. (Harp et al, 2002).

The landslide in Reparto had approximately 400,000 cubic meters of soil that destroyed the houses in this area, as seen in Fig. 2 (Harp et al, 2002).

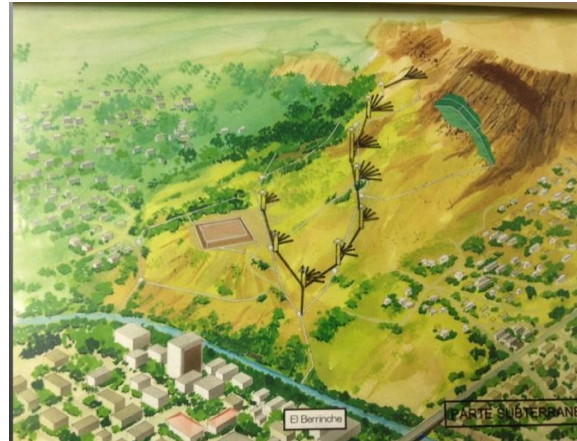
Fig. 3 General layout of countermeasure works in Berrinche. (CCI&ESS, 2011)

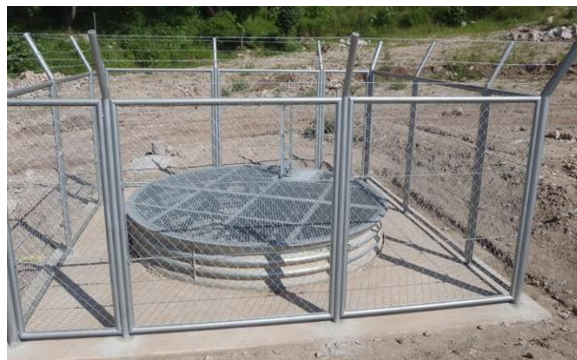
Fig. 4 Drainage well from the outside, with its protection cover and surrounding fence to avoid intruders. (Taken by Froilán Castro, 2013)

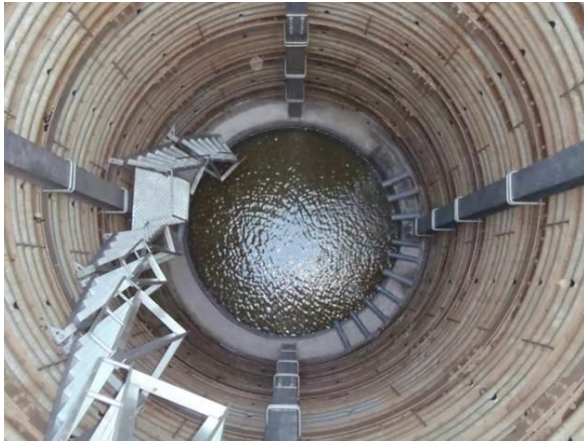
Fig. 5 Drainage well seen from above with its ladder for maintenance and at the bottom water is captured from the intake pipes. (Taken by Froilán Castro, 2013)

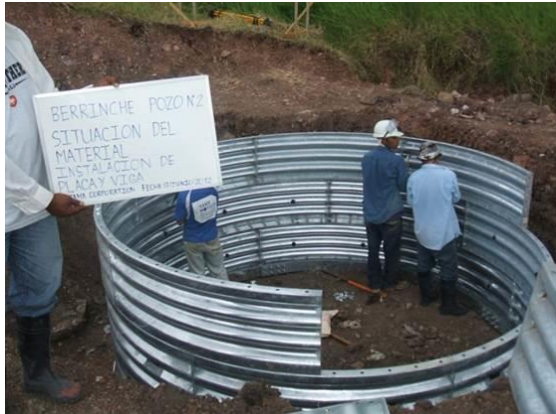
Fig. 6 Liner plate installation. (Taken by Froilán Castro, 2013)

Once the first liner plates were set, as seen in Fig.6, the top concrete base was casted. The process of excavation and liner plate setting continued. When the telescopic excavator was not able to reach any further, a mini excavator was placed inside to continue with the excavation until the design depth was reached.

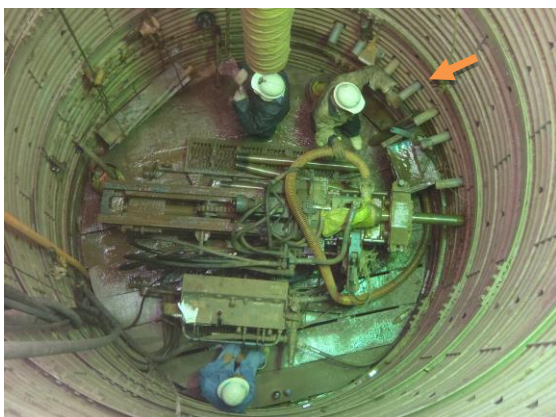
Fig. 7 Drilling of intake pipes. (Taken by Froilán Castro, 2013)

Following the well excavation, the drilling team would enter the well as seen in Fig.7. First, the drainage pipe was drilled and installed with a declining angle to drain water by gravity. This allowed water from the

The team would then drill the intake pipes. These were PVC pipes with a diameter of 40 mm. Ten pipes were placed in each level, each one with 50 meters in length and with small perforations on the top portion to allow water to come inside the pipe. Some drainage wells had two levels of intake pipes if the underground water level was really high in the surrounding area.

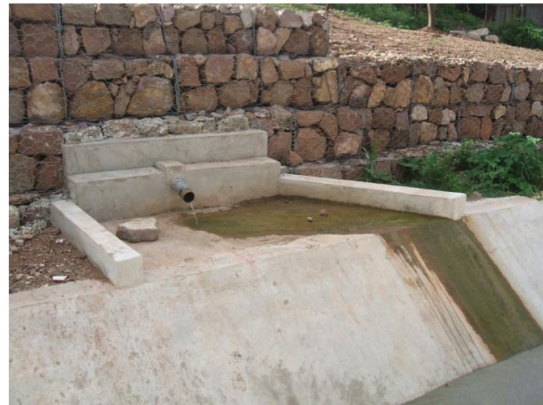
Fig. 8 Drainage pipe from well No.6 in Berrinche connected to the canal to finally discharge to the river. (Taken by Froilán Castro, 2013)

drilling works to be evacuated as well as the water brought into the well when the intake pipes were installed. The drainage pipe was a steel pipe with a diameter of 90 mm. One well was connected to the next well through the drainage pipe, until finally one of the wells had the drainage pipe that reached a canal which would finally discharge the water to the river Choluteca in the case of Berrinche and to the residual waters canal in Reparto, as seen in Fig.8 and Fig. 9.

The canals were constructed along the roads and along the landslide area to evacuate rainwater and avoid the soil from saturating. These canals reach the bottom portion of the mountain to discharge the rainwater as well as the underground water coming from the drainage wells. To avoid soil erosion from blocking the canals some of them have concrete on the sides with rocks at certain intervals as seen in Fig.10, while others have gabions as seen in Fig.8.

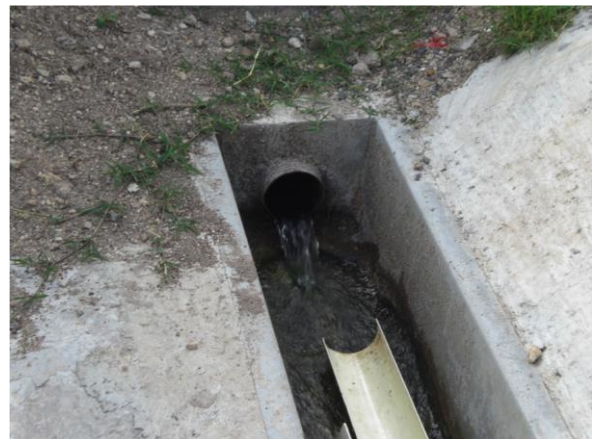
Fig. 9 Drainage pipe from well No.2 in Reparto connected to the canal to finally discharge to the residual waters canal in this area. (Taken by Froilán Castro, 2013).

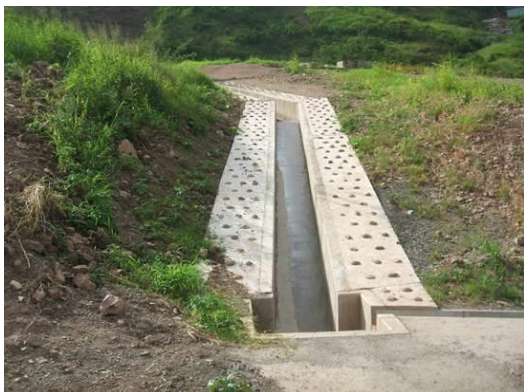
Fig. 10 Canal with concrete sides (Taken by Froilán Castro, 2013)

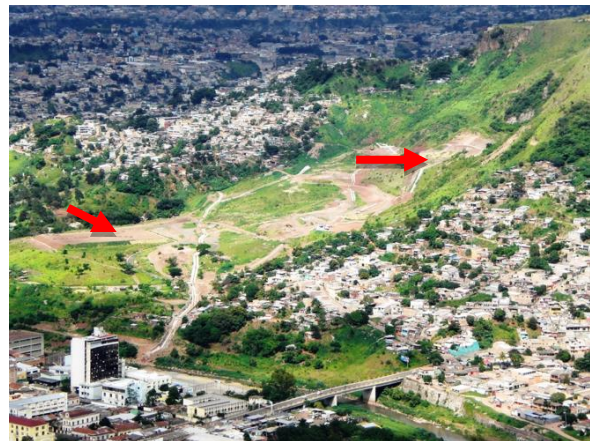
Fig. 11 In Berrinche, soil was removed from the top and compacted at the soccer field area, acting as a counterweight. (Taken by Froilán Castro, 2013)

Soil from the top portion of the mountain was excavated to reduce weight and transported to the bottom portion. Here it was compacted to act as a counterweight to the mountain allowing overall greater stability, as seen in Fig.11.

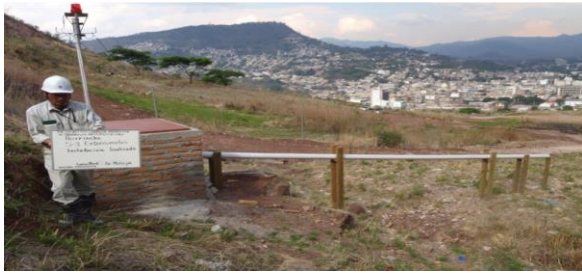
Fig. 12 Extensometer. (Taken by F. Castro 2012, F., 2012).

They measure displacements on the surface ground. The extensometer is placed in a protection box and from here a cable is extended protected by a PVC pipe with the end on a wooden stick, as seen in Fig.12.. If the ground between the extensometer box and the wooden stick moves, the cable will be pulled and data will be taken in mm/hr. An alarm is set in case a displacement of more than 2 mm/hr occurs (CCI&ESS, 2011). This does not mean a landslide is occurring but maintenance personnel must check the area and keep monitoring the site.

During the construction works no displacements were detected. Unusual readings occurred due to locals moving the cable.

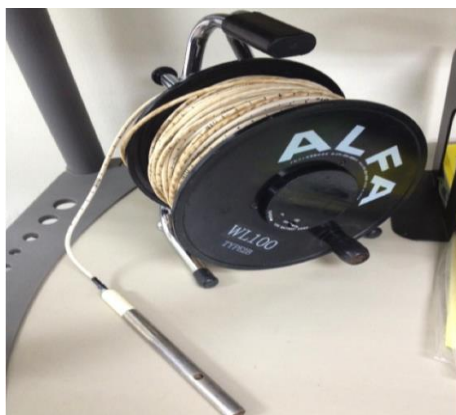
Fig. 13 Underground water level meter (Photo by author, 2013)

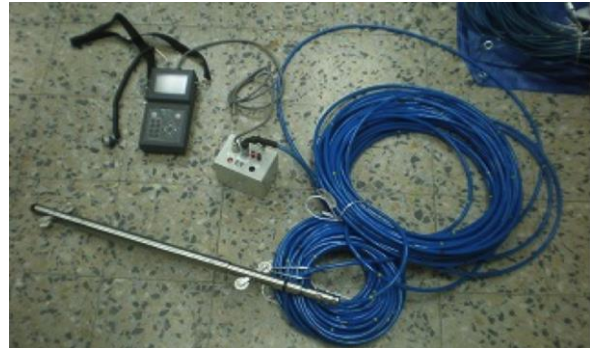
Fig. 14 Inclinometer. (Photo by author, 2013).

Inclinometers, shown in Fig.14, are used to make a profile of the underground soil. A pipe must be vertically drilled up to a certain depth. The inclinometer is inserted and readings are taken every 50

cm to create the profile. Overtime, these profiles can be compared to see if movements have occurred.

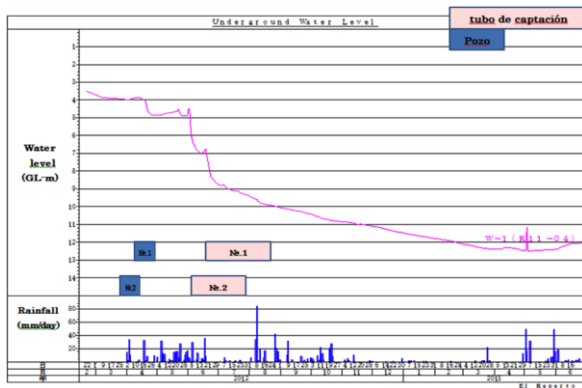
Fig. 15 The graph shows at the beginning of the projects, water was found 3 meters beneath the surface in Reparto. As the construction of the wells and pipes started, the water was discharged and at the end of the construction, water was found at 12 meters below the surface. (CCI&ESS, 2013)

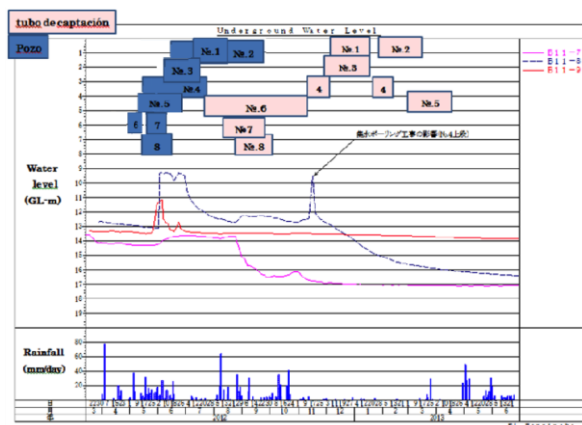
Fig. 16 Changes in underground water level can be seen from the three underground water level meters installed in Berrinche. (CCI&ESS, 2013).

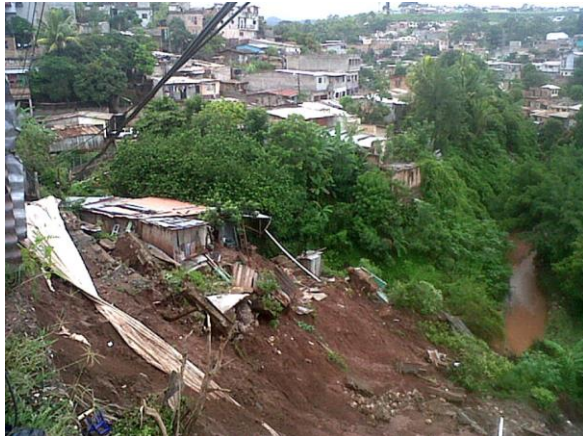
Fig. 2 The Izaguirre neighborhood suffered a landslide episode in 2014. Several houses were damaged and many inhabitants were affected. (This image is courtesy of El Heraldo newspaper.)

complex geological setting, the city’s disorganized urban growth in the last 40 years has forced many inhabitants to build weak homes on unstable land along the rivers or on the steep slopes that surround the city (Angel et al., 2004). Tegucigalpa’s vulnerability to landslides was evident in October 1998, when Hurricane Mitch triggered a massive episode of landslides in the city (Harp et al., 2002; JICA, 2002). Although many inhabitants have become aware of the threat of landslides every year during the rainy season (which extends from May to October), the scarcity of job opportunities in nearby smaller but safer towns discourages these inhabitants to move away from Tegucigalpa (Pearce-Oroz, 2005). Fig. 2 shows a precarious neighbourhood in Tegucigalpa that experienced a recent landslide episode.

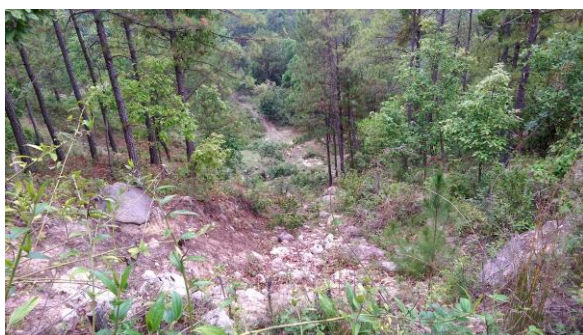
Fig. 7 The only landslide recorded in Carrizal-Semane

The only known landslide recorded in Carrizal-Semane occurred in August 2012, according to the testimony of the inhabitants (see Fig. 7 and Fig. 8). It caused crop damages and cracks in nearby houses. The landslide trigger was a short and intense rainfall.

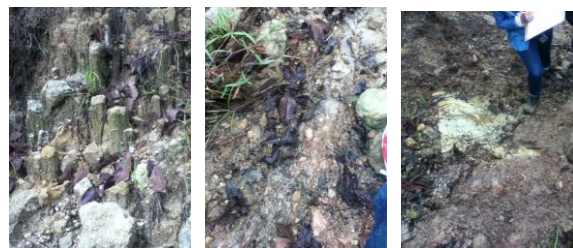
Fig. 8 Material detached due to the landslide

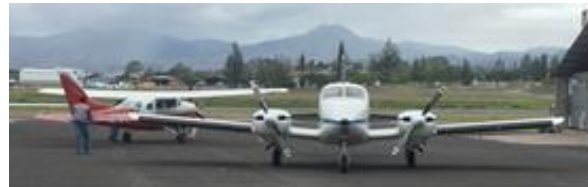
Fig. 1 Aircraft of LiDAR system based on Honduras. Courtesy of ACI

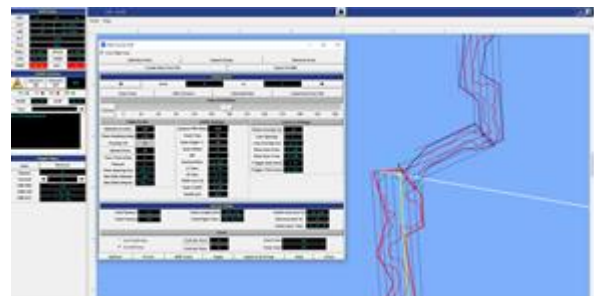
Fig. 5 Determining the flight plan using several parameters such as altitude, speed, passes, point density, etc.

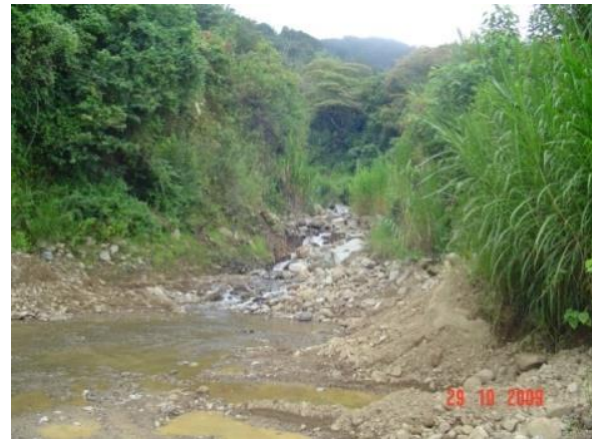
Fig. 3 Alluvial deposits

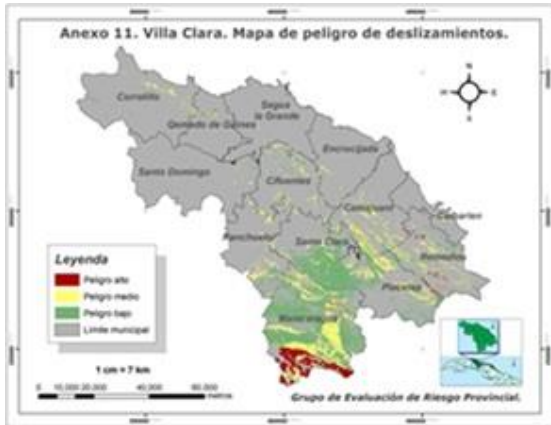
Fig. 3 Landslides classified Hazard map of Villa Clara. Note that the small southern part of the province has a high hazard, belonging to the Manicaragua municipality.

It is characterized by covering areas with moderate slope sand lithological conditions, for occurrence of gravitational movements, and erosive phenomena such as small gullies and dragging the alluvial-colluvial

deposits, because of rainfall incidence (Fig. 3) classified hazard map of Villa Clara province.

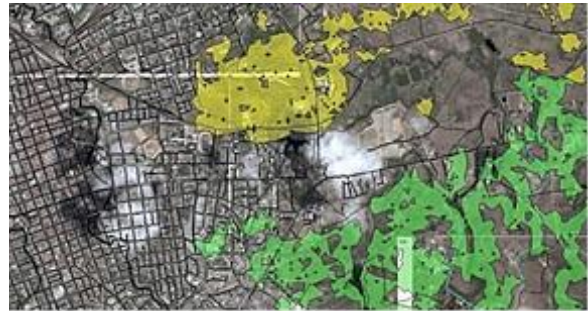
Fig. 4 Santa Catalina west part of the Santa Clara city with low and middle landslides hazard

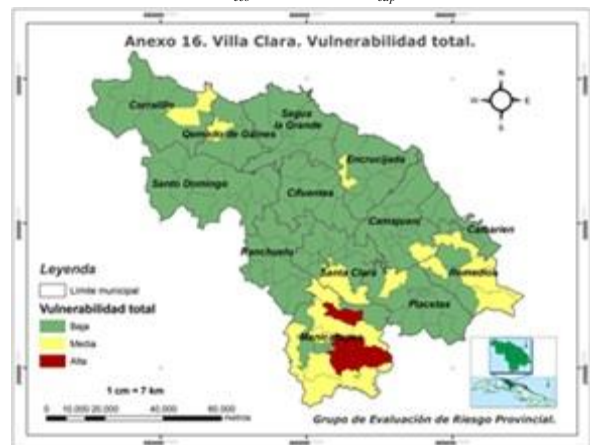
Fig.5 Total vulnerability map of Villa Clara province

The total vulnerability is the result of the sum of all vulnerabilities. Our result reveals that all municipalities have low vulnerabilities, as can be showed in Fig. 5 and 6.

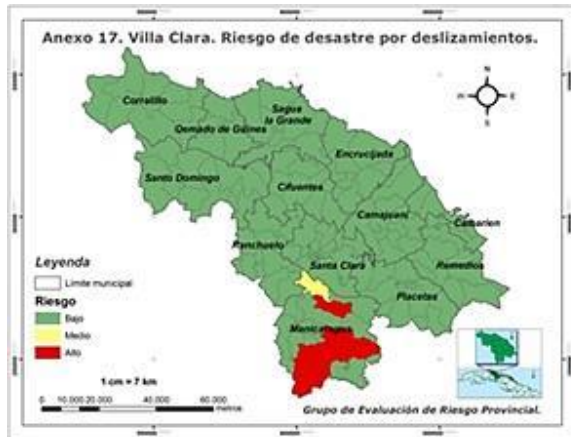
Fig. 7 Risk map of Villa Clara province

The results show that the mountain municipalities are at higher risk of landslide disaster, for example Manicaragua, Jibacoa, Capiro and Caracatey villages.

Other municipalities with risk of landslides are Remedios and Camajuaní by the presence of chains of residual heights limestone origin.

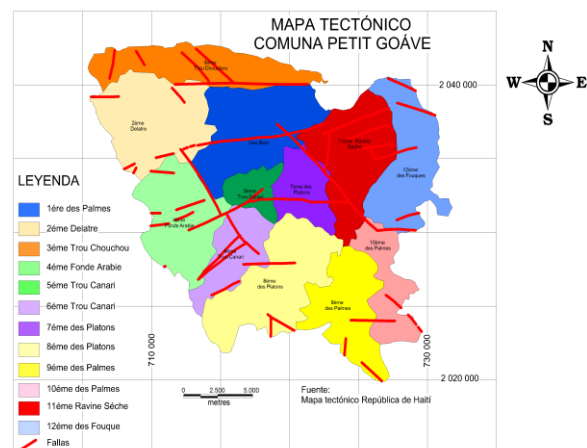
Fig.1. Tectonic map of the Petit Goáve commune

Tectonic features present in the study area show the evolutionary uniqueness of this area, limiting the lithological bodies with two sets of fundamental faults, extending in the direction E-W and another system of sub vertical faults with a NW - SE predominant direction. There are other fault systems with less representation associated with these, which shows the stresses the entire area is subjected because its geodynamic position, as well as tectonic events that have been developed at the regional level and proximity to structures or fault systems of major importance, fig. 1.

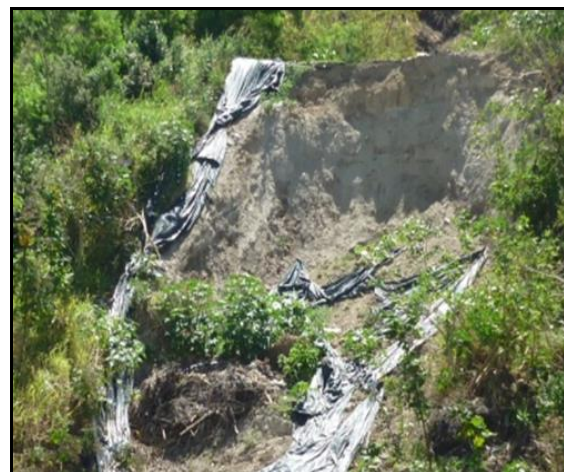
Fig. 2 Landslide in San Francisco Street, Antiguo Cuscatlán, El Salvador, which occurred during an unspecified rainfall event in October 2010 (photograph taken by Alonso Alfaro on March 18<sup>th</sup>, 2011)

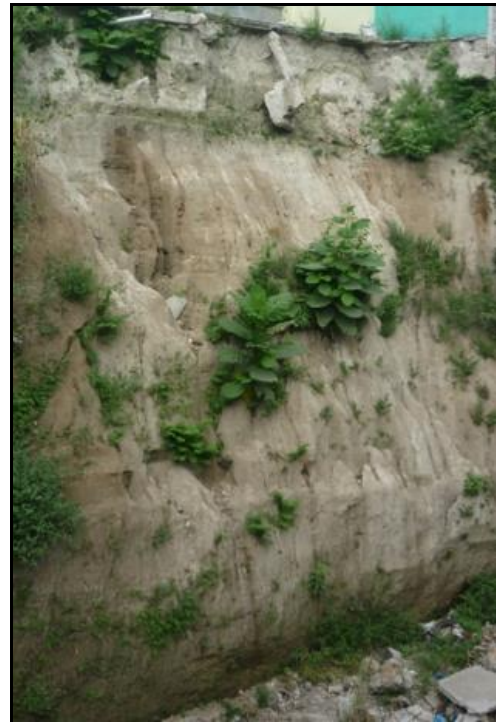
Fig. 4 Erosion problem in the Tierra Blanca formation of the Jardines del Pepeto 3 community, Soyapango, El Salvador. It occurred during the passage of Hurricane Ida in 2009 (photograph taken by Aleyda Montoya on May 25<sup>th</sup>, 2011)

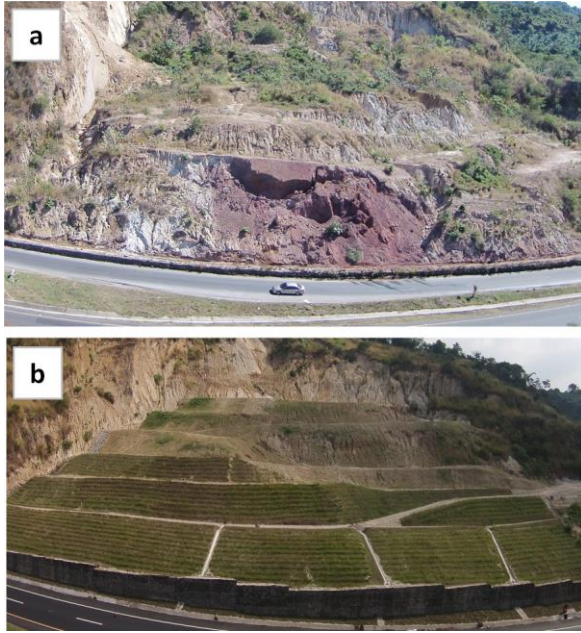
Fig. 6 a. Landslide located at the km 18.5 of the CA-01 East route in El Salvador. It occurred during the night of January 17<sup>th</sup>, 2009 (photograph taken by Yuri Rodriguez on January 5<sup>th</sup>, 2014). b. Control measure applied to the affected slope (photograph taken by Jorge Urrutia on December 17<sup>th</sup>, 2015)

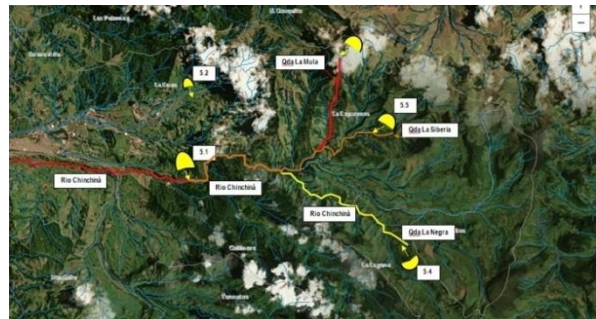
Fig. 4 Landslide inventory map examples over satellite images

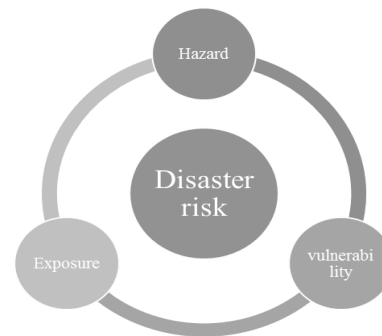
Fig. 2 Interaction of hazard, vulnerability and exposure to risk

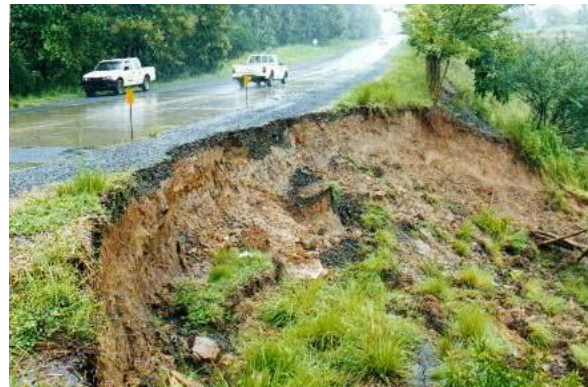
Fig. 1 Rotational slip in the Panamerican Highway, Tole, Chiriqui province (photo taken by Ministry of Public Work, Panamá in 2001)

1. Shallow landslides in residual soils (falling soil, rocks and trees): these can be fast (i.e., a few m/s) or slow (i.e., some mm/year) and are accelerated during the rainy season.
2. Rotational landslides in soils: occur in weathered clayey soils (saprolite), mainly. Eventually, rock fragmentation occurs. The break is fast and occurs during or after heavy rainfall (> 100 mm/d). Fig. 1 shows a rotational slide in a cohesive, highly plastic soil on the Panamerican Highway.

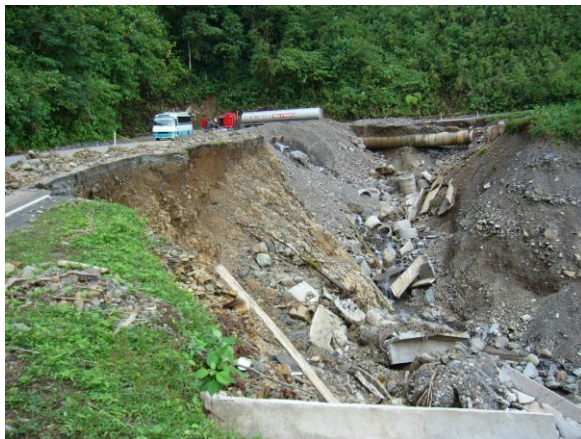
Fig. 2 Road slip at Chiriqui-Bocas del Toro conditioned by the presence of geological faults and poor design of drainage system (photo taken by Eric Chichaco in 2012)

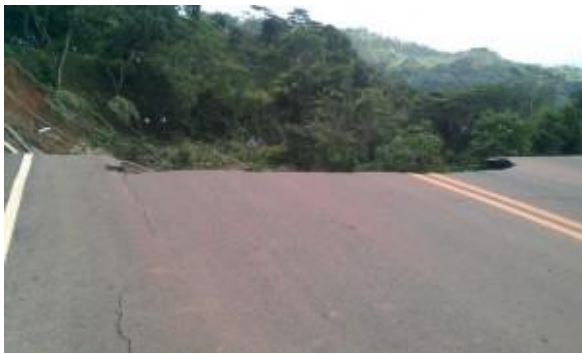
Fig. 3 Cebo Curve at Transistmica road, Quebrada Ancha, Province of Colon (photo available at [www.laopinionpanama.com](http://www.laopinionpanama.com) in 2012)

In Panama, two seasons are distinguished from the meteorological point of view: the dry season and the rainy season. The rainy season begins in May, extending until November or December, with annual minimum average of 1,000 mm and annual maximum average of 7,000 mm. It is considered the main external factor triggering landslides in our country. Landslides triggered by rain are related to the intensity, duration and distribution of rainfall. Fig. 3 shows a significant slide in the Trans-Isthmian Highway triggered by rainfall.

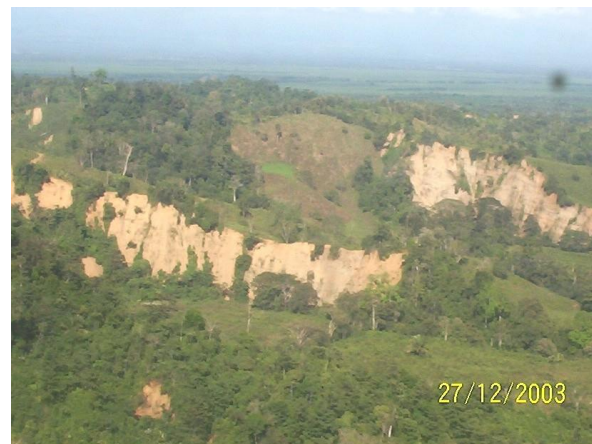
Fig. 4 Landslides on fault planes because of the December 25, 2003 earthquake,  $M_w=6.2$  in Puerto Armuelles (taken by Eduardo Camacho in 2003)

Seismic events usually have a moderate to high magnitude on the Richter scale, and greater than VI on the Modified Mercalli scale-MM (see Fig. 4). In the Isthmus of Panama, both the movement of the plates as well as geological faults have historically generated several earthquake-triggered landslides. The magnitudes of these earthquakes range from  $M_w=4.5$  (e.g., in the slopes of Baru Volcano, Boquete, Chiriqui Province) and  $M_s=7.9$  (e.g., along the ridges and mountains to the northeast of Panama City), according to Chichaco (2012).

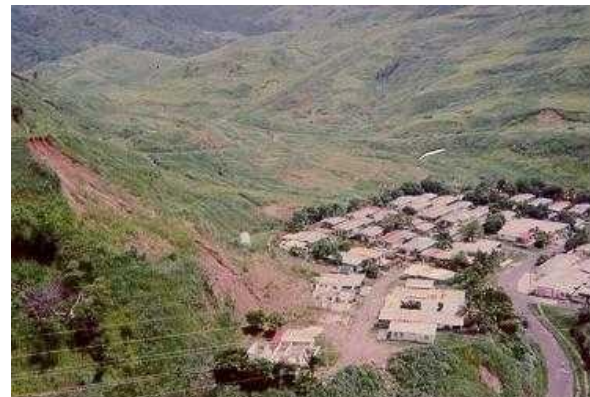
Fig. 6 Aerial view of the slide at Villa Esperanza in October 1992 (photo taken by Jaime Toral in 1992)

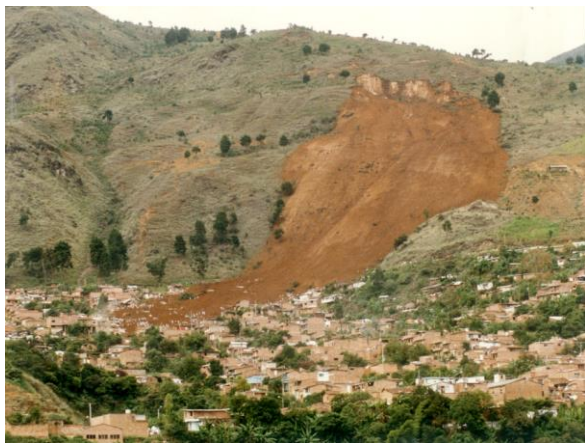
Figure 1 Aerial view of shallow landslide triggered by rainfall in Medellín (Colombia) in September of 1987 with more than 500 casualties (Photo: El Mundo Newspaper).

usually called soil slips, have a planar slip surface (Figure 1). These landslides are characterised by their shallow thicknesses (0.3–2 m), which are much smaller than their flow lengths, and by the slip of the surface fault parallel to the slope and the escarpment's small area (Anderson & Sitar 1995). This paper presents the results and discussion of the application of SHIA-Landslide and SHALSTAB models to the La Arenosa catchment located in Colombia. The obtained results show that the model is effective to be used on tropical mountainous watersheds, which are subjected to high rainfall intensities.

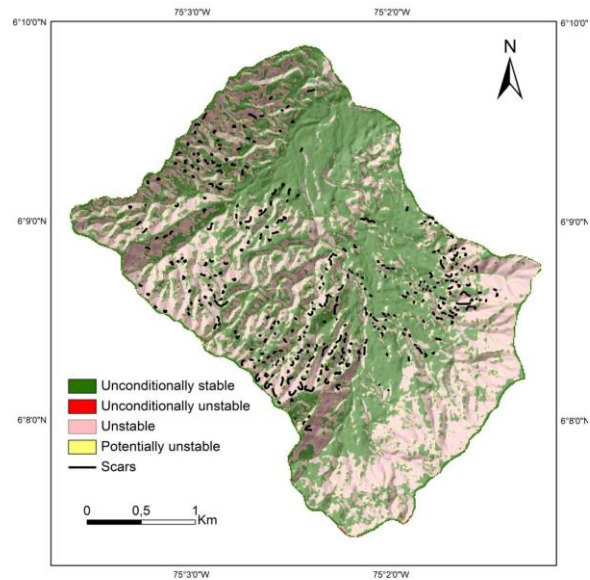
Figure 2 Areas with landslide occurrence triggered by the September 21st 1990 rainstorm simulated by SHALSTAB using q=90 mm/h.

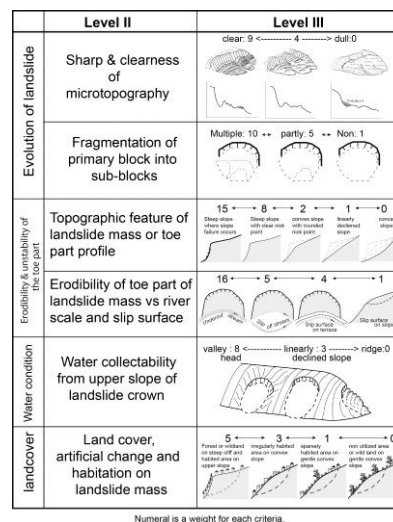
Fig. 7 Schematic illustration of weighting system for landslides locating along the river courses
