# **Proceedings of 2019 IPL SYMPOSIUM ON LANDSLIDES**

**16 – 19 September 2019  
UNESCO Headquarters in Paris, France**

# 2019 IPL SYMPOSIUM ON LANDSLIDES

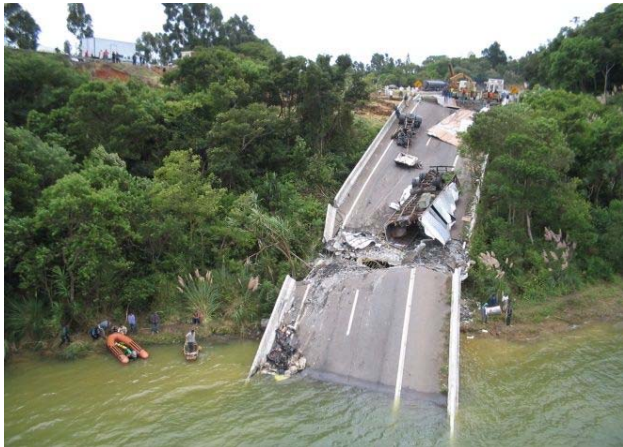
Figure 1 Bridge fall over the Capivari River caused by landslides, affecting the most important Brazilian highway that connects the southeastern and southern regions (2005).

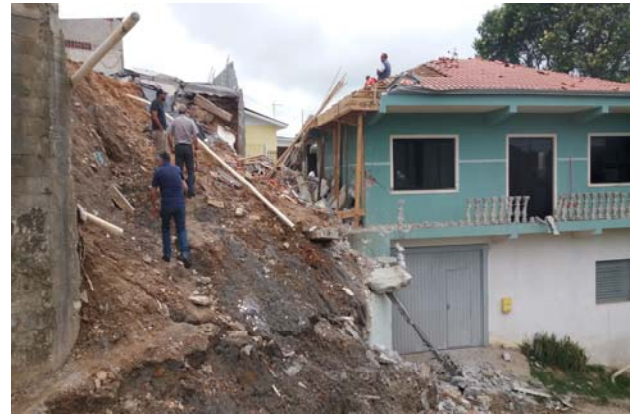
Figure 5 “Mission” phase to respond a landslide accident in a small city of Paraná State, Brazil (2018).

Damage to buildings and urban infrastructure was noted, such as the destruction of houses, streets and parts of the sanitation system. The largest movement reached 250m<sup>3</sup> (Fig. 5) and destroyed houses and the street. In addition, collapses occurred in areas of karstic terrain, caused by hydrogeological changes related also to rapid and intense precipitation.

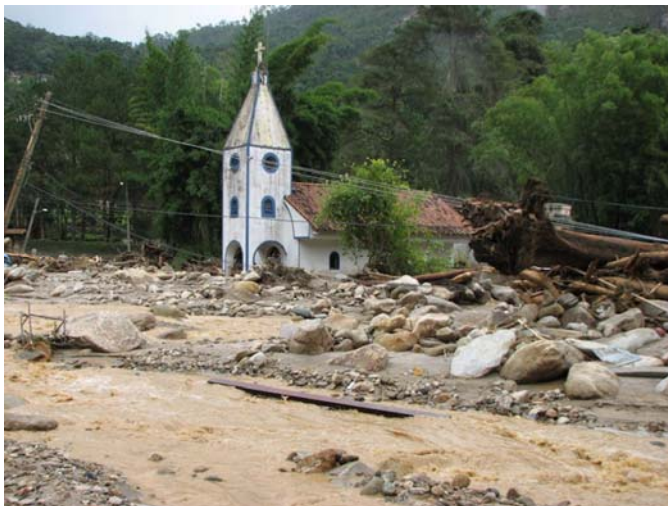
Figure 9 - Church in rural area of the city of Teresópolis affected by flow type mass movement in the State of Rio de Janeiro.

These geological processes have caused serious damage to infrastructure, and thousands of homes, secondary and main roads, communication systems and sanitation services have been damaged or destroyed (Fig.9).

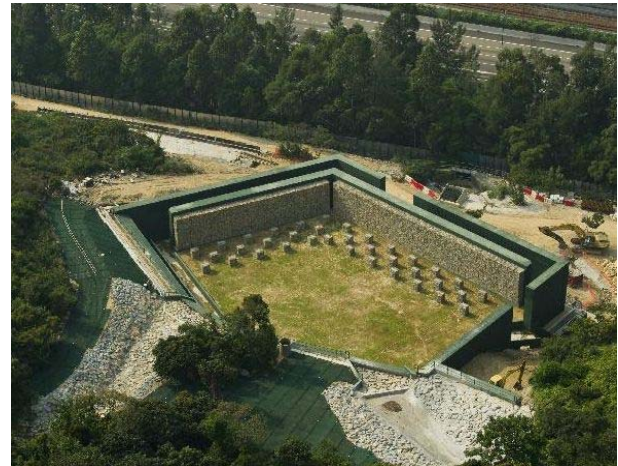
Figure 1 Rigid debris-resisting barrier constructed in Hong Kong

Since 2010, Landslip Prevention and Mitigation Programme (LPMitP) has been launched in Hong Kong and is managed by the Geotechnical Engineering Office (GEO) to systematically tackle landslide risk associated with vulnerable natural hillsides with an aim to reducing the risk to an as low as reasonably practicable level. More than a hundred of rigid debris-resisting barriers have been constructed to safeguard assets and human settlements in their downstream areas (see Fig. 1).

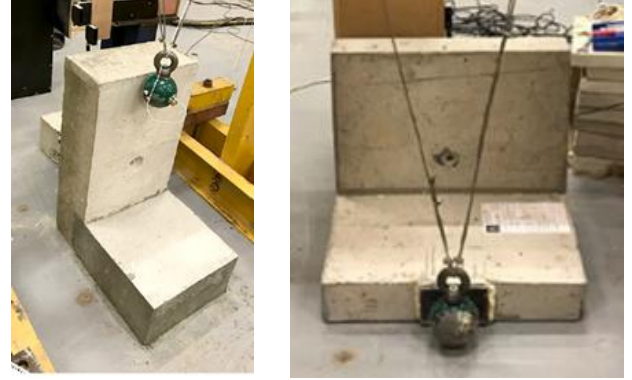
Figure 3 Small-scale pendulum impact tests for verification of new design philosophy

The formulae of displacement-based approach was rigorously derived. Notwithstanding this, two series of small-scale pendulum impact tests were carried out to verify this approach in collaboration with the University

of Melbourne (see Fig. 3). Concrete barrier was constructed and was impacted by iron sphere under different impact velocities. The barrier’s translational and rotational movements were measured using laser sensors. Yong et al. (2019) and Lam et al. (2018a) reported the test setup and measurement results. They found that the measured movements matched well with the predicted movements based on the analytical solutions.

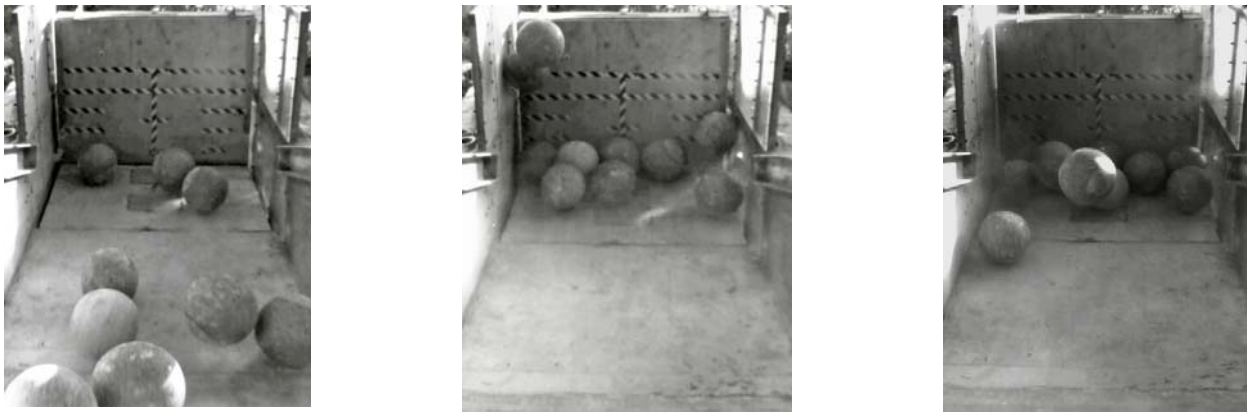
Figure 5 Snapshot of a flume test for verification of new design philosophy

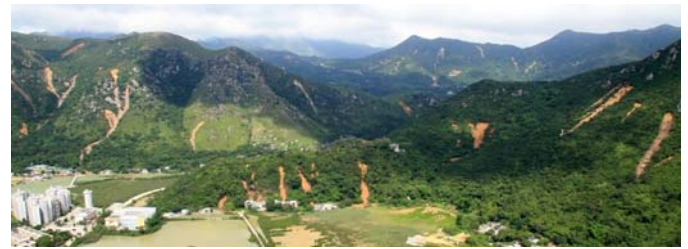
Figure 7 Multiple landslides occurred in Lantau, Hong Kong in 2008

Rigid barriers are capable of retaining landslide debris with a designated volume. In case of exceptionally massive or recurrent landslides triggered by extreme rainfall scenarios (see Fig. 7) which exceed the designated volume, the barriers may be overwhelmed and overflow of debris to the downstream may occur. In addition, there have been cases that barriers had intercepted landslide debris in the field without being noticed for quite some time after the landslides had occurred, due to their inaccessibility and obstructed visibility. To facilitate timely emergency responses to the above situations, a Smart Barrier System has been developed to provide alerts to the government agencies and relevant stakeholders when landslide debris impacting onto a barrier is detected. This system has been tailor-made to suit the local conditions of natural hillsides in Hong Kong.

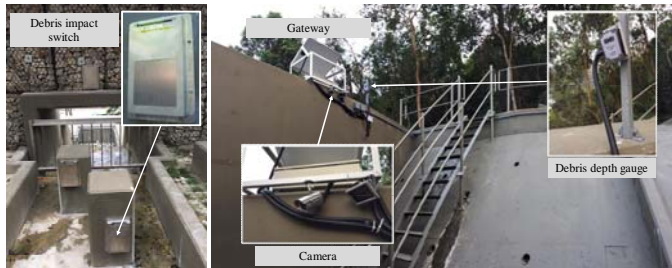
Figure 10 Trial field installation of Smart Barrier System

The Smart Barrier System has been installed at a number of rigid barriers in Hong Kong for in-situ testing and proof-of-concept purposes (see Fig. 10). As the system has been exposed to outdoor environment subject to true weather conditions, the durability of the system can also be tested.

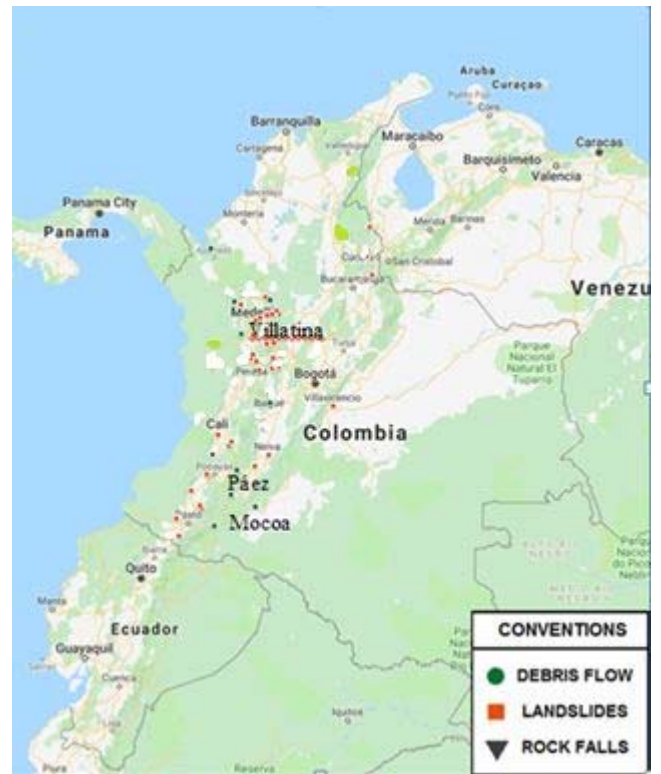
Figure 5 Spatial distribution of catastrophic events in Colombia from 1997 to 2017.

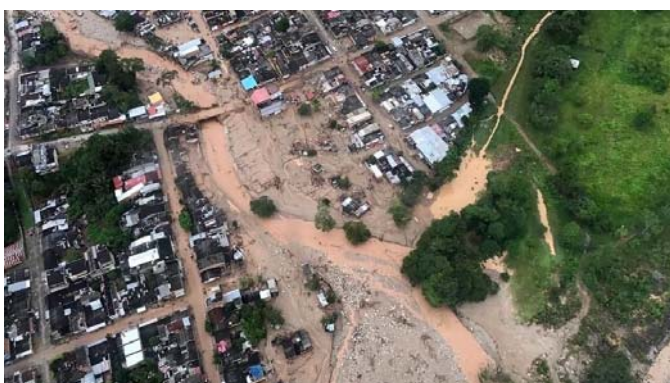
Figure 8 Aerial photo of Mocoa in the zone affected by the torrential flow (El Tiempo, 2019. Picture from: Presidencia de la República).

of April 1<sup>th</sup>, after prolonged and intense rain three rivers overflowed and many landslides were generated in the upper part of the basins, producing a very large torrential flow that cover part of the urban area as shown in Figure 8. According to the data reported by the Disaster Risk Management Unit, the flow caused 332 deaths, 398 injured and 77 missing people. The number of destroyed houses is not reported but the number of affected houses was 1.200. This event was very impacting in Colombia and important resources have been invested in recovery and in detail hazard studies in the affected area, particularly one developed by the Colombian Geological Service at scale 1:5000 (SGC, 2018).

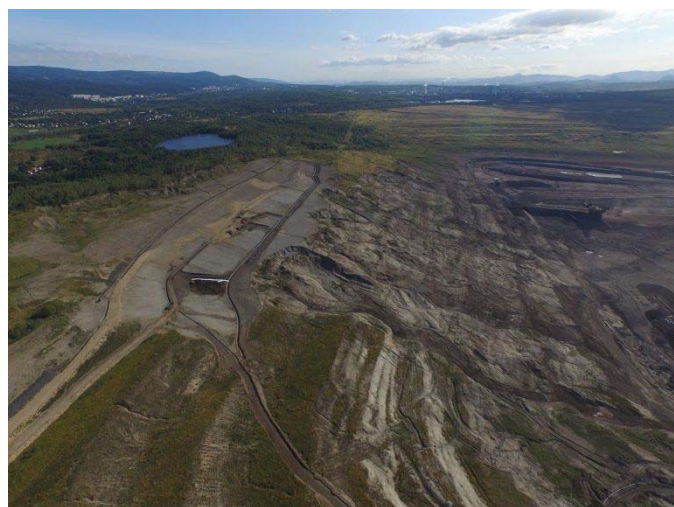
Figure 4 An aerial view on the Albrechtice landslide. In the left site is remarkable up to 10 m high head scarp. In the middle stabilization ground works and original landslide relief (head scarps, earthflows, tension cracks, etc.) in the lower part of the slope (foto: Burda, June 2015).

The evolution of the movements between 2007 and 2012 led to the development of a large complex landslide (Dikau, 2004) with difficult terrain morphology, a series of partial landslides, block landslides, earthflows and mudflows (Fig. 4). These earthflows present a serious complication for coal mining itself because their accumulation toes cover coal seam and thus its excavation is technologically more difficult, more expensive and primarily more risky.

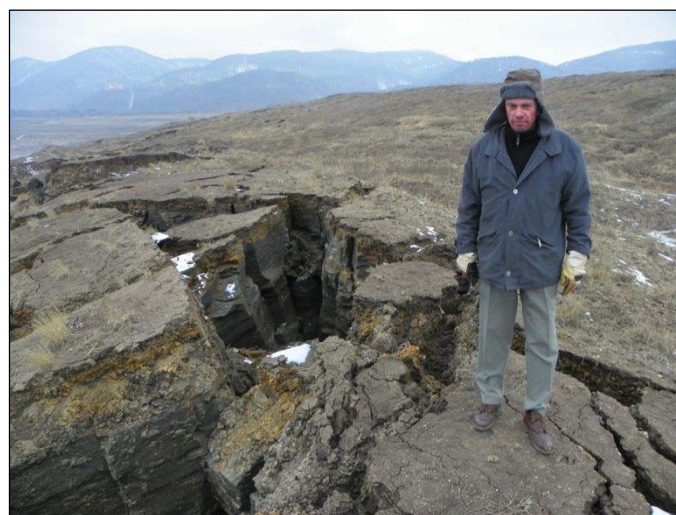
Figure 6 Head scarp in stiff-fissured clays under 190 m asl. (foto: Burda, January 2013).

The area affected by the landslide was calculated to be approximately 57.7 ha and the total volume of moving soils was up to 5-10 mill. m<sup>3</sup> (Burda et al., 2018a). Shear planes were bound to the upper soft clays (ca 227 – 190 m asl.) of the Miocene claystones additionally loaded by the consolidating masses of the Albrechtice dump, but

reached even greater depths of stiff-fissured claystones under 190 m asl. (Figure 5 and 6).

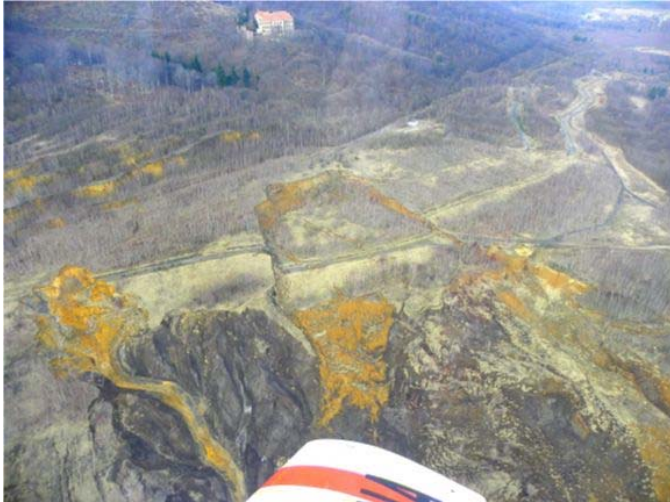
Figure 7 An aerial overview of the landslide complex situated at the edge of the open-pit mine (foto: Burda, January 2011).

The January 2011 landslide (Fig. 7) represents the reactivation of a large complex slope deformation that has been recorded previously (Špůrek 1974; Rybář 1997). The original 1950s slope deformation occurred as a result of surface subsidence due to the collapse of galleries in

older (active in 1940 - 1977) underground mine (Špůrek 1974). This deformed the entire mass of overlying rocks and, at least in part, contributed to the development of deep-seated fault planes. These subsidence induced fault planes enable water from the permanent and intermittent aquifers to infiltrate more easily into the underlying claystones and to thereby become a significant mechanical discontinuity surface.

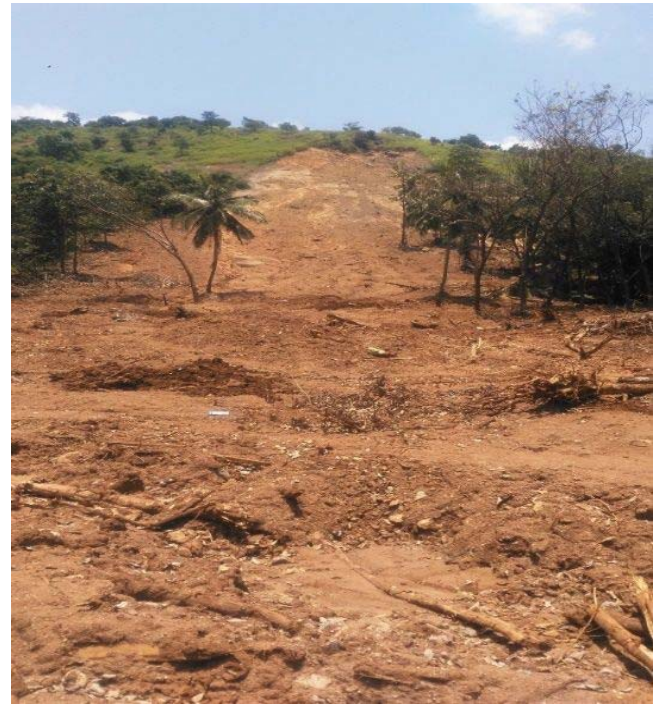
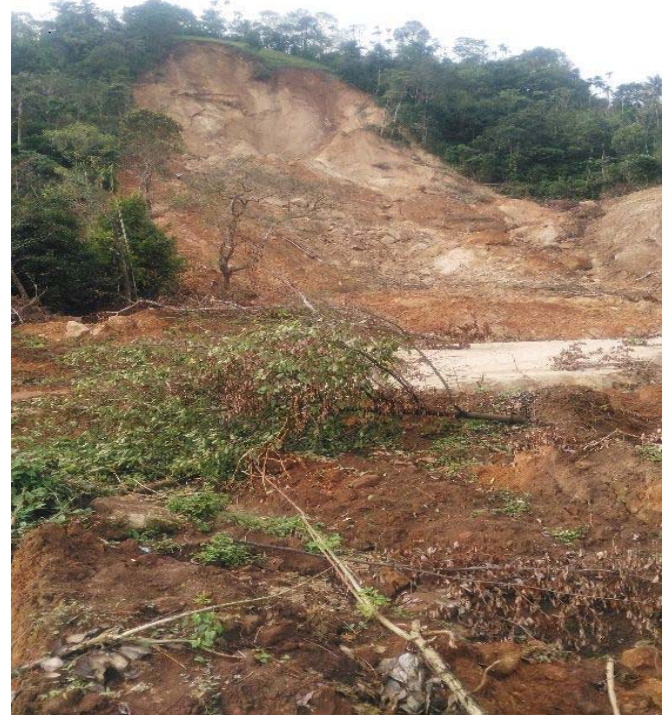
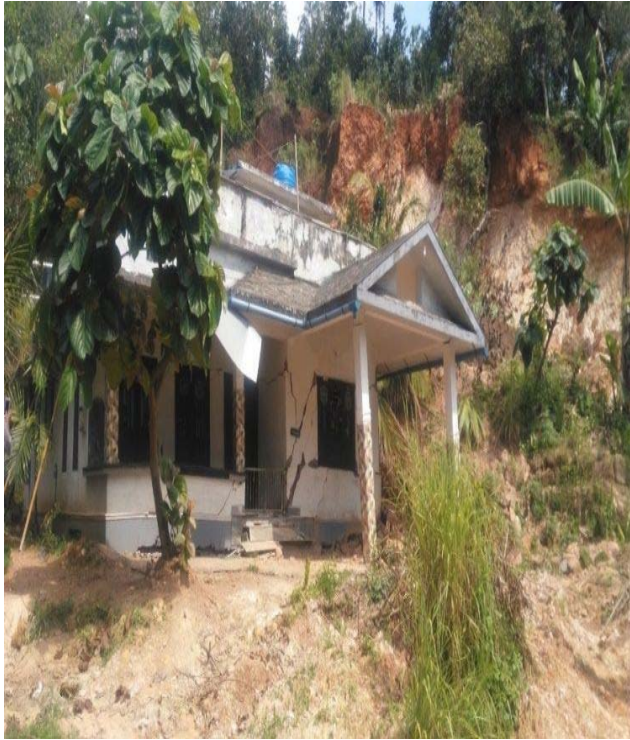
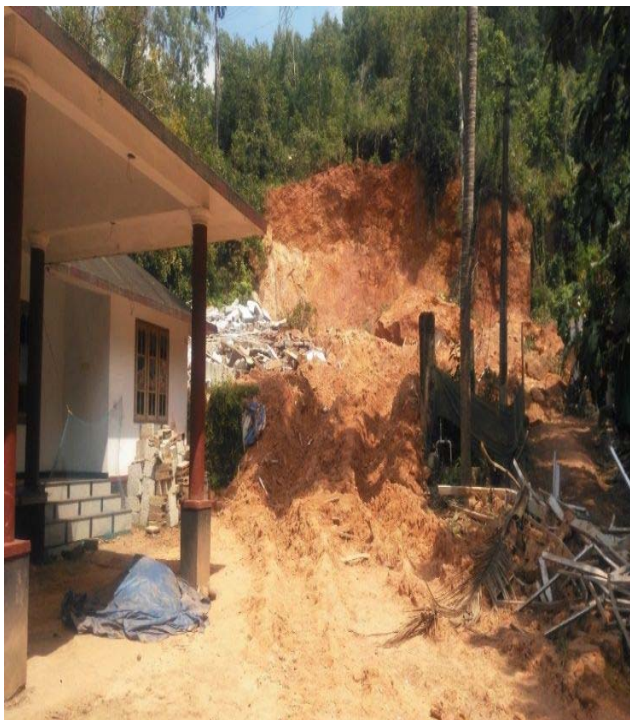
Fig. 2 Kerala 2018 Landslides, (a) Nenmara Landslide, (b) Upputhodu landslide, (c) Kaithakonda Landslide (d) Peringavu Landslide

Authors currently investigating the Kaithakonda and Peringavu earth slide type landslides. The view of Kaithakonda and Peringavu landslides are shown in figs. 3c and 3d. The Kaithakonda landslide occurred in the midnight of 15<sup>th</sup> August 2018. The slide killed 3 people and damaged a house located at the toe. The subsoil consists of highly weathered silty sand followed by sandy silt. The rotational failure occurred due to heavy rainfall and reduction in shear strength of sandy silt layer. The daily rainfall on the day of landslide occurrence observed from the nearby rain gauge station was 221 mm. Peringavu earth slide type landslide occurred on the 15<sup>th</sup> August 2018. The view of landslide and damaged buildings are shown in fig. 3d. The landslide killed eight people and completely damaged a two-story residential building. The heavy rainfall of 221 mm on the day of landslide occurrence allows the rainwater to infiltrate into the highly weathered sandy silt layer and reduced the shear strength of the soil caused a rotational type slope failure. A numerical modelling consists of stability analysis considering the effect of rainfall infiltration in addition to the field and laboratory tests being conducted to understand the failure mechanism. Various remedial measures are to be modeled numerically in order to identify the suitable site-specific remedial measure for Kaithakonda and Peringavu rotational earth slide type landslides.

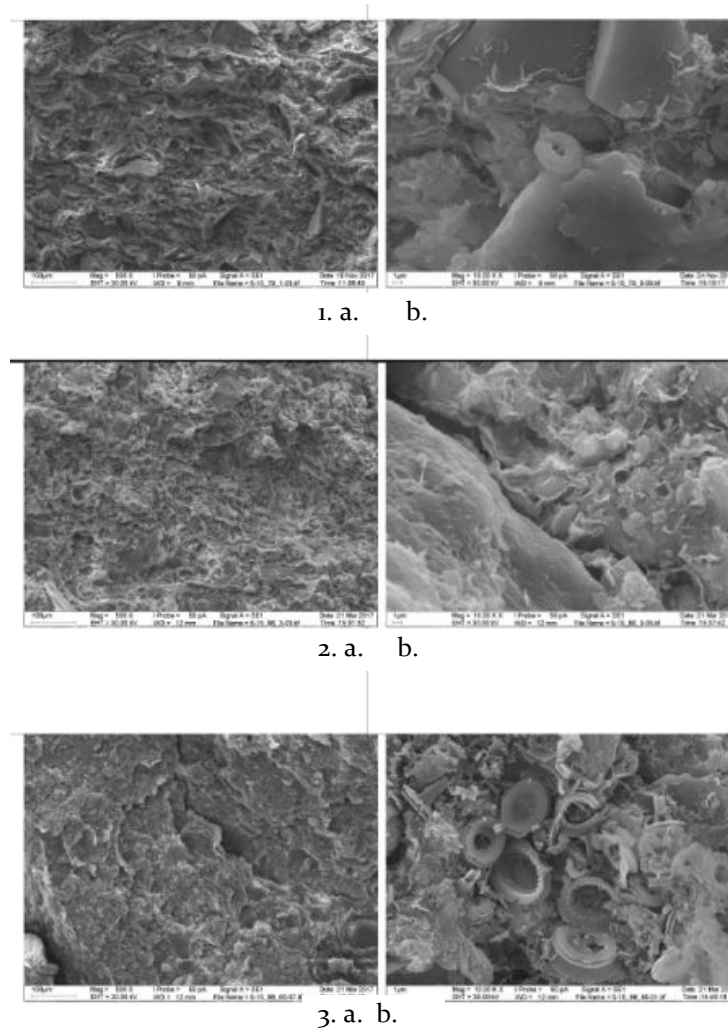
Figure 3 SEM images of Jurassic clay microstructure

1. Yermolinskaya strata: a. Increase x500. b. Increase x10000
2. Kolomenskaya suite: a. Increase x500. b. Increase x10000
3. Podmoskovnaya suite: a. Increase x500. b. Increase x10000

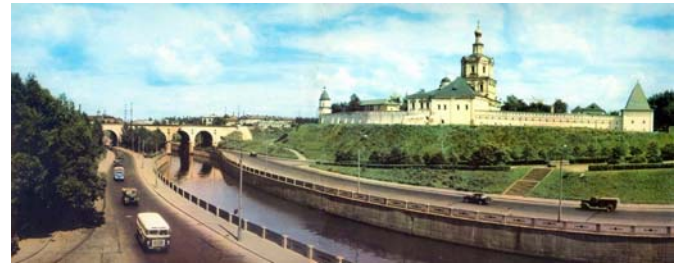
Fig. 1. Andronievskaya embankment with Svjato-Andronikov monastery.

The places of high landslide risk are Andronievskaya embankment (Figs. 1, 2), Nikolo-Yamskaya embankment (Fig. 3), Kotelnicheskaya embankment (Fig. 4), Samotechnaya Street (Fig. 5) in the center of Moscow.

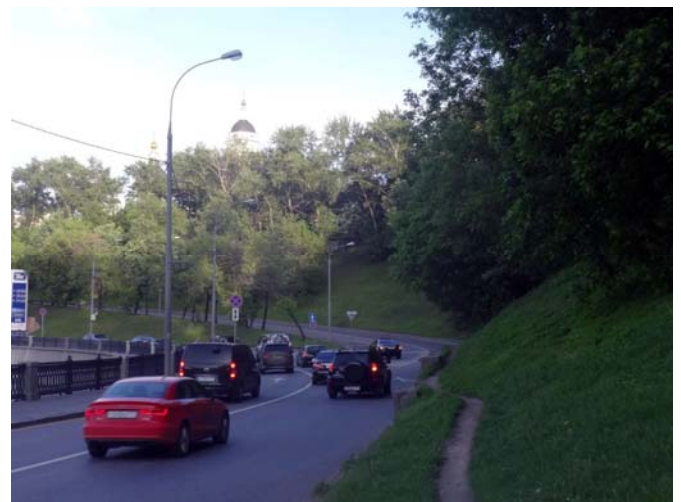
Fig. 3. Nikolo-Yamskaya embankment

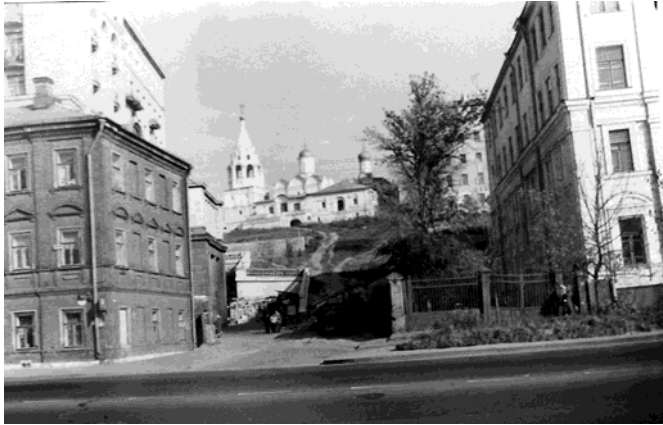
Fig. 4. Kotelnicheskaya embankment

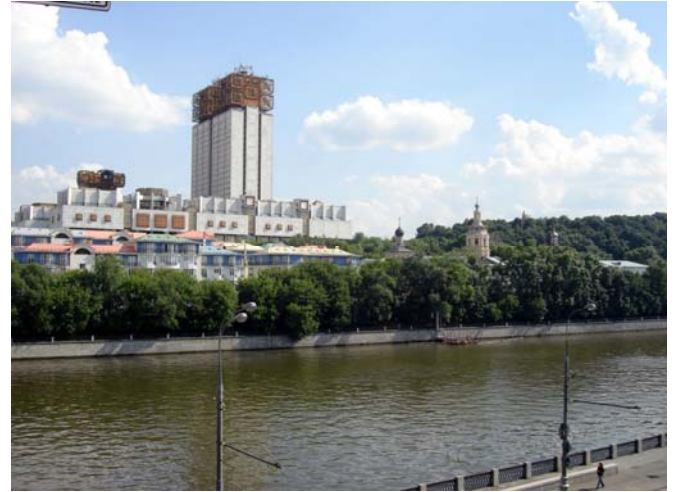
Fig. 7. Vorobiovy Mountains with building of Presidium RAS (Russian Academy of Sciences), Andreevsky monastery and new living houses.

The places of highest landslide risk are Vorobiovy Mountains (Hills) (Figs. 6,7) and Kremlin Hill. (Figs. 8, 9). They are shown as white circles in the map of geological danger in Moscow. (Fig. 10).

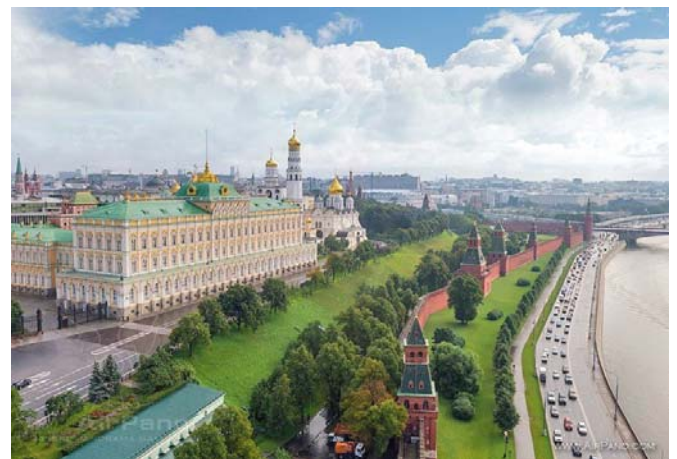
Fig. 8. Kremlin embankment.

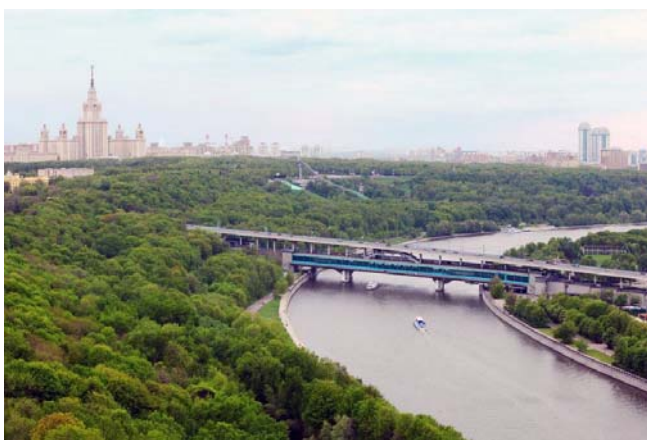
Fig. 6. Vorobiovy Mountains with Moscow State University, ski-jumps and metro-bridge.

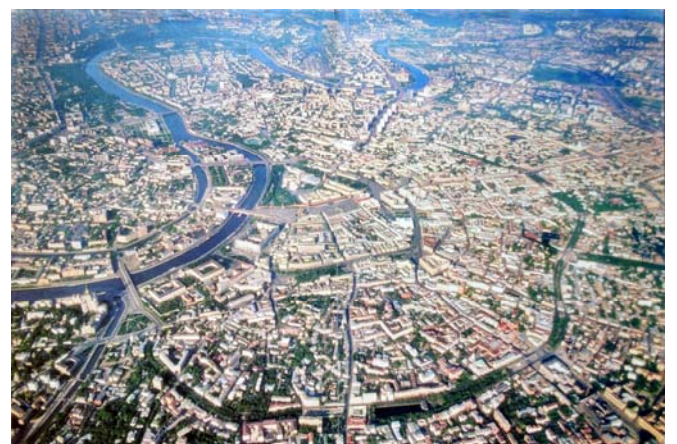
Fig. 9. Center of Moscow with Kremlin hill and Moskva river.

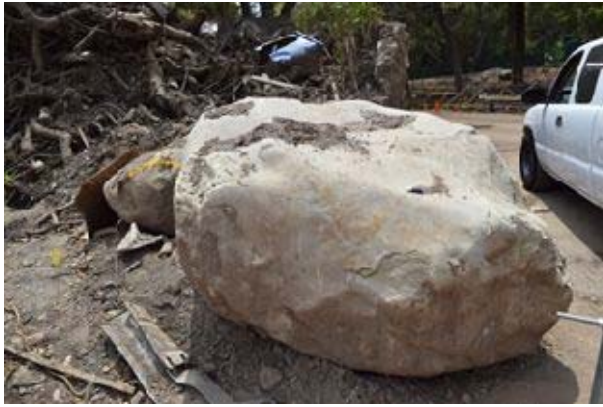
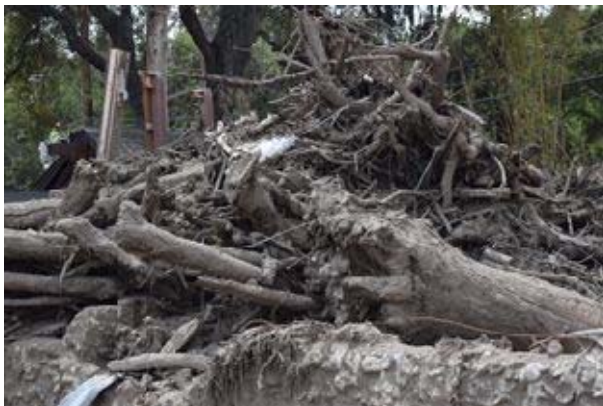
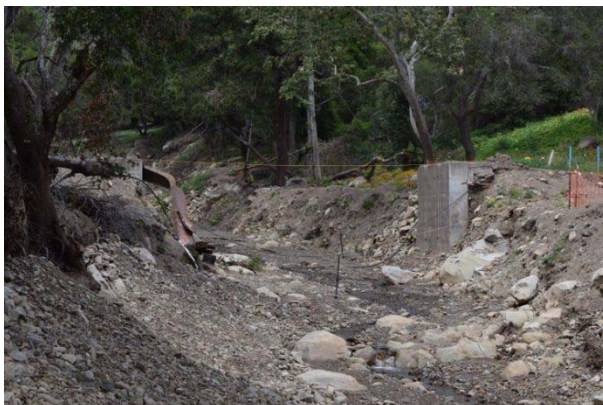
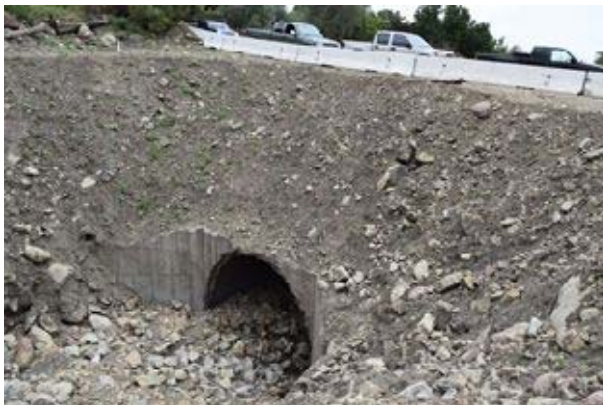
Figure 1 Debris found in the Montecito debris mass.

The Thomas Fire started on December 4, 2017. It burned approximately 300,000 acres of vegetation in the Santa Barbara and Ventura Counties, California, destroyed over 1000 buildings, 2 fatalities and caused damages exceeding \$2.2B. Declared contained on January 12, 2018, the Thomas Fire was the largest wildfire in California's history. While the fire was ongoing, the affected area saw a series of heavy rainfall events, which triggered debris flow events in the city of Montecito in Santa Barbara County, CA at 11:30 am GMT on January 9th, 2018. These debris flow events resulted in 21 fatalities (plus another 2 missing individuals, who were presumed dead) and injuries to over 160 people. The debris flow events are also estimated to have caused at least \$177 million in property damage, approximately \$7 million in emergency responses (RND, Inc. 2018), and \$43 million for the clean-up (Noozhawk, 2018). Over 60 residential buildings were completely damaged with an additional 450 residential buildings having partial damage. Partial damage was observed in 20 commercial buildings while 8 commercial buildings were completely damaged. In addition to the damages to the buildings, 10 to 12 feet of debris accumulated on major highways, including US 101, and local streets. The debris flow events also resulted in the loss of utilities including water, power and gas. Mudslides and debris mass blocked or washed away bridges and culverts. Figure 1 shows the debris carried in the flows.

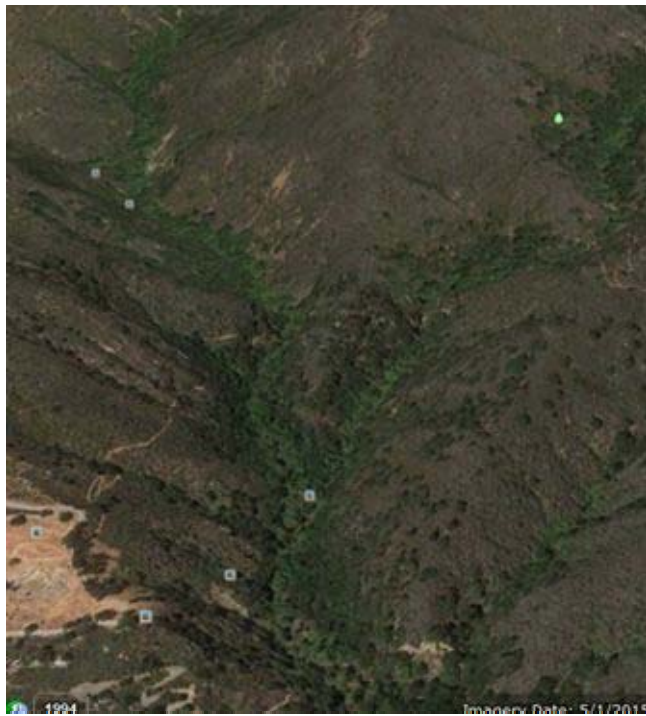
Figure 2 Google Earth imagery of the creek and watershed before (left) the Thomas Wildfire and after (right) the wildfire and Montecito debris flow events.

The field conditions after the Montecito debris flows were investigated through on-site visits and high resolution images released for public use by Google as a response to the federally declared emergency. Aerial views of the debris flow area before and after the wildfire and debris flow events are shown in Figure 2. The figure illustrates the complete loss of vegetative cover following the wildfire. Additionally, the wildfire was responsible for leaving thick deposits of ash on the ground surface and changing the properties of the top soil due to the high heat. As a result of the ash deposits, a reduction of the permeability of the soil corresponding to a substantial increase in the run-off can be expected. The exposure to the high heat from the wildfire caused a brittle and cracked surface prone to localized seepage. The high resolution imagery also indicated that the debris flow events resulted in a widening of the creek from 2 to 3 m to 20 to 40 m in width. Furthermore, evidence of loose debris mass with the potential to flow along the channel bed could also be found from the images. Two drainage basins in the area were completely filled by the debris (consisting of tree branches, roots, boulders, etc.) The debris, then, overflowed into the community, onto local roads and highways and about 100 m into the Pacific Ocean. Despite the large amount of debris involved in January 9th event, a significant amount of loose debris was still present along the creek channel with the potential to flow in the event of an intense rainfall in the future.

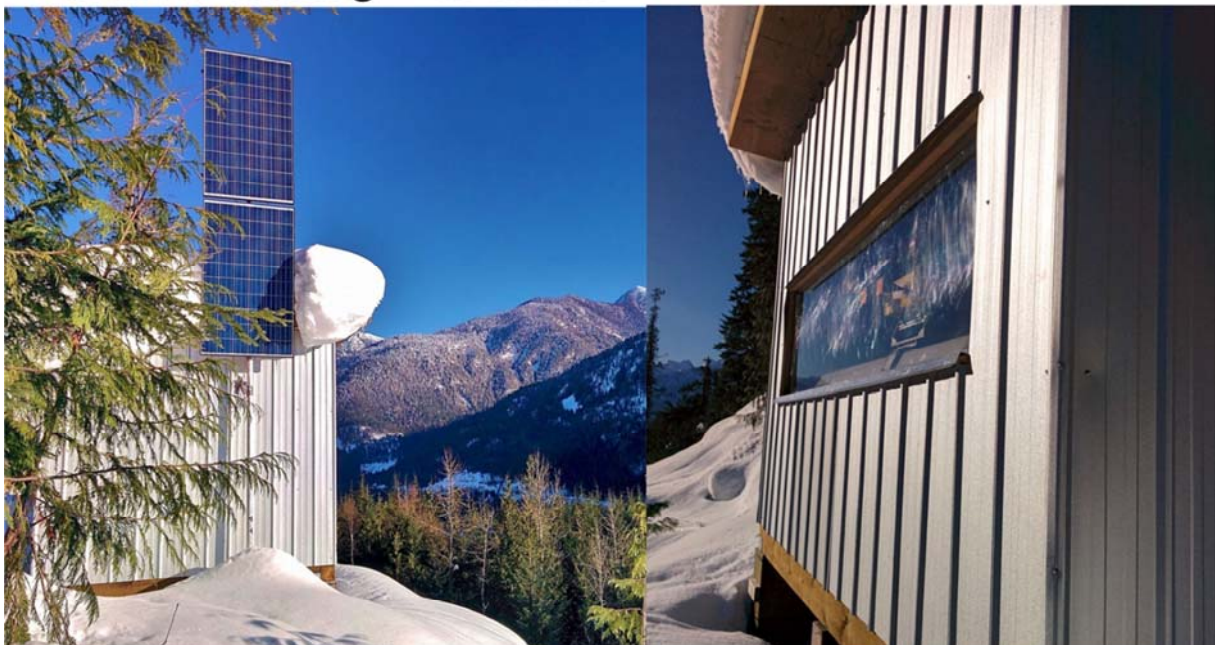
**Fig 6.** GB-InSAR installation up stream of the BCHydro's Revelstoke dam, British Columbia, Canada. Installation is monitoring the unstable slope at Checkerboard Creek. Note: location is remote without power supply, steep north-south valley, and some of the highest amounts of snow accumulation in Canada.

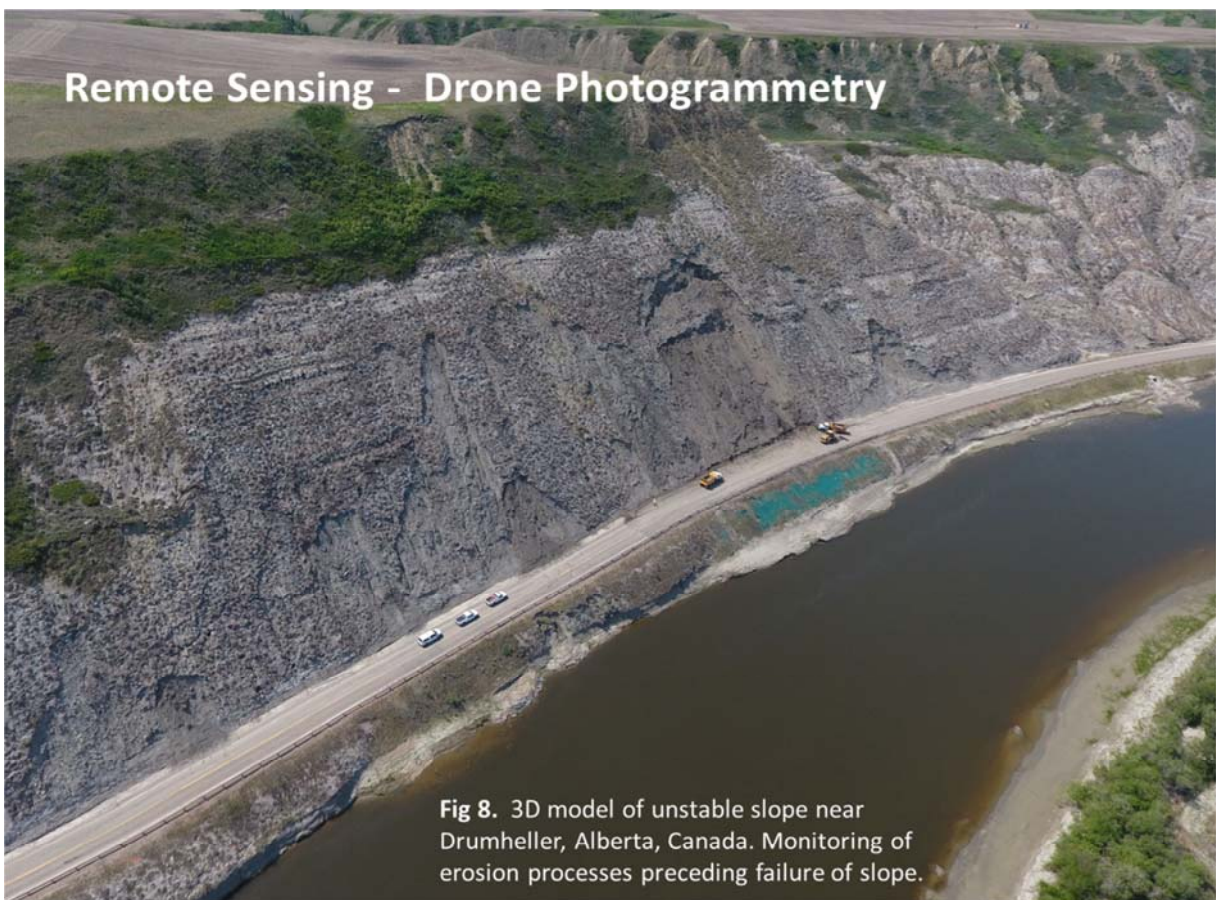
**Fig 8.** 3D model of unstable slope near Drumheller, Alberta, Canada. Monitoring of erosion processes preceding failure of slope.

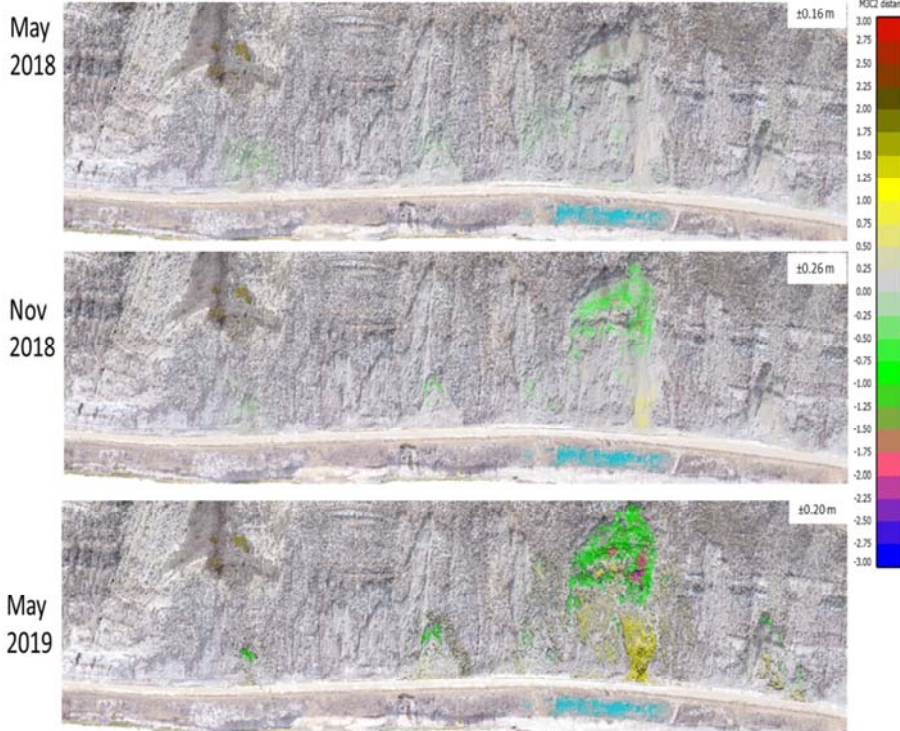
Fig 9. Drone photogrammetry used for quantifying the erosion processes that precede slope failures that impact roadway. And, development of monitoring program.

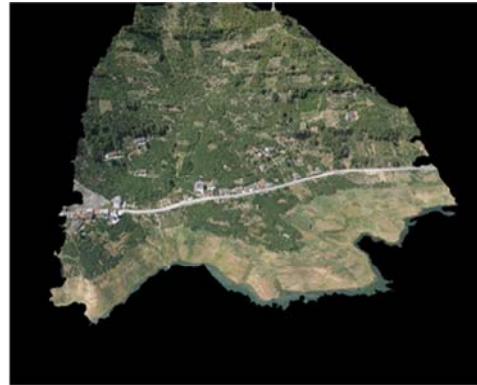
3D model by UAV images

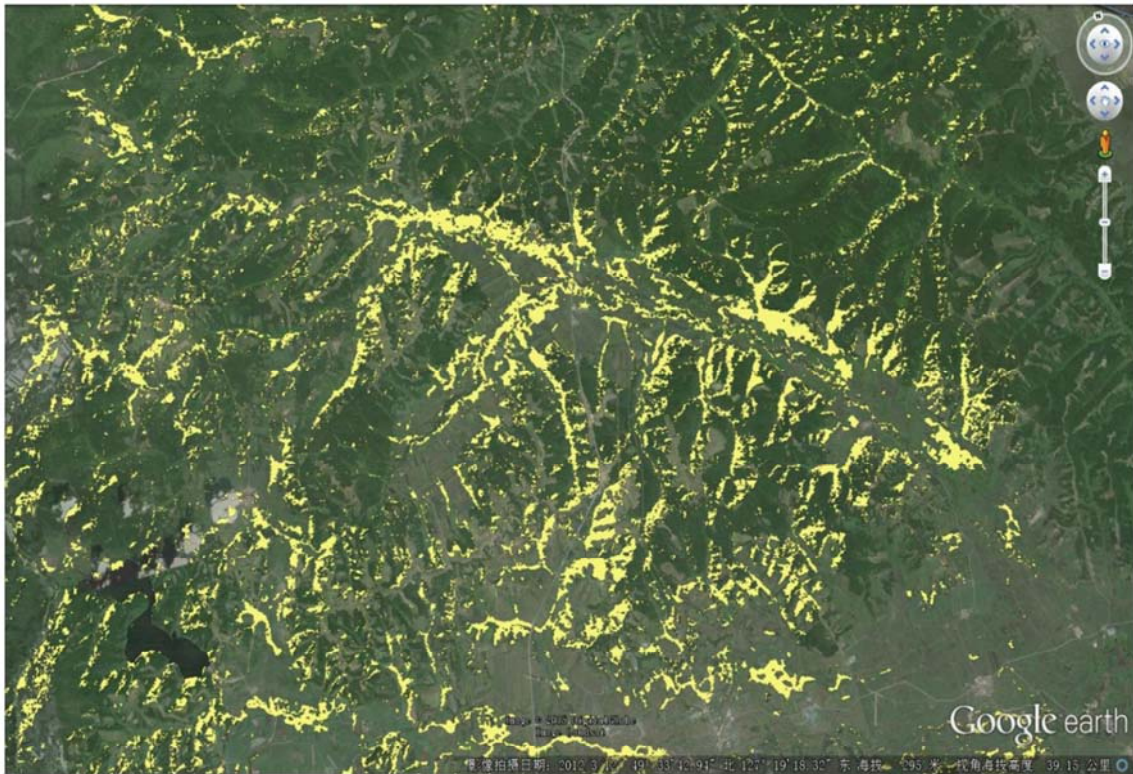
PF distribution using Landsat 7 ETM+ Imagine data,2012

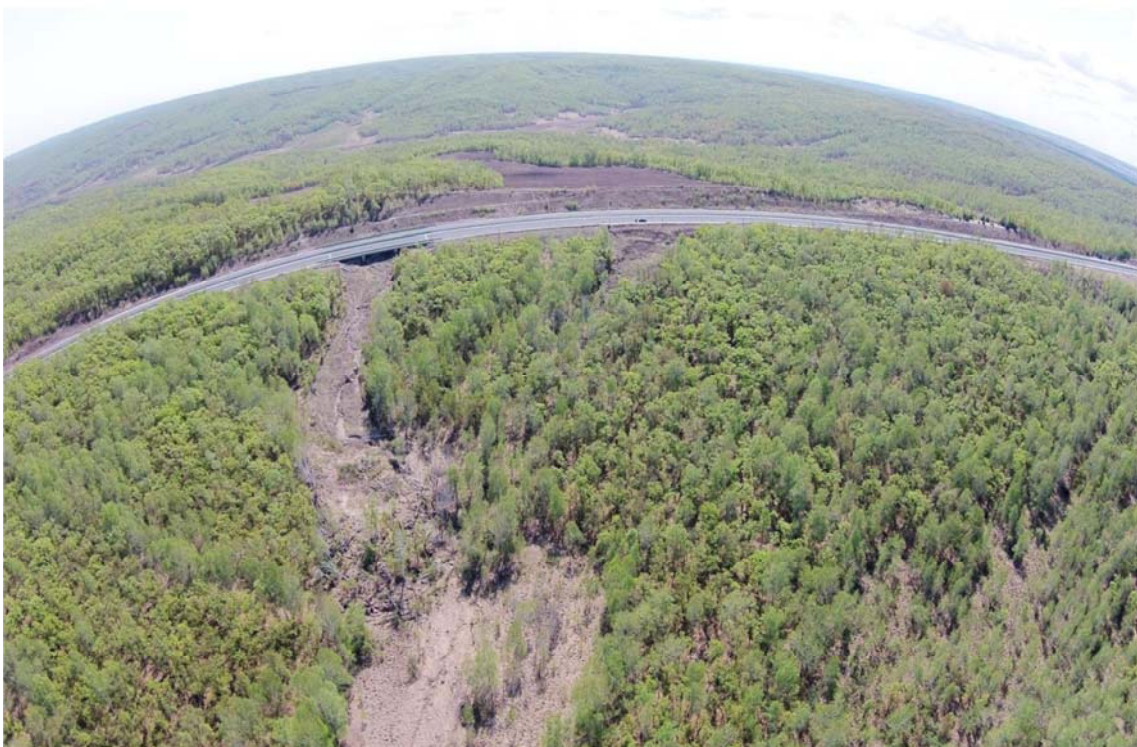
K177+550滑坡虽经抗滑桩支挡，旧滑坡前缘出现新滑坡

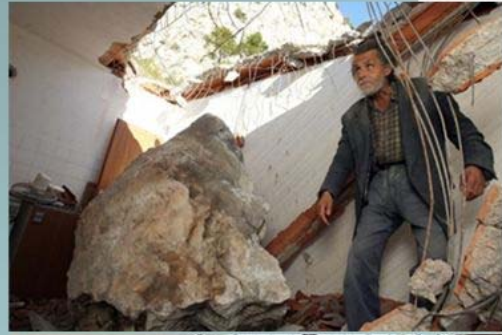
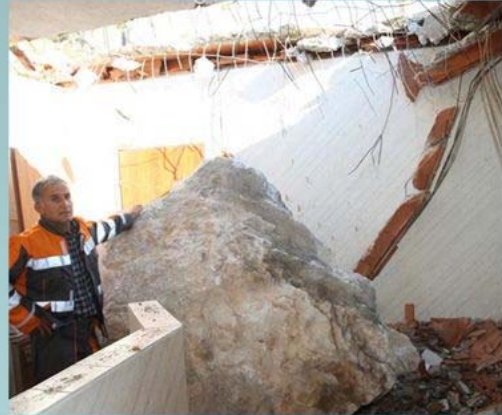
- Several blocks fallen from the cliffs hit directly in the houses and came through the construction in the past without any injured and human victim.
- These occurrences pointed on necessary rockfall hazard and risk analyses and rockfall protection measures.

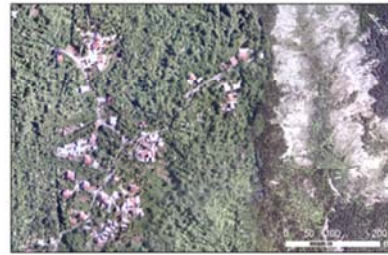
## LiDAR topographic datasets

- airborne laser scanning in March 2012
- last returns density: 4.03 points/m<sup>2</sup>
- *bare-earth* Digital Terrain Model 1 x 1 m

- derived from the 1 x 1 m DTM
- ArcGIS 10.0 software tools

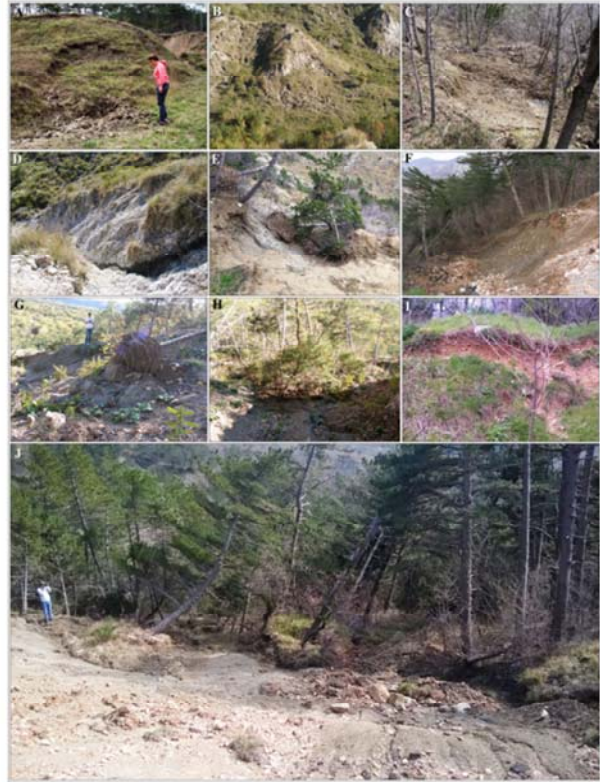
## Debris slides

- 376 landslides located within gullies
- 108 landslides located on slopes outside gullies
- very small to moderate-small, shallow to moderate-shallow landslides

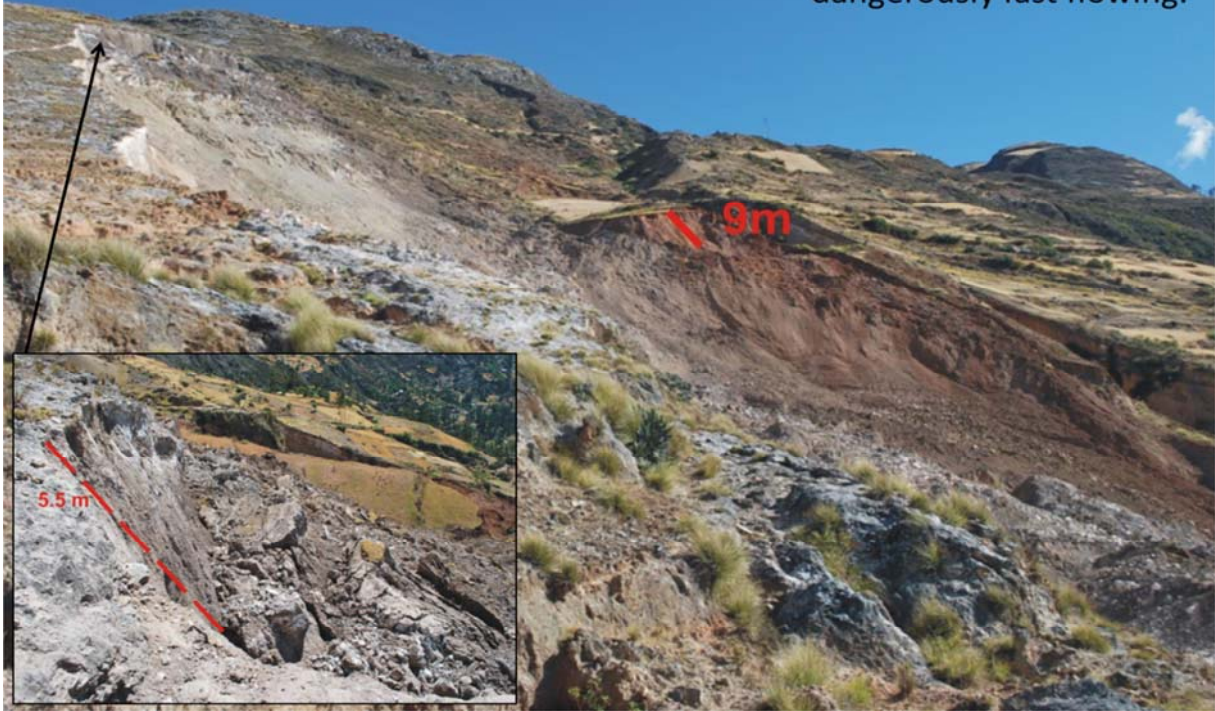
The flow quickly stopped on flat ground where several houses were damaged.

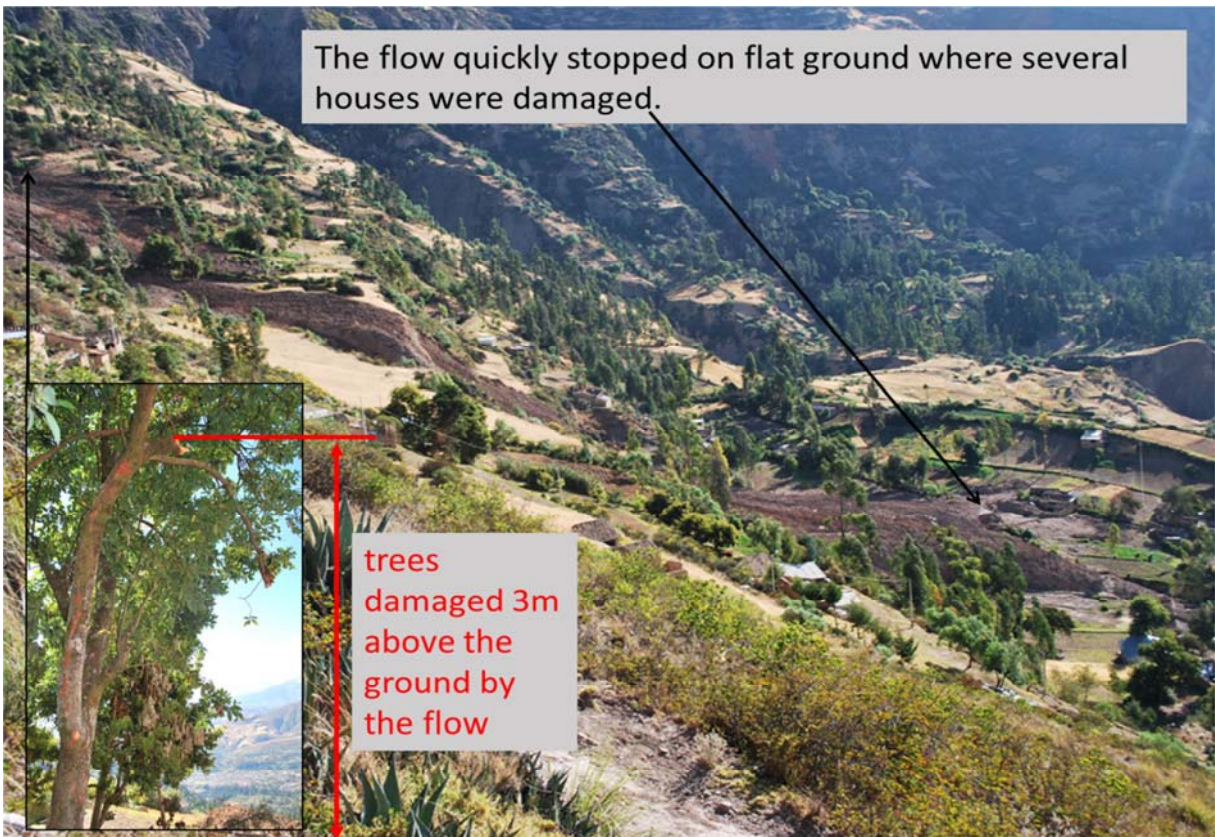
High hazard of reactivation was identified at three parts of the landslide.

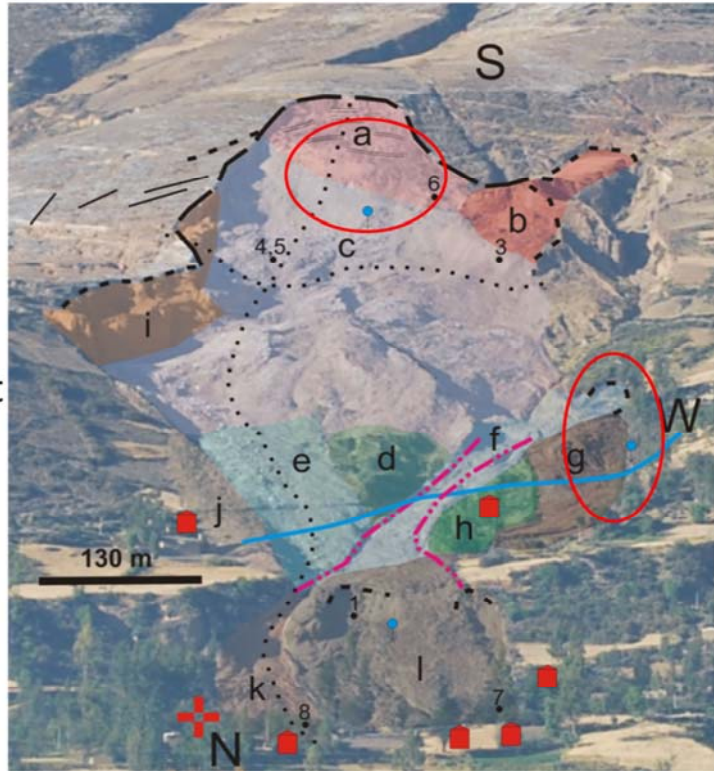
2009

Comparison of two photographs of landslide accumulation probably explains the perceived process of „mountain healing“ (Vilímek et al., 2016).

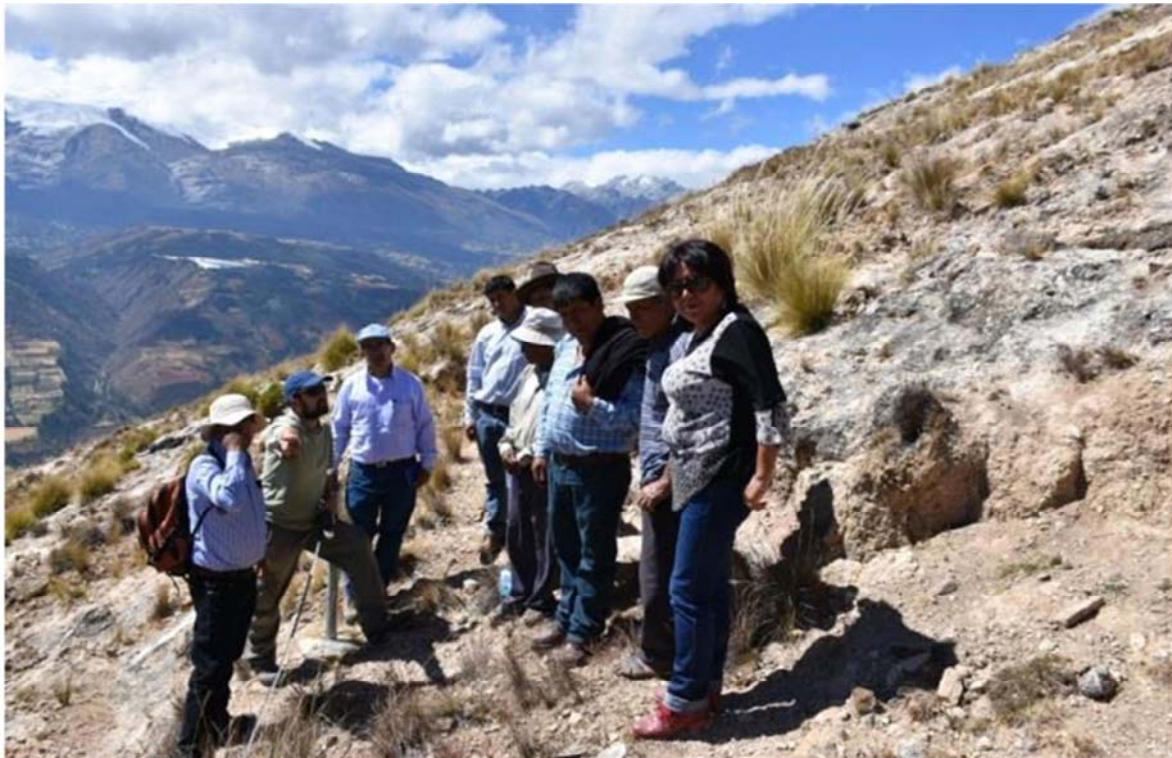
Field explanation of the landslide monitoring technique to the Rampac Grande community representatives, (Klimeš et al., 2019)
