# **Proceedings of 2019 IPL SYMPOSIUM ON LANDSLIDES**

**16 – 19 September 2019  
UNESCO Headquarters in Paris, France**

# 2019 IPL SYMPOSIUM ON LANDSLIDES

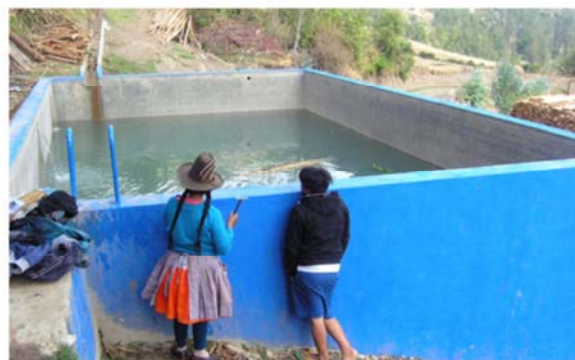
Construction of two water reservoirs (2018, cost of 26,000 USD) – site selection and financial support of the Peruvian state were obtained using the landslide hazard map of the 2016/2017 project.

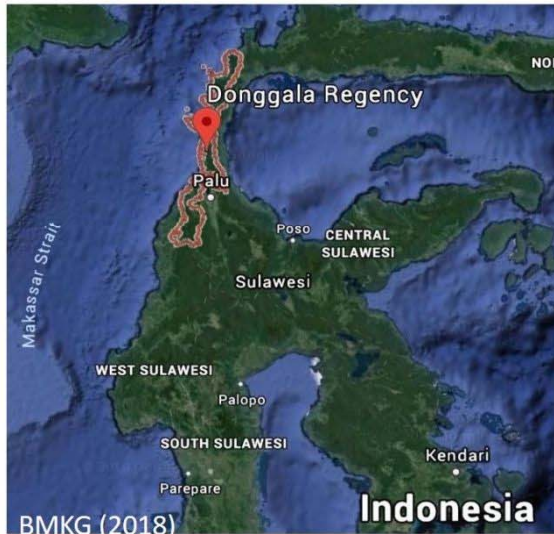
## 2018 Palu Earthquake

- The epicenter of M7.5 Earthquake was northeast of Palu City at a relatively shallow depth of 10 km.
- The earthquake was followed by a series of 6 m (max) tsunami waves.
- The earthquake caused liquefaction and earth flows, which affected 400 hectare.
- The earthquake, tsunami, and liquefaction caused severe damage and resulted in a death toll of >2000.
- Sept-Oct 2018, 21 earthquakes >M5 with  $\pm 10$ km depth.
- Total Loss \$ 1.5 billion

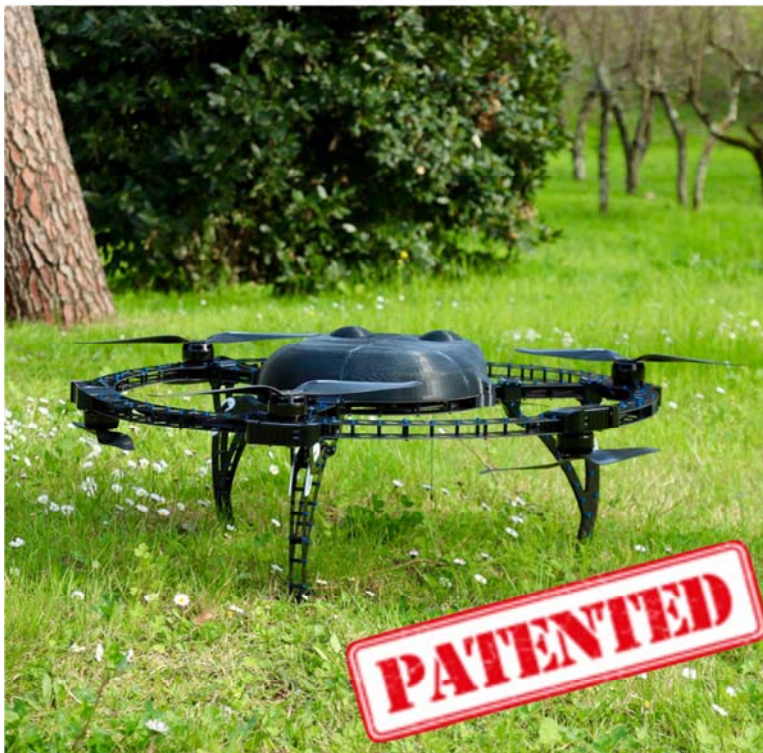
## Multi sensor drone (SATURN)

Multi and Hyper Spectral

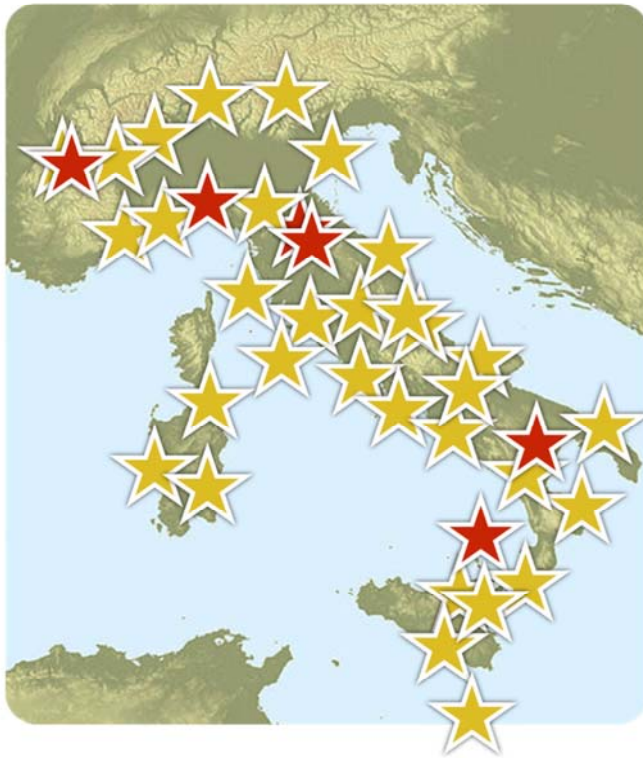
## Monitoring sites

40+  
monitoring  
sites

6 active now

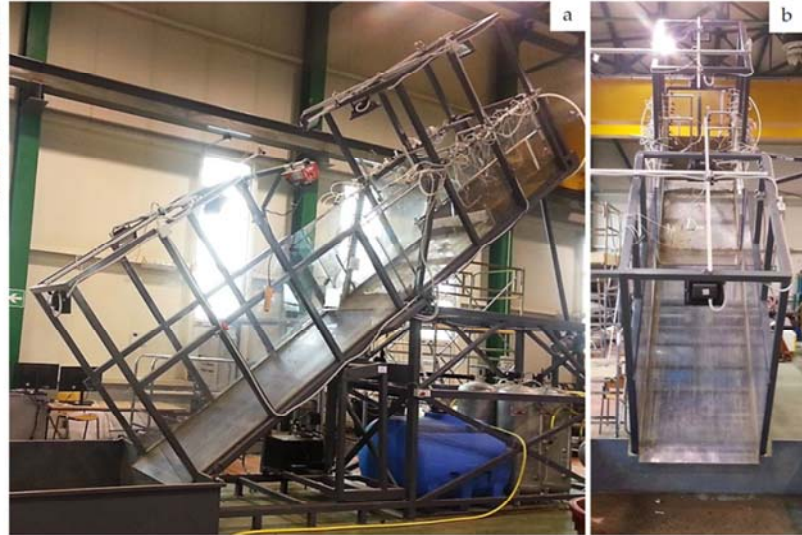
Figure 2: Physical model: a) Side view b) Frontal view.

Channel	Length	Width	Height	Max Slope
Upper part	3 m	1 m	1 m	55°
Lower part	3 m	1 m	1 m	40°

For that purpose a physical scale model at the University of Calabria was designed and built, very useful for carrying out complex tests to analyze the response of loose soils or debris in terms of stability. Two channels compose it; the first one is adopted for analysing the triggering mechanisms, the second one for the propagation phases. Both channels are equipped with suitable sensors for monitoring the main physical variables, i.e.: spray nozzle systems, to apply a rainfall intensity; minitensiometers and TDR for measuring respectively suction values and water content; miniaturized pressure transducers for pore water pressures; laser displacement sensors.

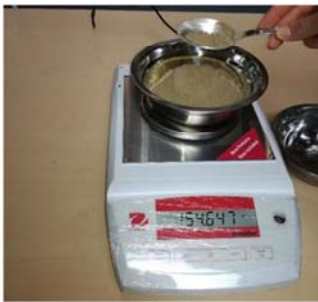
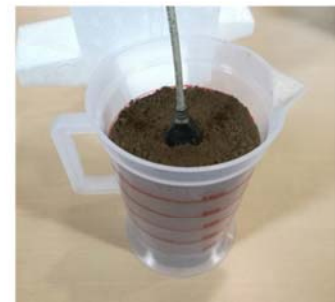
Laboratory tests

Weight <sub>(water)</sub> [g]	Volumetric water content			$\epsilon_b$
	$\theta = V_w / V_{tot}$	$\theta$ (Topp)	$\Delta$	
40	0,066	0,042	0,024	3,50
80	0,106	0,061	0,045	4,26
120	0,146	0,1035	0,0425	6,06
170	0,196	0,164	0,032	8,88
220	0,246	0,221	0,025	11,87
270	0,296	0,3305	-0,0345	19,14

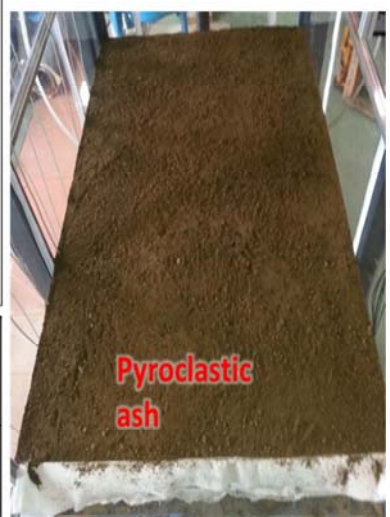
## TEST T1

STEPS	Angle of inclination (degrees)	Rainfall intensity (mm/h)	Time
<i>Infiltration horizontal slope</i>	0	50	50 min
<i>Evaporation</i>	0	0	14 days
<i>Redistribution</i>	38	0	8 days
<i>Failure</i>	38	50	40 min

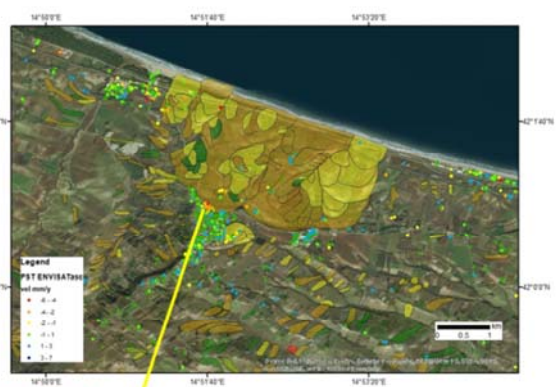
PST – ENVISAT ASC data

time-interval 2003 - 2010

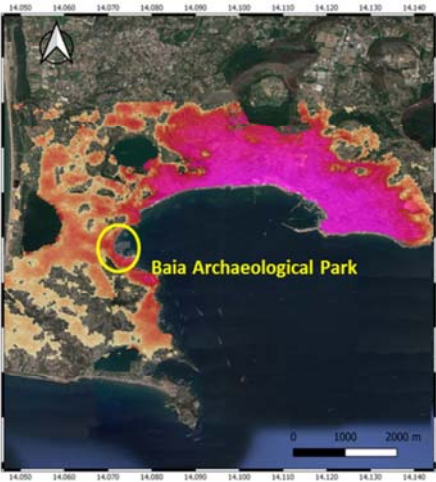
Area di interesse: Baia - Pozzuoli  
 Immagine di base: Google Maps  
 Scala: 1:35000  
 Tipo di analisi: analisi di instabilità basata su tecniche di analisi interferometrica  
 Tipo di strumento: Satellitare  
 Tipo di sensore: SAR (Synthetic Aperture Radar)  
 Risonanza del sensore: Sonda-1  
 Risoluzione del sensore: 10 m  
 Osservazioni: Si segnala un'importante attività di sollevamento in tutta l'area analizzata e posta intorno al golfo di Pozzuoli. In particolare il sollevamento più importante si ha in corrispondenza del Rione Rione Terra di Pozzuoli, e l'effetto deformativo risulta essere presente anche nell'area del Parco Archeologico di Baia

Velocità di deformazione del suolo (mm/anno)	
0	0
1.5	1.5
3	3
6	6
9	9
15	15
30	30

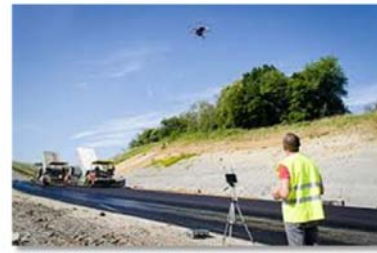
The **drone-based photogrammetric imaging** and **LIDAR technology** also provide non-invasive, high-precision end-products, while overcoming some limitations of the InSAR technology (limited coverage in vegetated areas and geometric constraints related to sensor acquisition).

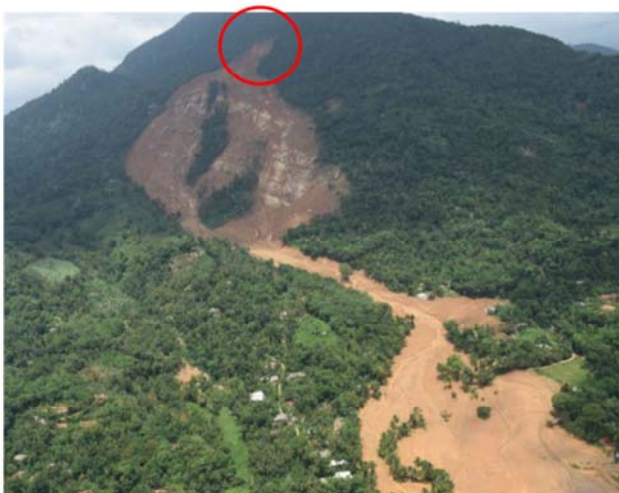
Aranayake landslide in 2016, Sri Lanka: Debris mass from 600m altitude slid over a 2 km distance. 125 people were killed.

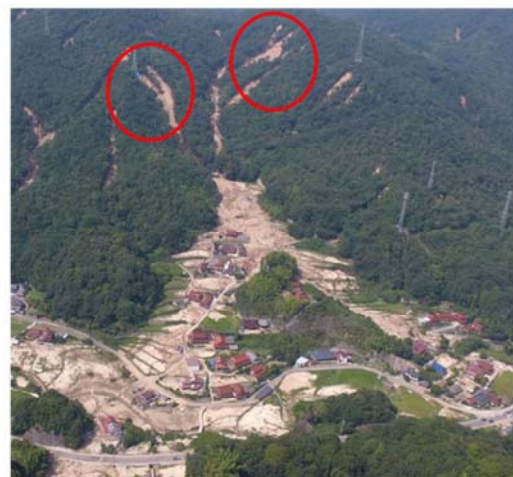
In June, 2018, a seasonal "Baiu" front extending over the western Japan became stationary causing thousands of RRLLs including this one in Yasuura, Hiroshima. The debris mass from 150m altitude slid over a 1 km distance killing one lady.

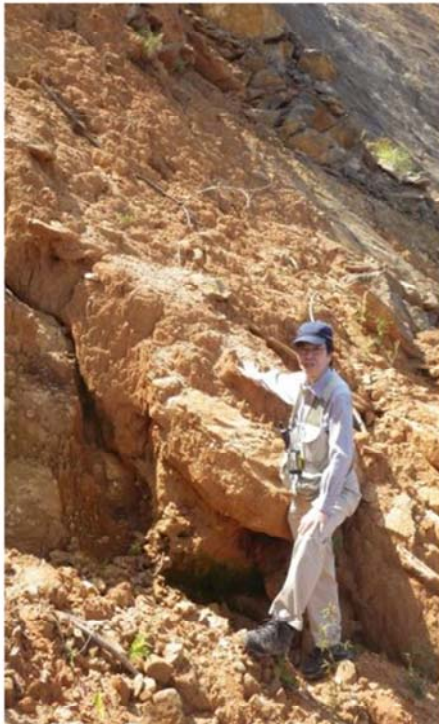
Sliding surfaces were found developed in the interiors of weathered surface layers at Aranayake and Kure

**Samples from sliding surfaces were taken for Dynamic loading ring-shear tests.**

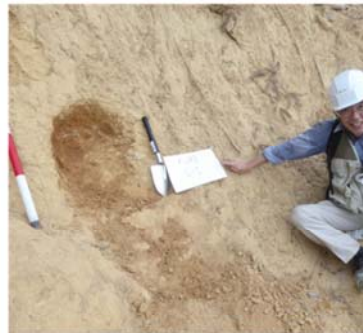
Source areas in Aranayake (left) and Kure (right)

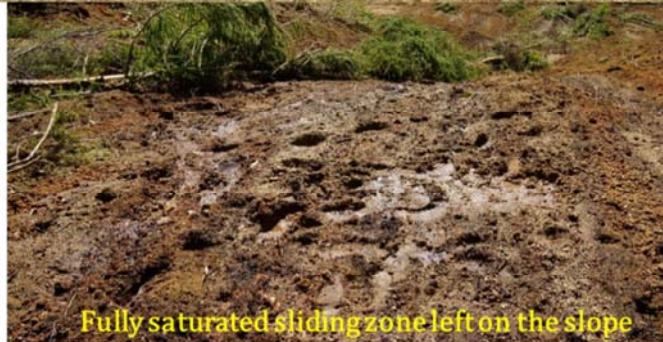
Fully saturated sliding zone left on the slope

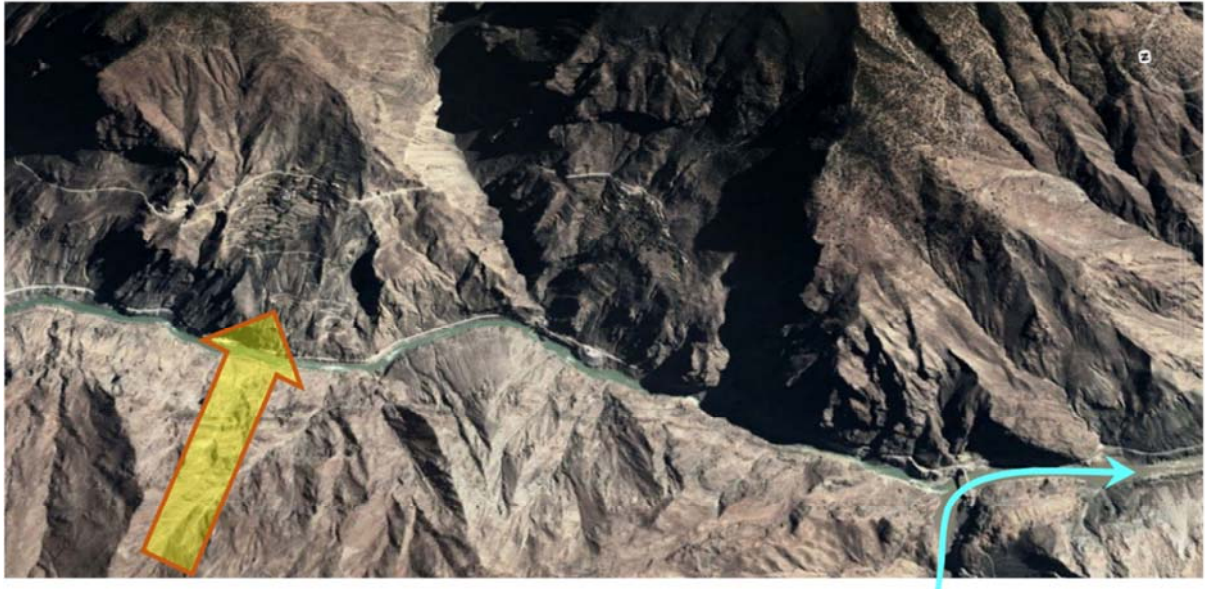
Intensively crushed debris with rare boulders inside and with preserved evidence of bedding in the internal part of the breached rockslide dam overlain by coarse boulder carapace

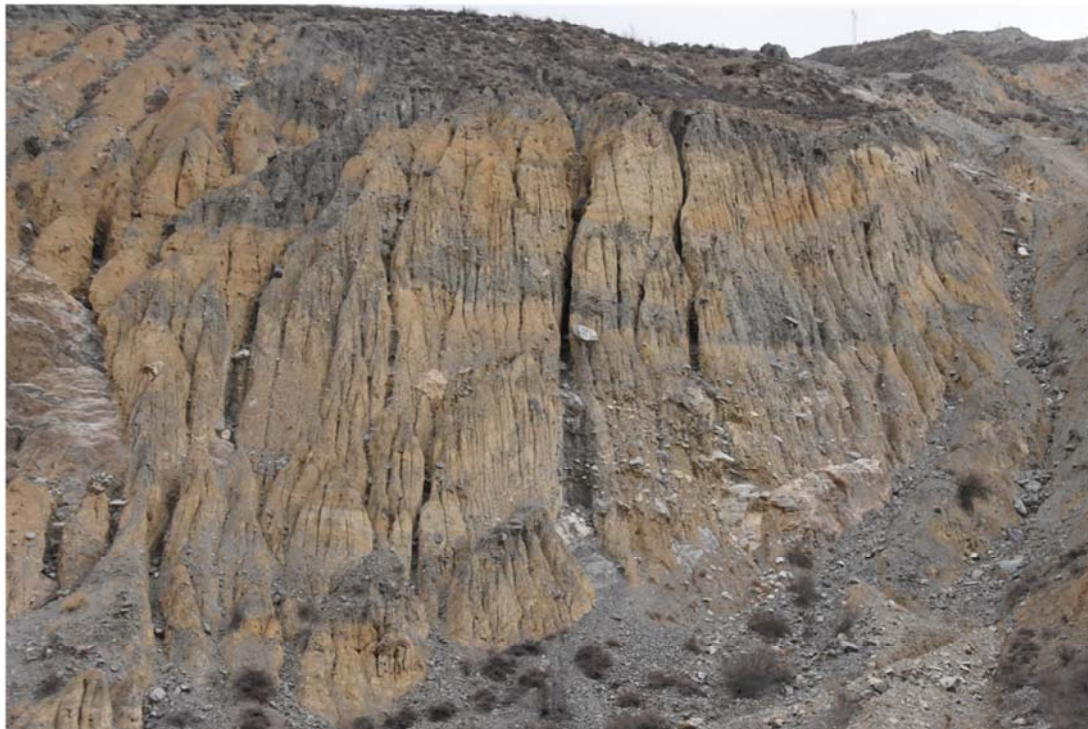
Dual structure of rockslide (rock avalanche) dam in the Jinsha River valley at  $29.316^{\circ}$  N,  $99.074^{\circ}$  E and sharp contact between fragmented and blocky zones.

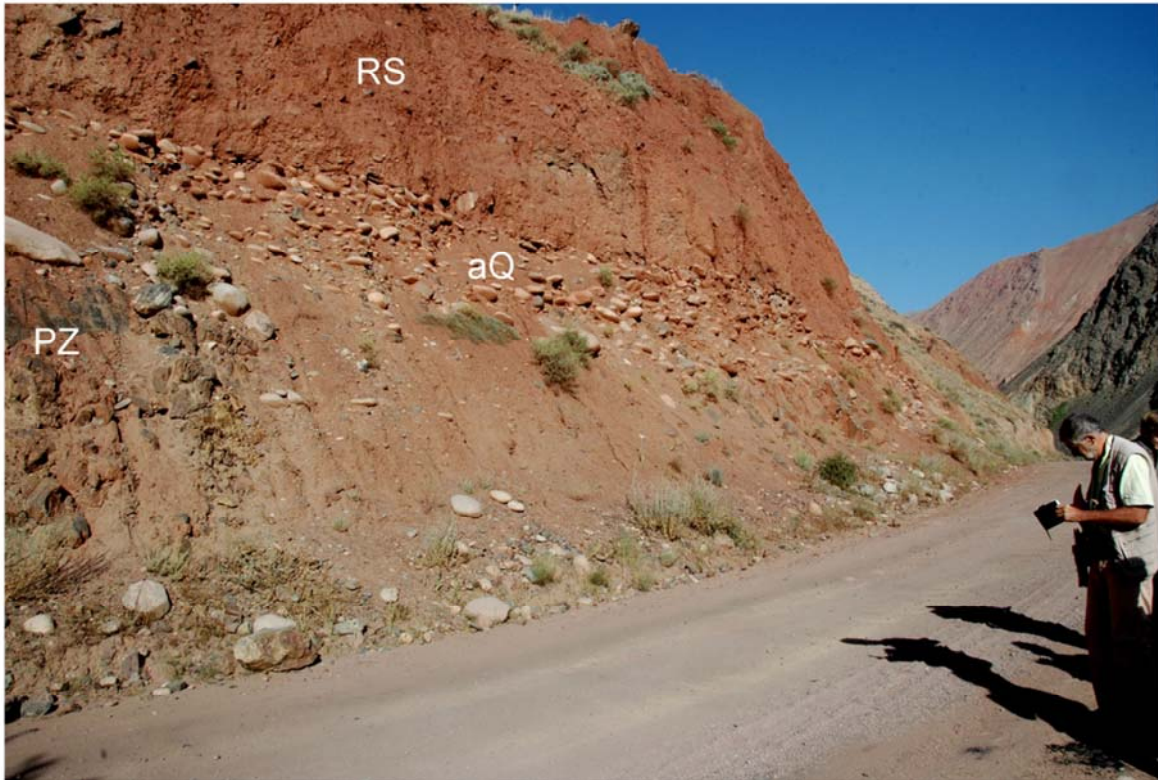
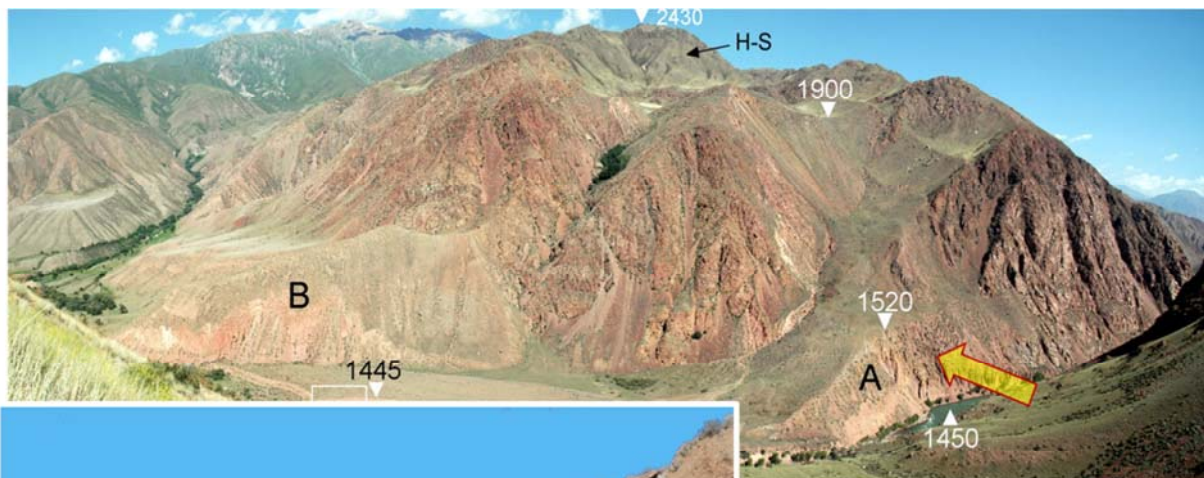
Lower Aral rock avalanche, Central Tien Shan, at  $41.799^{\circ}$  N,  $74.29^{\circ}$  E. Fragmented granite overlaid by coarse carapace of the same granite.

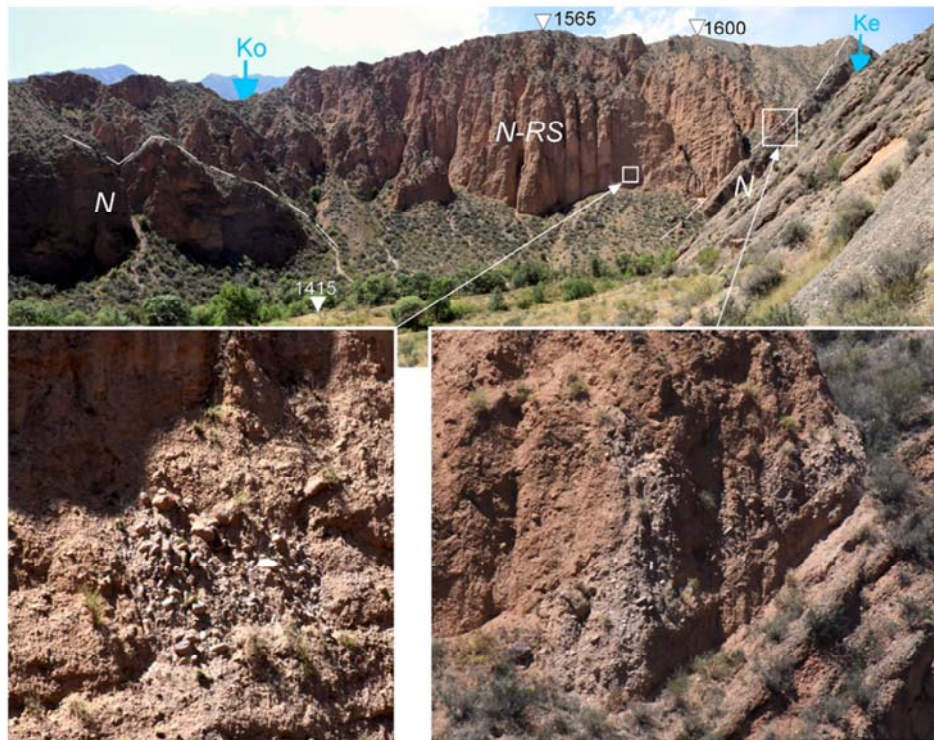
Sometimes big “blocks” of alluvium remain in rock avalanche debris, as it was found in the frontal part of the Karachauli rock avalanche in Central Tien Shan, at  $41.733^{\circ}$  N,  $74.073^{\circ}$  E.

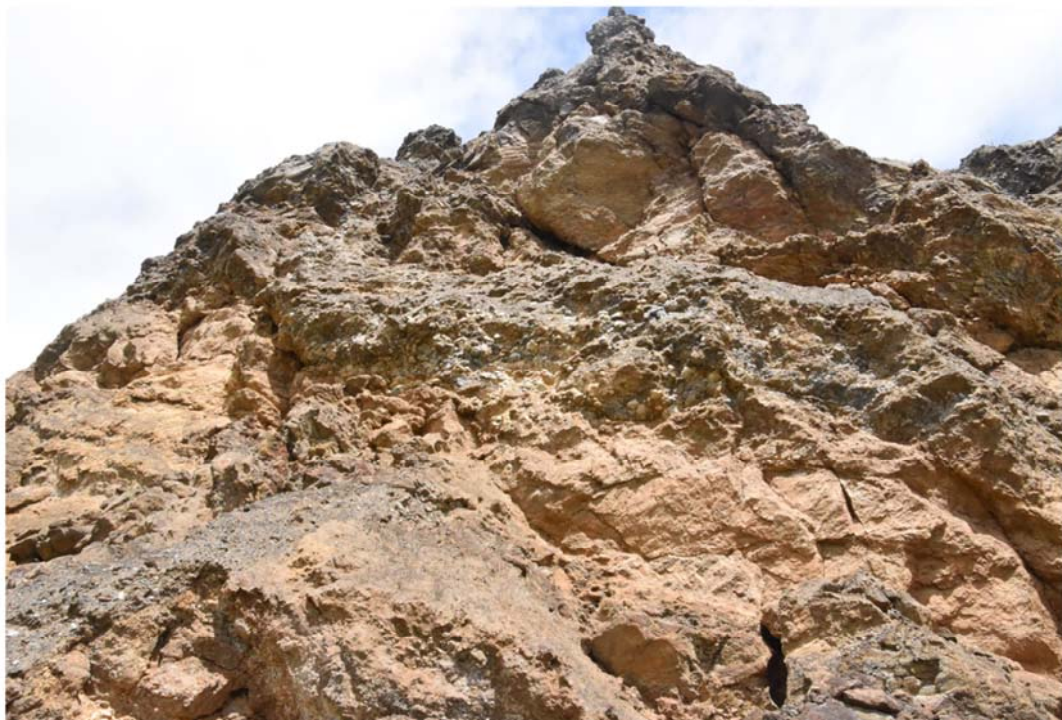
Similar inclusion of the fluvial pebbles in rockslide deposits was observed at the upstream part of the Ancient Diexi rockslide in Minjiang River valley, Sichuan, China”, at  $32.041^{\circ}$  N,  $103.668^{\circ}$  E.

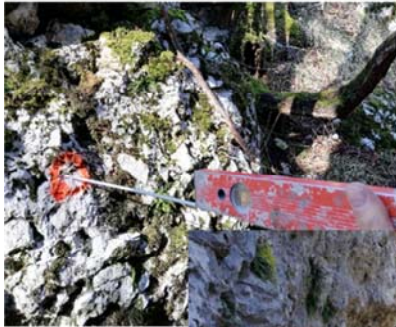
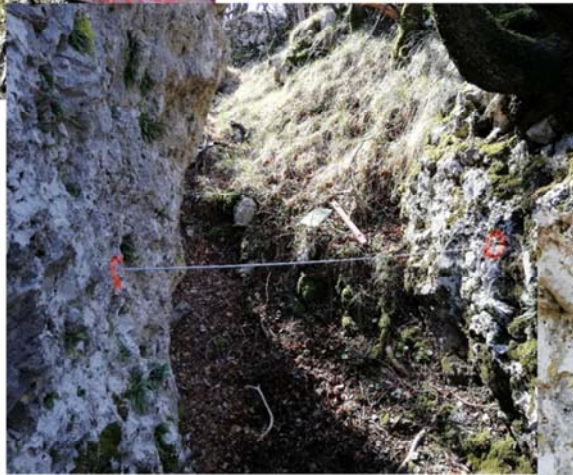
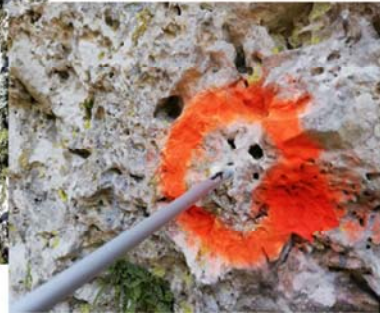
## 2018 Activities – Crack measurements

Simple crack opening measurements:

- Fixed point built-in
- Zero measurement (until now)

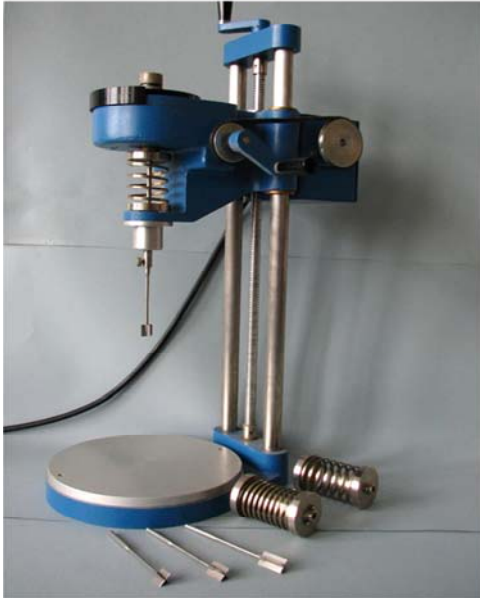
Laboratory vane (ELE)

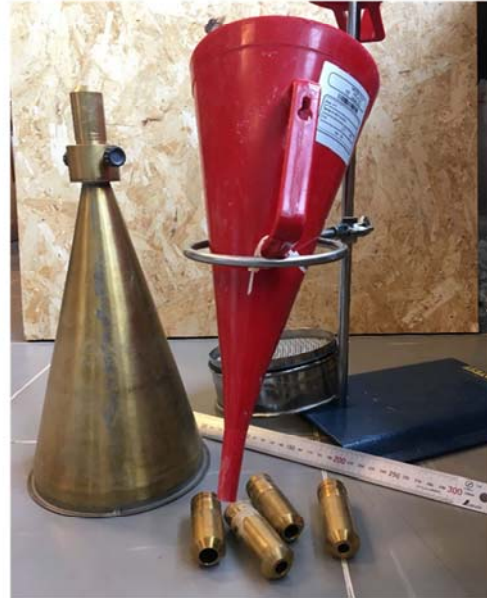
Marsh cone (funnel) viscometer  
4.76, 8, 9, 10, 11, 13 mm orifice

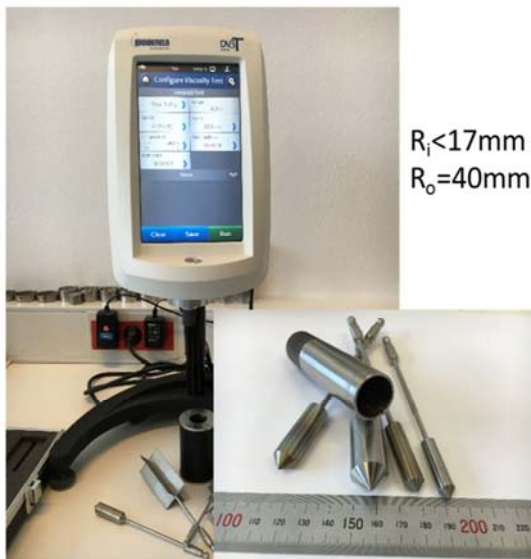
DV3THB, Brookfield –  
shear rate controlled coaxial cylinder rheometer

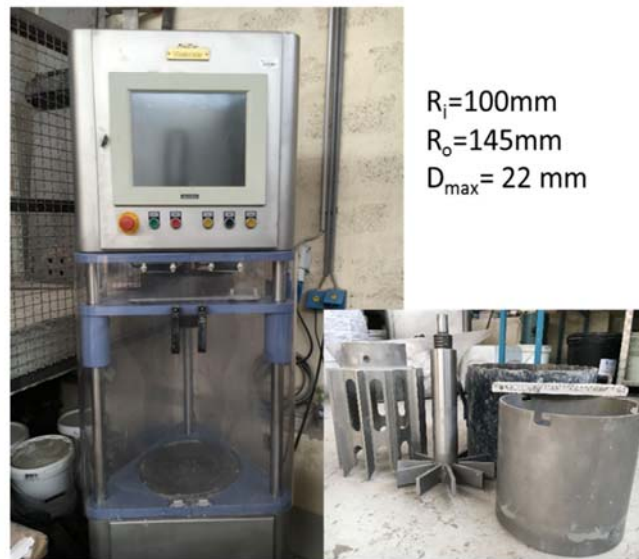
ConTec Viscometer 5,  
Shear rate controlled coaxial cylinder rheometer,

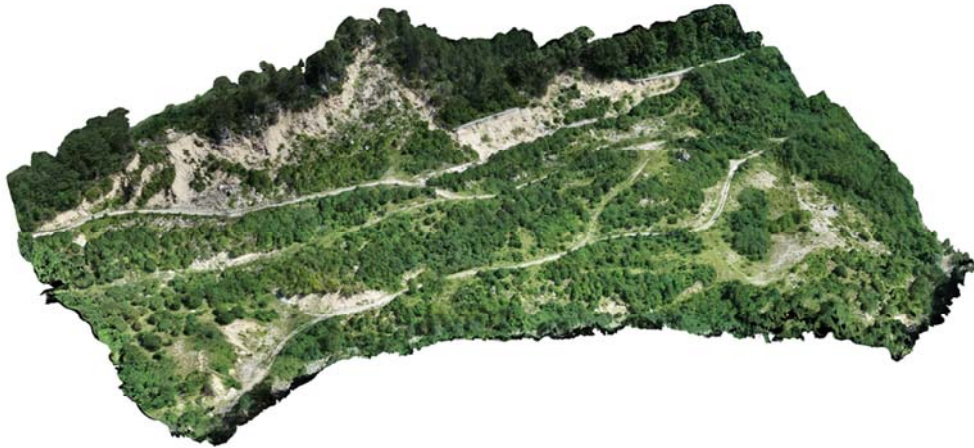
## 3D model and volume calculations

- UAV, August 2018
- 5 cm horizontal accuracy

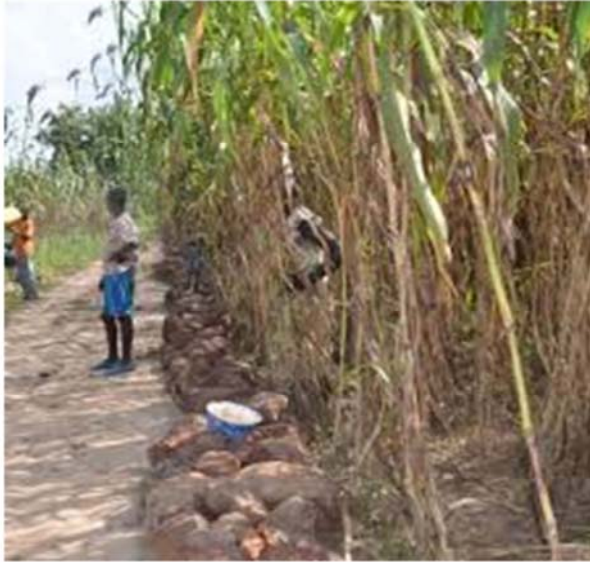
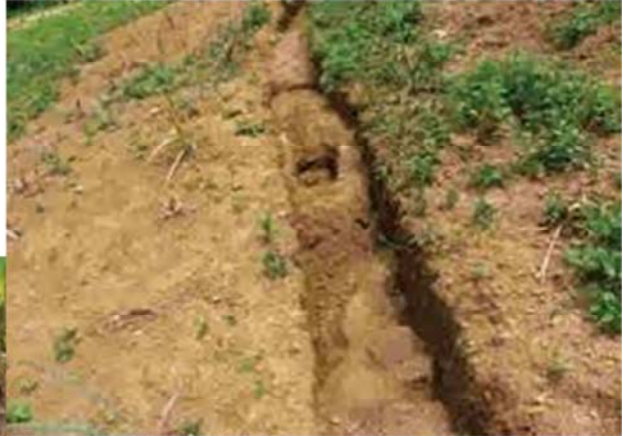
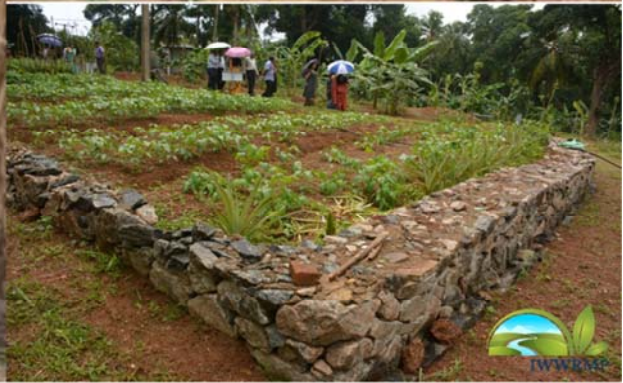
## Stone bunds: Simple yet effective water and soil conservation

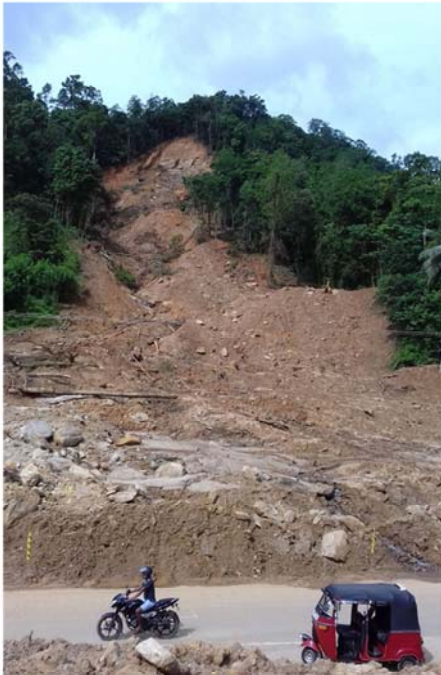
May 2017 Athwelthota landslide in Kalutara District Sri Lanka, which killed 09 people. Landslide was initiated from residual soil origin.

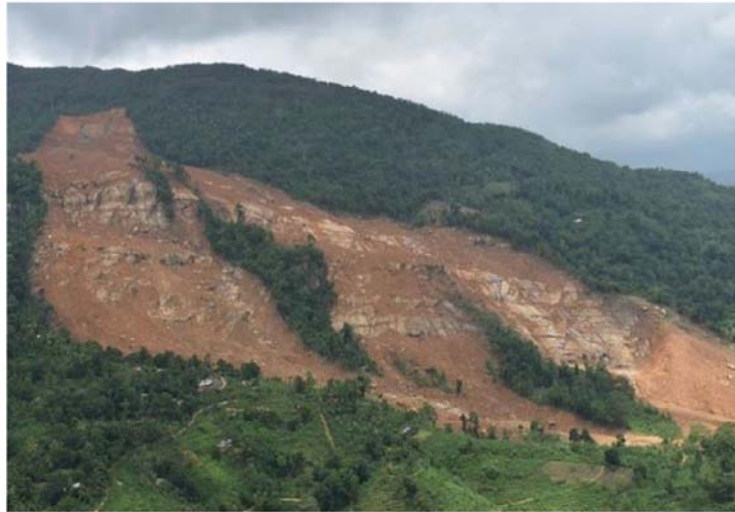
May 2016 Aranayake landslide in Kegalle District, Sri Lanka, which killed 127 people. The image indicates landslide failure initiated in residual soil and boundary intact with weathered rock face.
